American Littoral Society  
Restoring Ecologically Beneficial and Resilient Infrastructure At The  
Mouth of Maurice River, Basket Flats  
Abiotic Physical Monitoring Report for 2023

Stockton University Coastal Research Center

*November 2024*

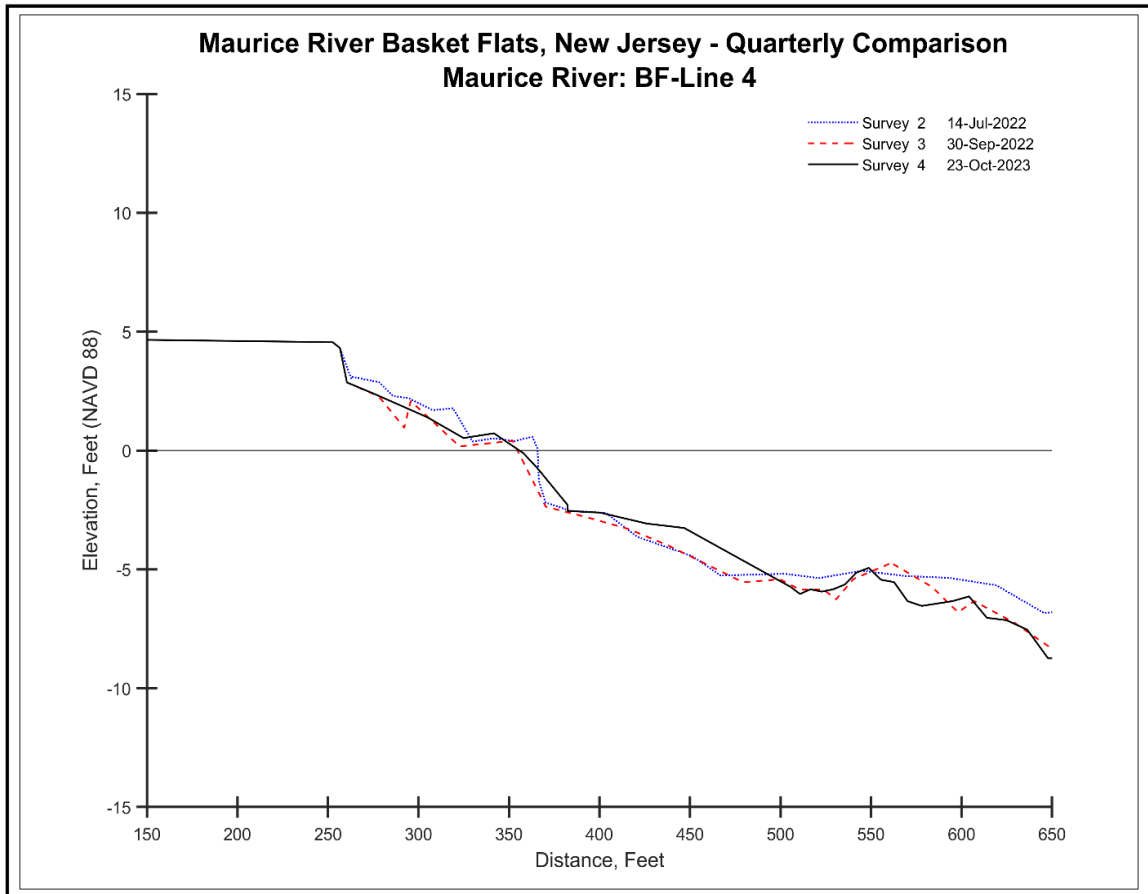
**Figure 5. Line 4 is located leeward of breakwater unit #9 near the eastern end of the project. Direct survey comparisons show onshore sediment losses (-2.03 yds<sup>3</sup>/ft) between the pre and post construction surveys (survey 2-survey 3). The shoreline position shifted landward -11 feet between the pre, and post construction surveys. Further offshore, there was pattern of scouring that occurred seaward of the breakwater location. One year following construction the onshore volume changes stabilized (0.63 yds<sup>3</sup>/ft) with minor inflation in elevation above the zero-elevation datum. The marsh edge remained unchanged. The shoreline position leeward of breakwater unit #9 advanced seaward slightly (1 foot) from fall 2022 to fall 2023. Immediately nearshore within the breakwater lee the elevation inflated with an accumulation of sediment (3.38 yds<sup>3</sup>/ft). Further offshore, beyond the breakwater location, additional sediment accumulated (6.98 yds<sup>3</sup>/ft) on the bay floor and resulted in a net gain below the zero datum of 10.36 yds<sup>3</sup>/ft of sediment.**

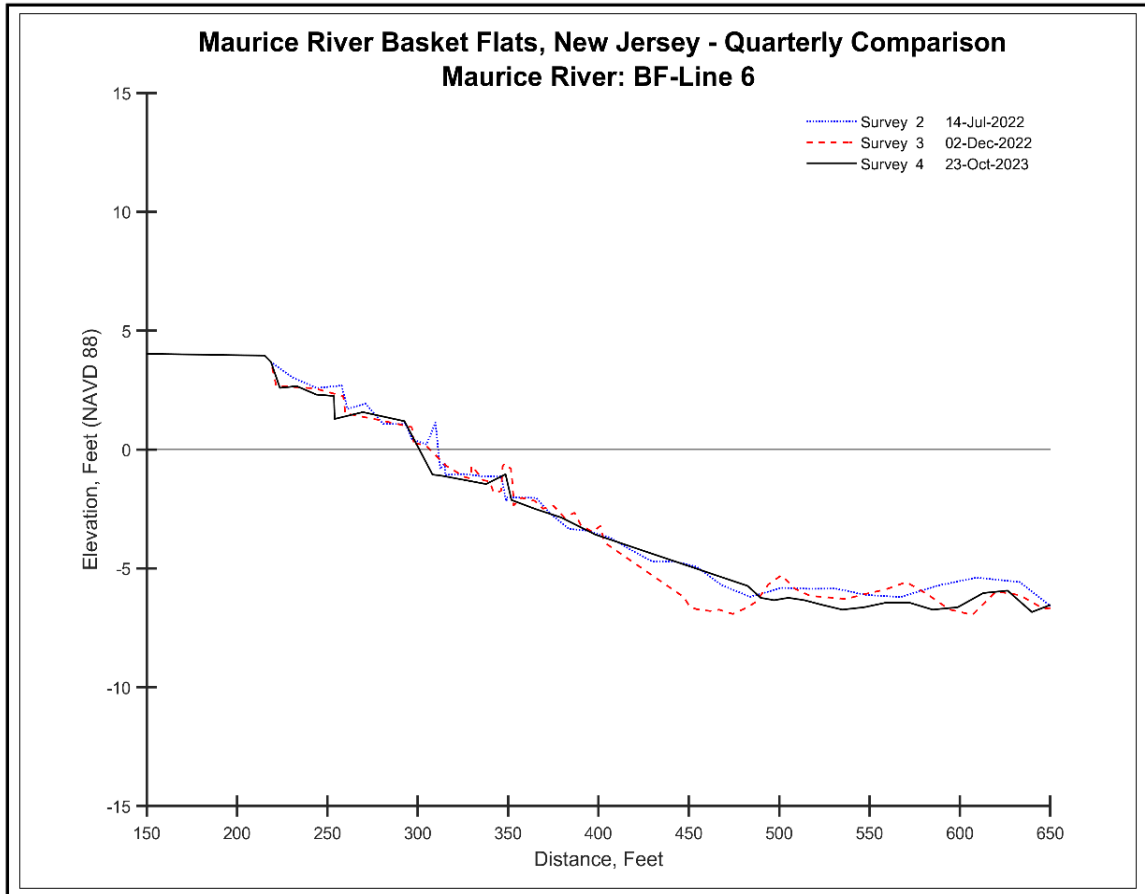
**Figure 6. Line 6 is located between breakwater unit #8 and #9 in the 25-foot gap. Comparisons between the pre and post construction surveys show some erosion of the marsh edge and platform (-0.87 yds<sup>3</sup>/ft) and sediment (-1.87 yds<sup>3</sup>/ft) and elevation loss along the nearshore bay floor. The shoreline position responded with an 11-foot shift landward between the pre and post construction surveys. One year following construction the onshore volume change was minor (-0.16 yds<sup>3</sup>/ft) with modest elevation deflation on the lower marsh platform while the marsh edge was stable from fall 2022 to fall 2023. The shoreline position at this site shifted landward (-6 feet) from December 2022 to October 2023. Immediately nearshore a modest volume of sediment accumulated (2.45 yds<sup>3</sup>/ft) in the breakwater lee while seaward there was some scouring. Additional accretion occurred further offshore prior to October 2023 that resulted in a net change below the zero datum of 5.35 yds<sup>3</sup>/ft of sediment.**

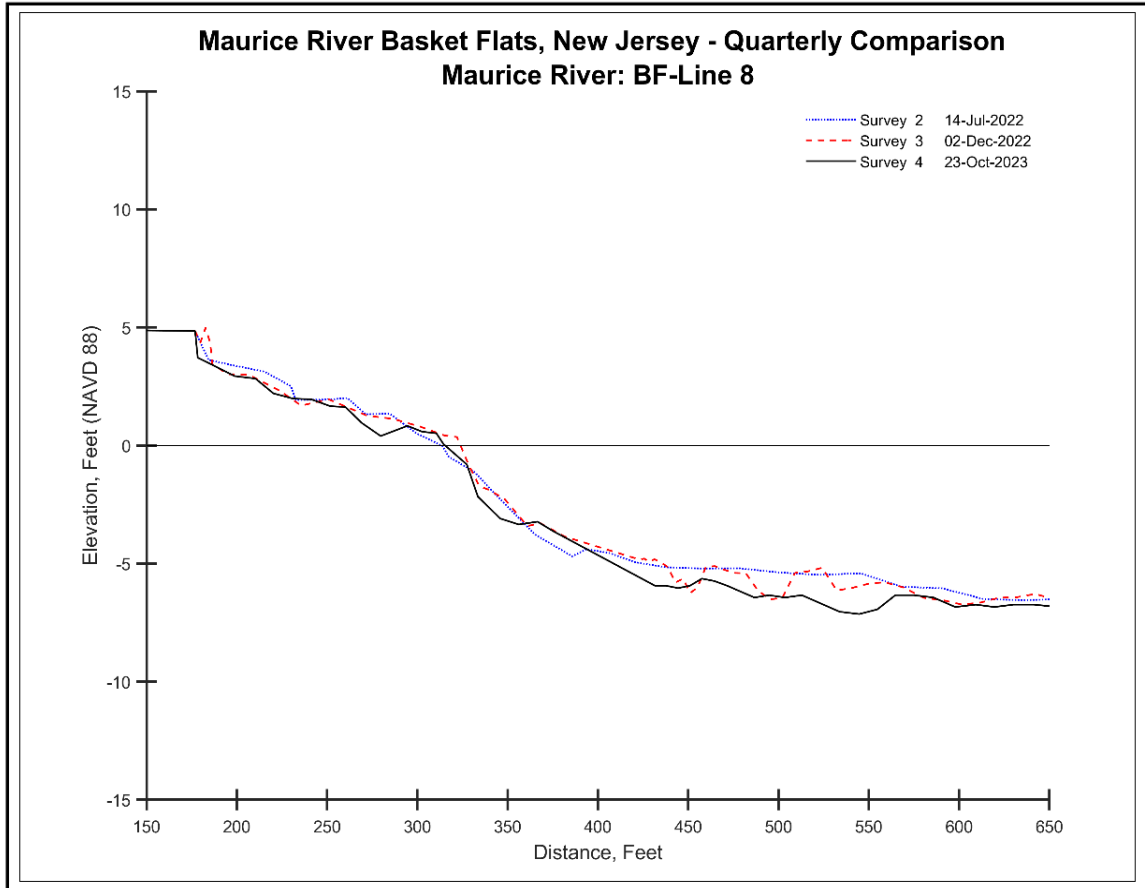
**Figure 7. Line 8 is located between breakwater unit #7 and #8 in the 25-foot gap. Survey comparisons show minor onshore sediment losses (-0.39 yds<sup>3</sup>/ft). But shoreline position shifted seaward 11 feet between the pre, and post construction surveys. Nearshore, there was pattern of scouring that occurred seaward of the breakwater location. One year following construction the onshore volume changes remained small (-1.23 yds<sup>3</sup>/ft) with modest elevation deflation from the marsh edge to the shoreline. The shoreline position within the gap between the breakwaters shifted landward (-9 feet) from December 2022 to October 2023. Immediate nearshore lost a modest volume of sediment (-1.71 yds<sup>3</sup>/ft) to scouring while further offshore scour deflated the bay floor elevation and resulted in a loss of -3.28 yds<sup>3</sup>/ft of sediment.**

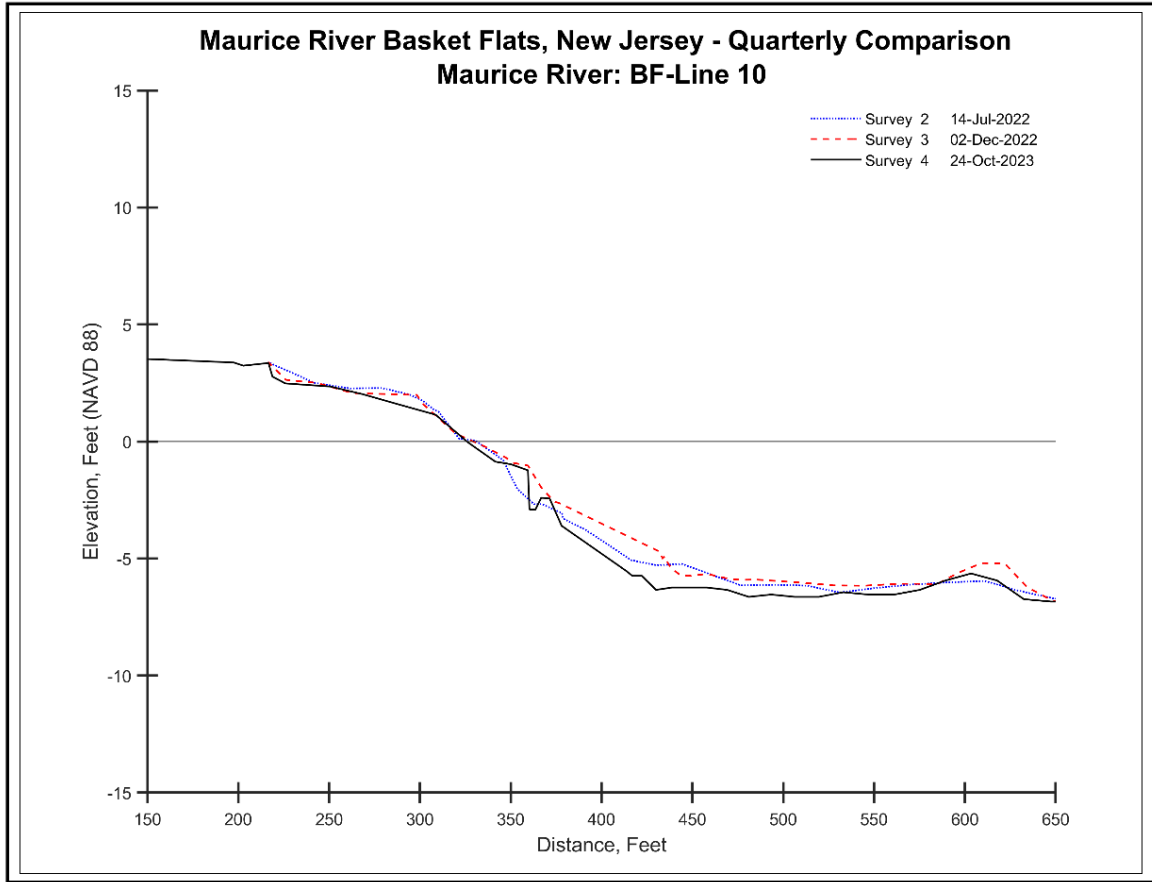
**Figure 8. Line 10 is located on the leeward of breakwater unit #7. Survey comparisons show minor onshore sediment losses at the marsh edge but relative stability along the beachface slope net onshore volume loss was  $-0.53 \text{ yds}^3/\text{ft}$  with less than 2 feet of landward shift in the shoreline position between the pre, and post construction surveys. Nearshore, sediment accumulated ( $2.48 \text{ yds}^3/\text{ft}$ ) on the lower slope in the lee of the breakwater elevating the bay floor in between the pre and post construction surveys. One year following construction the onshore volume changes were modest ( $-0.64 \text{ yds}^3/\text{ft}$ ) from the marsh edge to the shoreline. The shoreline position shifted landward ( $-3.5$  feet) from December 2022 to October 2023. Nearshore suffered scouring for a loss of elevation and volume ( $-6.36 \text{ yds}^3/\text{ft}$ ).**

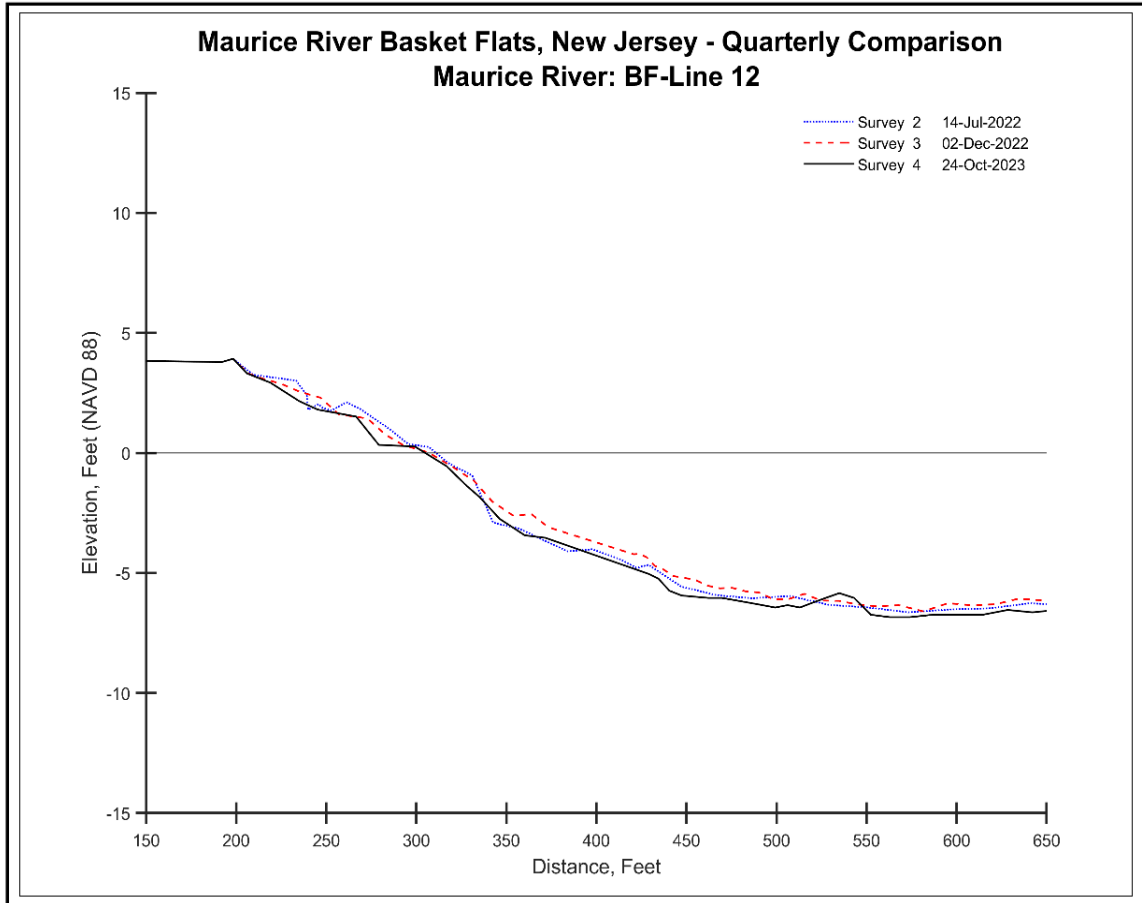
**Figure 9.** Line 12 is located on the leeward of breakwater unit #6. Survey comparisons show minor onshore sediment losses (-0.62 yds<sup>3</sup>/ft) between the pre, and post construction surveys focused on the upper marsh edge and along the lower beachface slope. Erosion at the beachface toe of slope resulted in a landward shift (-4 feet) of the shoreline position. Nearshore, sediment accumulated (5.02 yds<sup>3</sup>/ft) across the bay floor as a thin layer in between the pre and post construction surveys that inflated the nearshore elevation along the profile. One year following construction the onshore volume changes were modest (-0.82 yds<sup>3</sup>/ft) from the marsh edge to the shoreline. The shoreline position shifted slightly landward (-2 feet) from December 2022 to October 2023. Nearshore suffered scouring across the profile for a loss of elevation and volume (-7.34 yds<sup>3</sup>/ft).

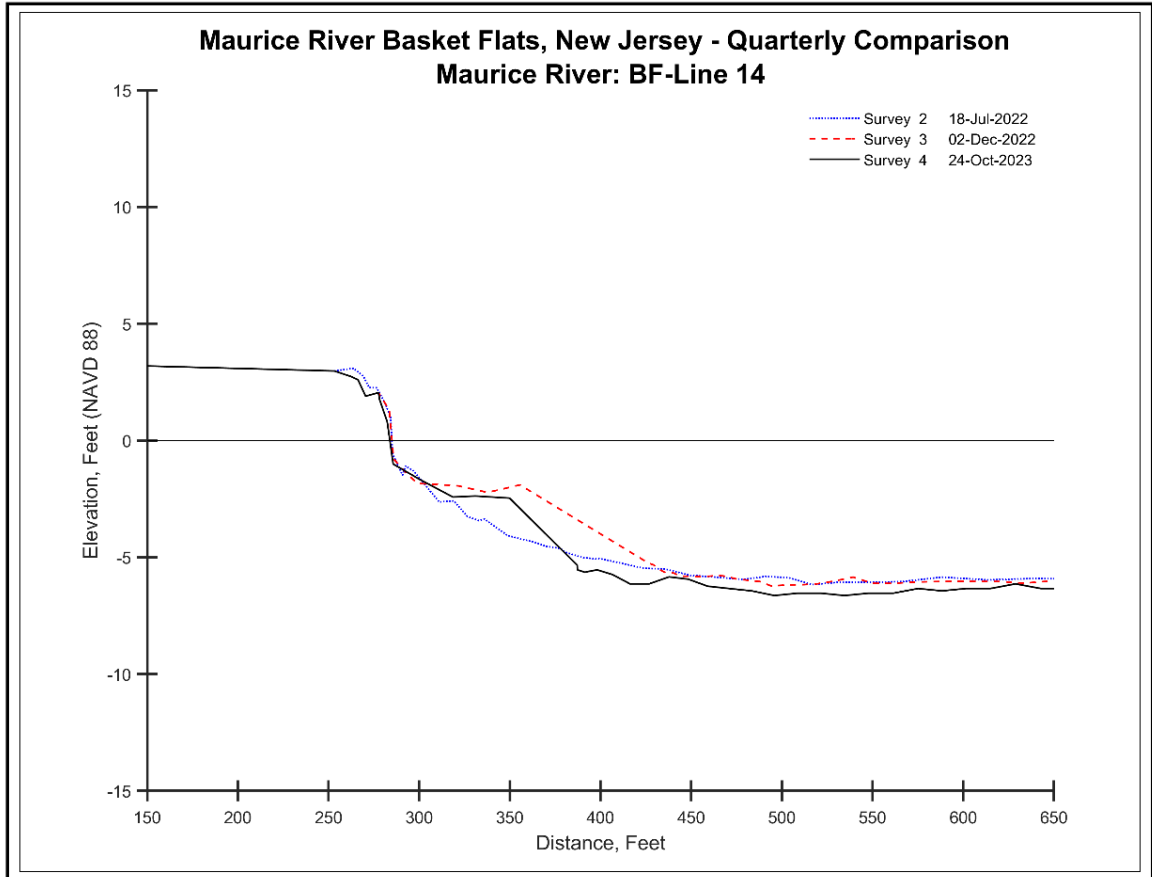
**Figure 10.** Line 14 is located on the leeward of breakwater unit #5. Survey comparisons show minor onshore sediment losses (-0.29 yds<sup>3</sup>/ft) between the pre, and post construction surveys focused on the upper marsh edge while the shoreline position was stable (0.05 foot). Nearshore, sediment accumulated (5.84 yds<sup>3</sup>/ft) behind the breakwater installation between the pre and post construction surveys that inflated the nearshore elevation. One year following construction the onshore changes were minor (-0.14 yds<sup>3</sup>/ft) from the marsh edge to the shoreline position that also remained relatively stable (-1 foot) from fall 2022 to fall 2023. In the lee of the breakwater the shallow nearshore suffered from scouring for a loss of elevation and volume (-8.16 yds<sup>3</sup>/ft). Seaward of the breakwater unit the loss of sediment continued removing a thin layer across the bay floor.

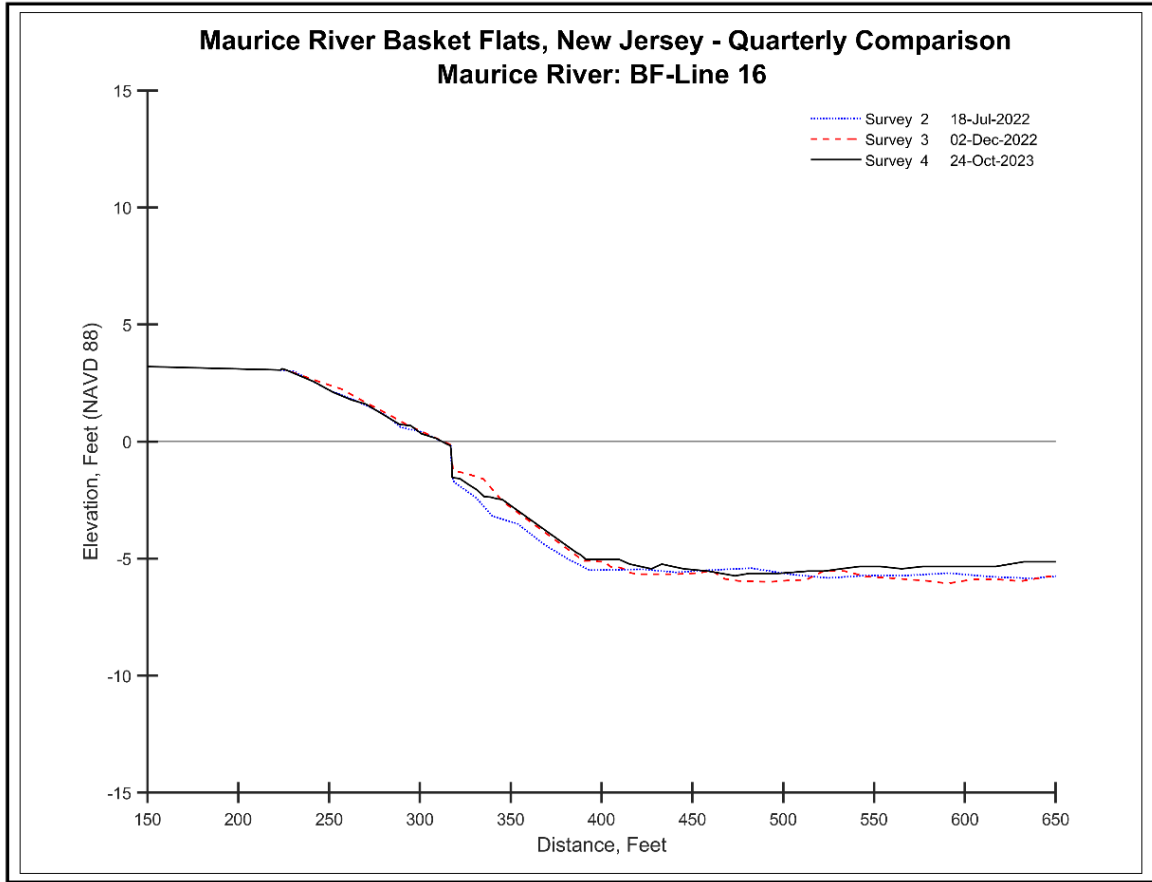
**Figure 11. Line 16 is located on the leeward of breakwater unit #4. Survey comparisons show minor onshore gains (0.37 yds<sup>3</sup>/ft) between the pre and post construction surveys while the shoreline position shifted landward slightly (-1 foot). Nearshore behind the breakwater installation there was a modest increase in the bottom elevation where sediment accumulated (2.0 yds<sup>3</sup>/ft). One year following construction the onshore changes were minor (-0.36 yds<sup>3</sup>/ft) from the marsh edge to the shoreline position that also remained stable (1 foot). In the lee of the breakwater the shallow nearshore accumulation was modest with 0.77 yds<sup>3</sup>/ft added. Seaward the breakwater unit there was significant accretion of sediment (30.64 yds<sup>3</sup>/ft).**

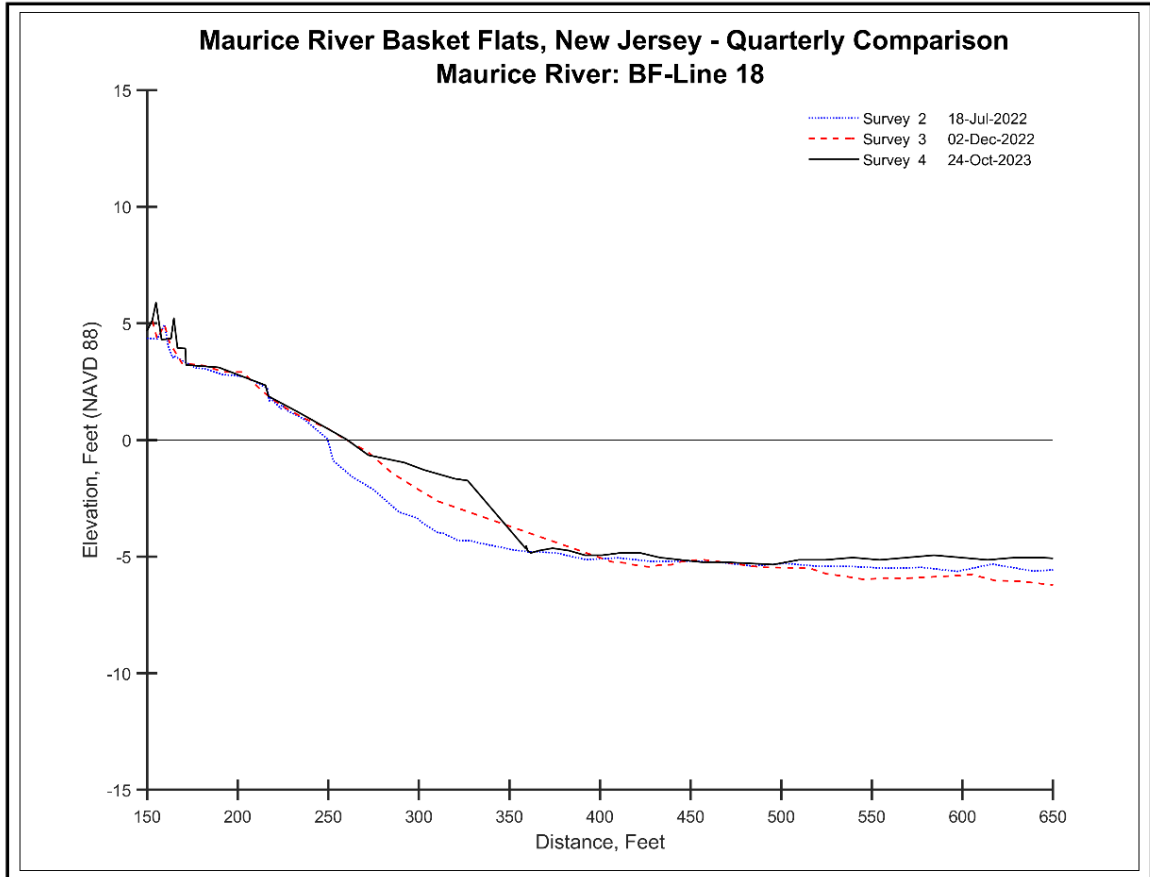
**Figure 12. Line 18 is located on the leeward of breakwater unit #3. Survey comparisons show minor onshore gains (0.41 yds<sup>3</sup>/ft) between the pre and post construction surveys but nearshore behind the breakwater installation there is considerable change in the bottom elevations where sediment rapidly accumulated (5.95 yds<sup>3</sup>/ft). The addition of this sediment in the shallow nearshore advanced the shoreline position seaward 10 feet. One year following construction the onshore changes were modest with minor sediment accumulation (0.43 yds<sup>3</sup>/ft) from the marsh edge to the shoreline position that also remained stable (0.4 feet). In the lee of the breakwater the shallow nearshore accumulated an additional 2.2 yds<sup>3</sup>/ft of sediment inflating the elevation. Seaward the breakwater unit there was significant accretion of sediment (34.34 yds<sup>3</sup>/ft).**

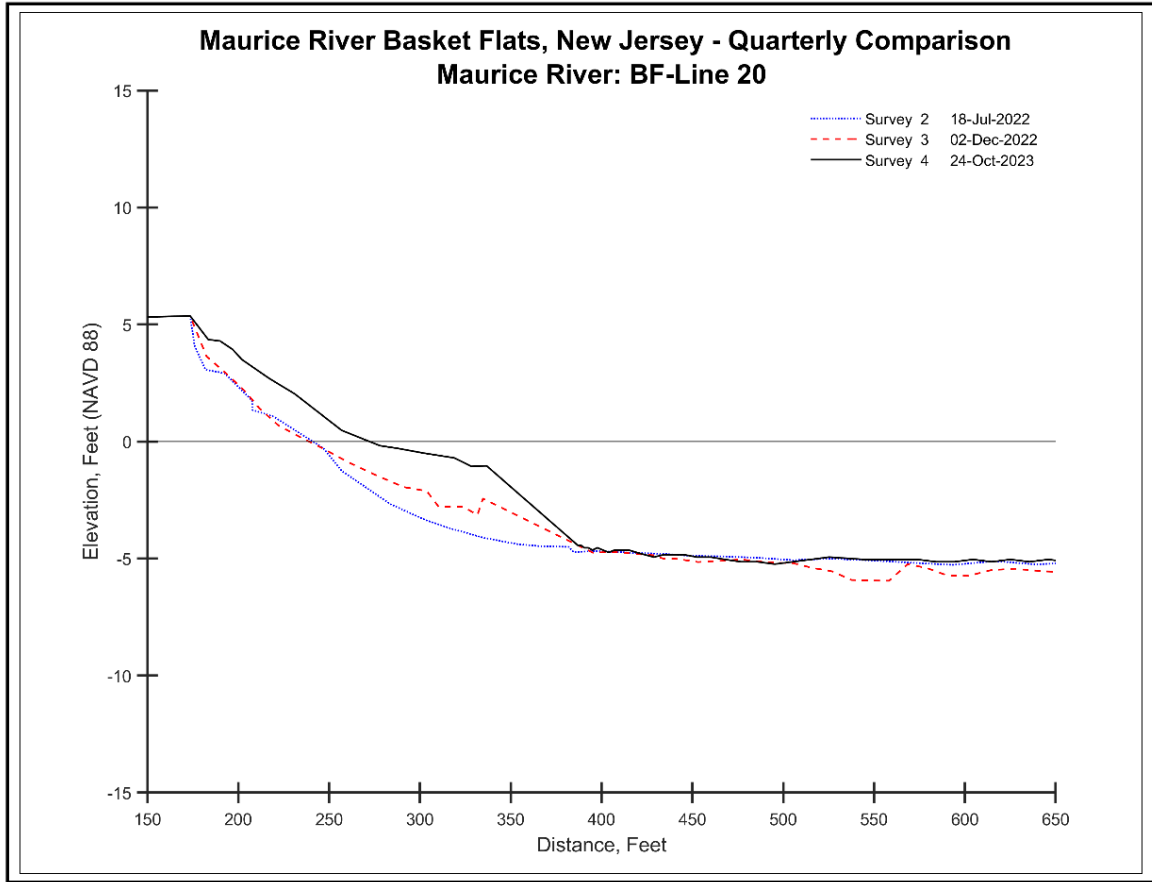
**Figure 13. Line 20 is located on the leeward of breakwater unit #2. Survey comparisons show minor onshore gains (0.29 yds<sup>3</sup>/ft) between the pre and post construction surveys but nearshore there is considerable change in the bottom elevations where sediment accumulated (2.90 yds<sup>3</sup>/ft). The breakwater was not included in the cross-section to show terrain changes only. One year following construction the onshore changes were significant with sediment accumulation from the marsh edge to the landward toe of the breakwater unit (11.25 yds<sup>3</sup>/ft) and the shoreline position advanced seaward 33 feet. On the nearshore platform additional sediment accumulated adding 12.67 yds<sup>3</sup>/ft of material to the bay floor one year following construction. This site clearly demonstrates the capacity for natural accretion in the lee of the breakwater unit overtime.**

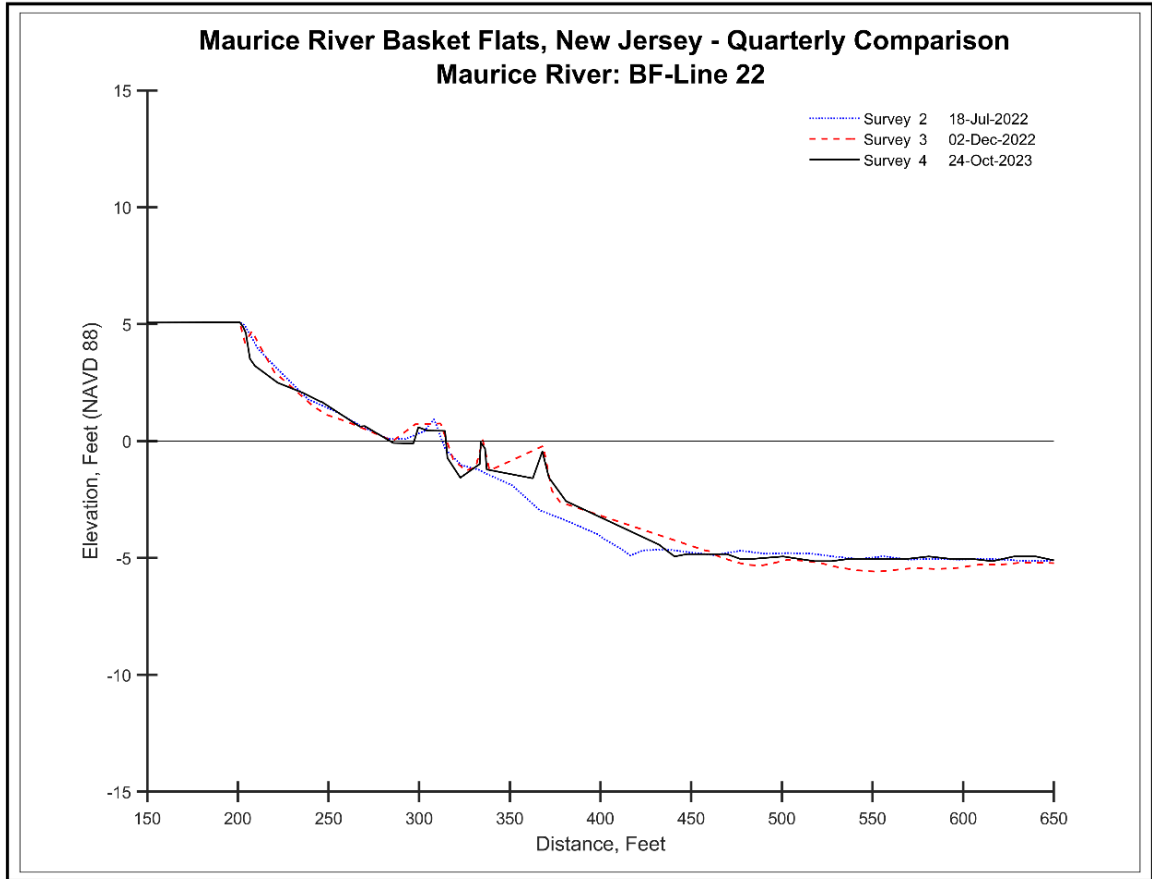
**Figure 14. Line 22 is located leeward of breakwater unit #1. Survey comparisons show little onshore change between the pre and post construction surveys but nearshore there is considerable change in the bottom where sediment accumulated. The breakwater was not included in the cross-section to show terrain changes only. Onshore volume changes from the pre to post construction surveys were minor (-0.16 yds<sup>3</sup>/ft) with a minor advance in the shoreline position (2 feet). One year following construction the onshore changes remained minimal with little volume change (-0.48 yds<sup>3</sup>/ft) and the shoreline was essentially stable (-0.4 feet). On the nearshore platform sediment accumulated adding 20.63 yds<sup>3</sup>/ft of material to the bay floor one year following construction.**

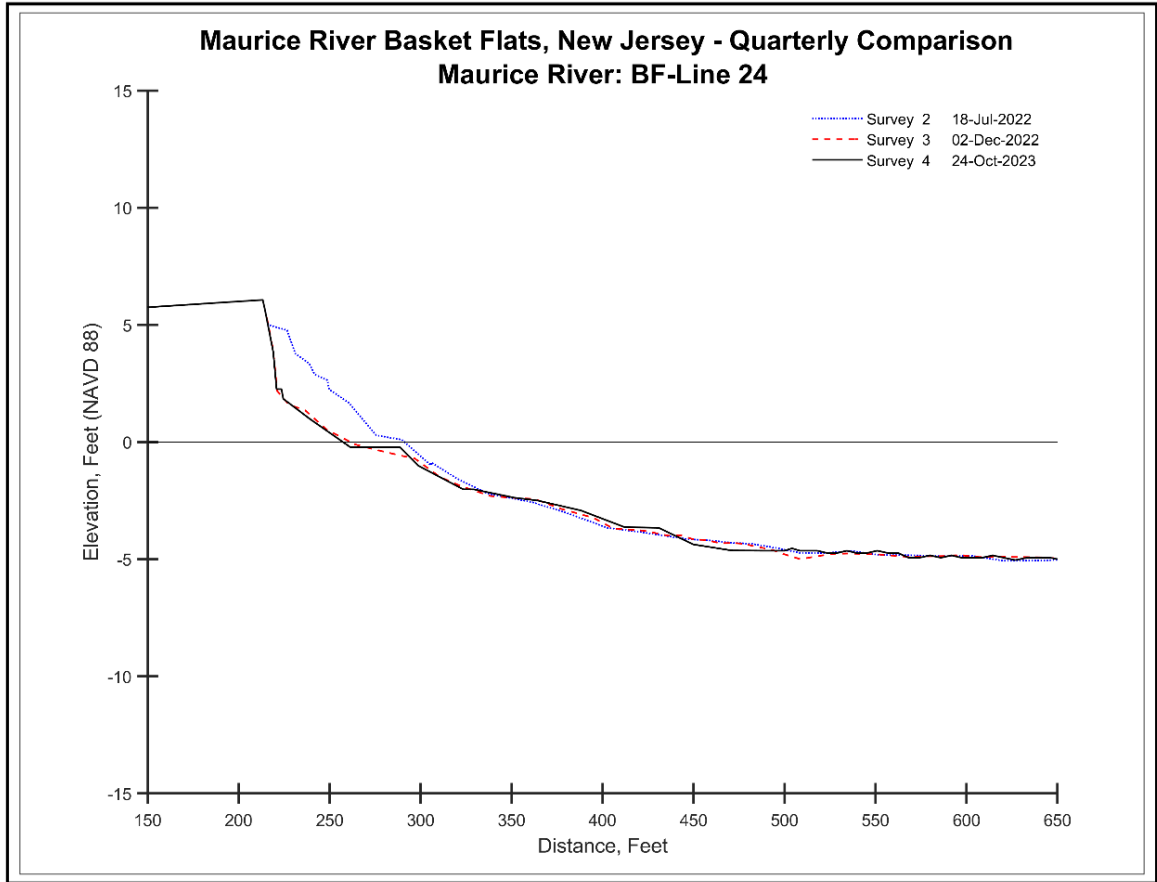
**Figure 15. Line 24 is located at the cove formed by the Basket Flats spit extension and orientation of the adjacent marsh. Comparison of the surveys shows a significant loss of sediment (-4.87 yds<sup>3</sup>/ft.) onshore and shoreline retreat (-30 feet) between the pre (July 2022) and post construction (December 2022) surveys. The shoreline stabilized during the year following installation of the breakwater units with minor changes (-0.12 yds<sup>3</sup>/ft. & -4 feet of shoreline loss). Line 24 is located just west of breakwater unit #1 outside the immediate lee of the structure but still receives partial shelter from approaching waves into the cove.**

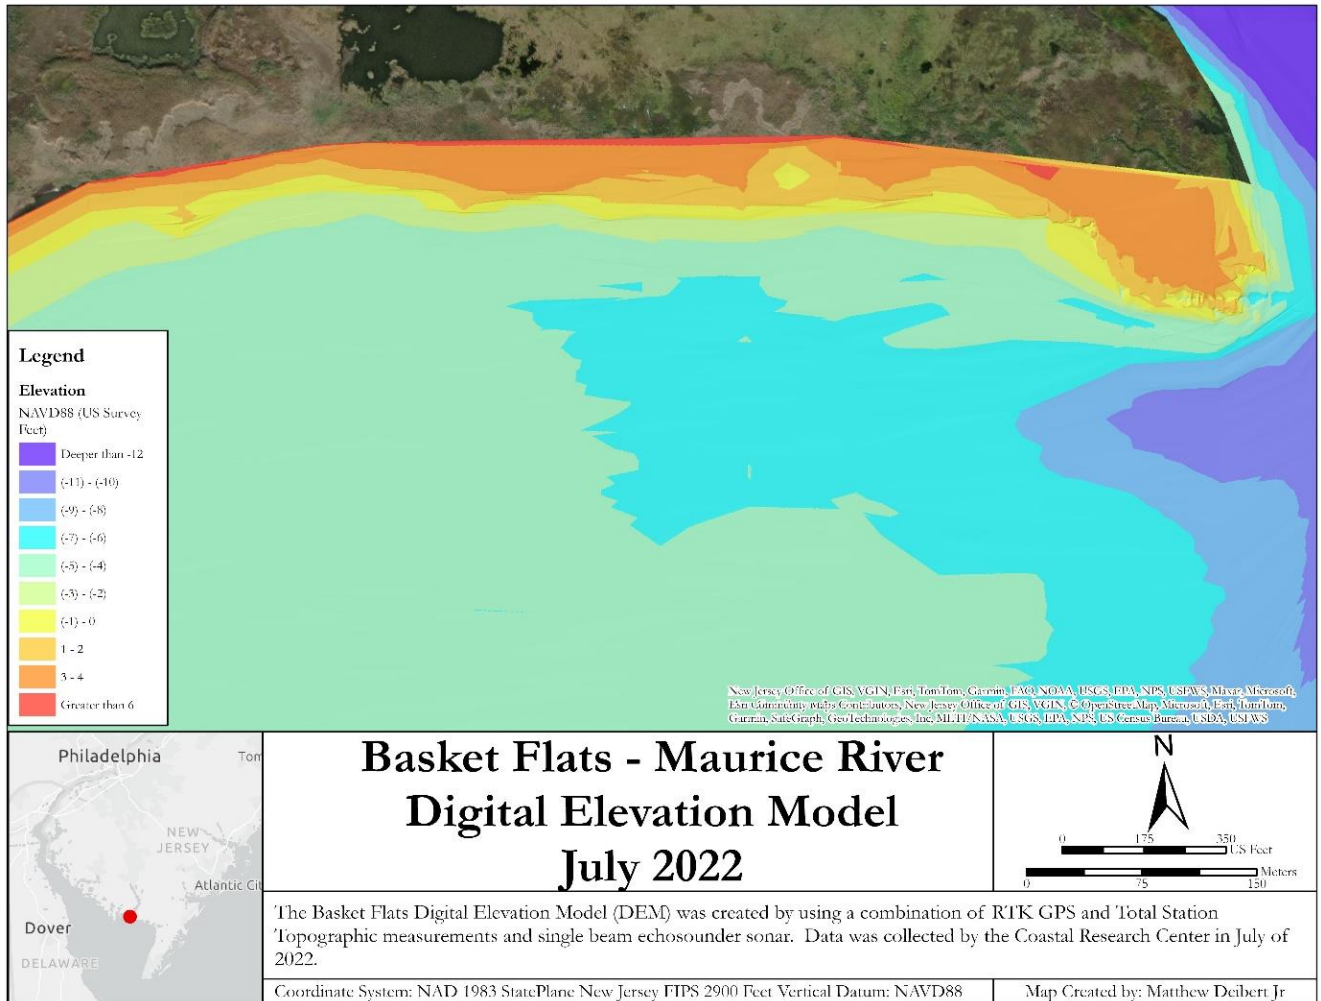
**Figure 16. The July 2022 DEM shows surface conditions prior to project construction. Red colors indicated the higher marsh edge elevations while orange are the lower marsh edge platform elevations. Yellow colors are representative of the intertidal regions while light green is shallow nearshore platforms. Blue colors show regions where the nearshore elevations are deeper while the purple colors indicate the main Maurice River channel edge. The western portion of the nearshore platform is a wide shallow cove area. At the eastern end of Basket Flats the channel margins have extended westward around the end of Basket Flats increasing the vulnerability of the tip to wave impacts and erosion.**

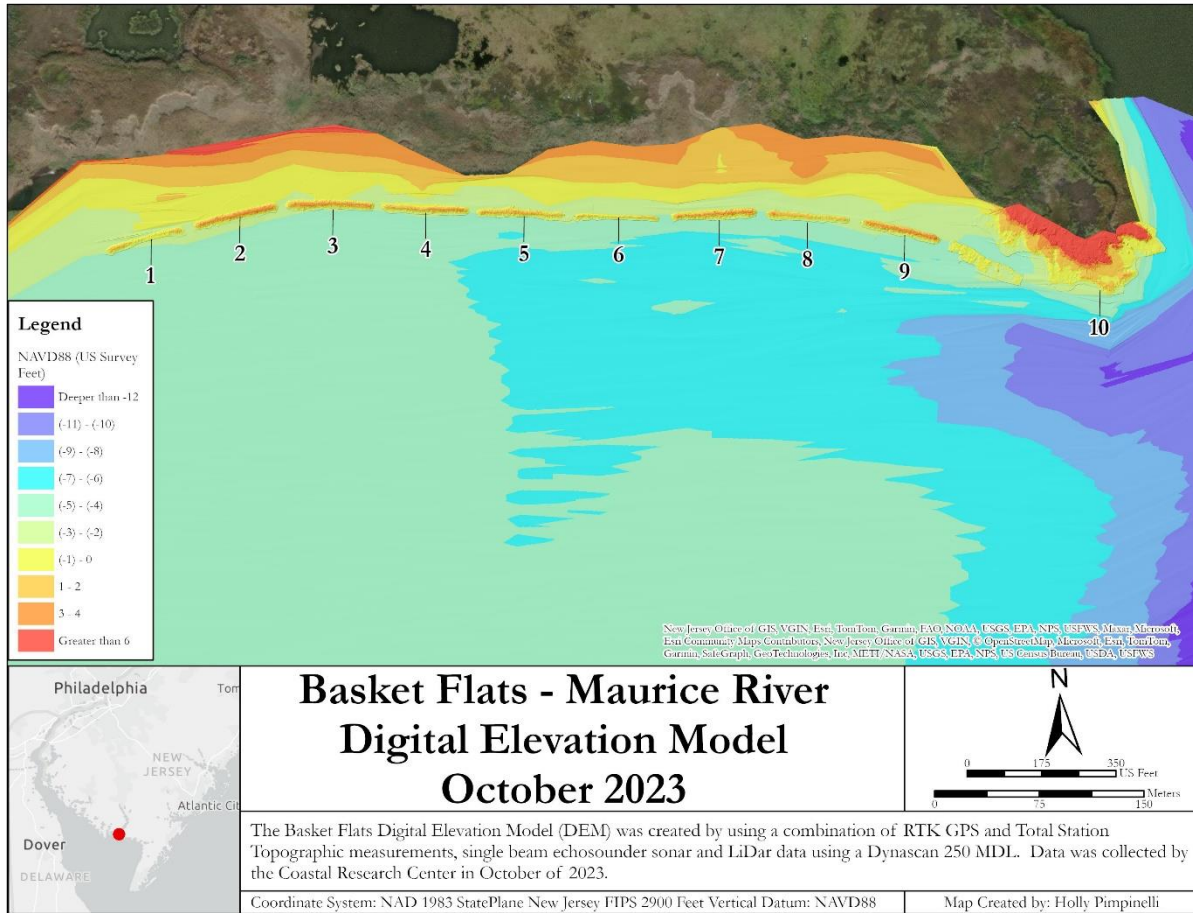
**Figure 18.** The fall 2023 DEM shows surface conditions one year following installation of the breakwater units and the partial revetment/sill. Breakwater units are labeled 1-9 from west to east while the revetment/sill is labeled as number 10. The color pattern again indicates reds and orange are regions with higher elevations while blues and purple are regions with lower elevations. Elevations on units #2, #3, #7 and #9 show relative stability while the other units have shown minor deflation in the crest elevation over the initial year.

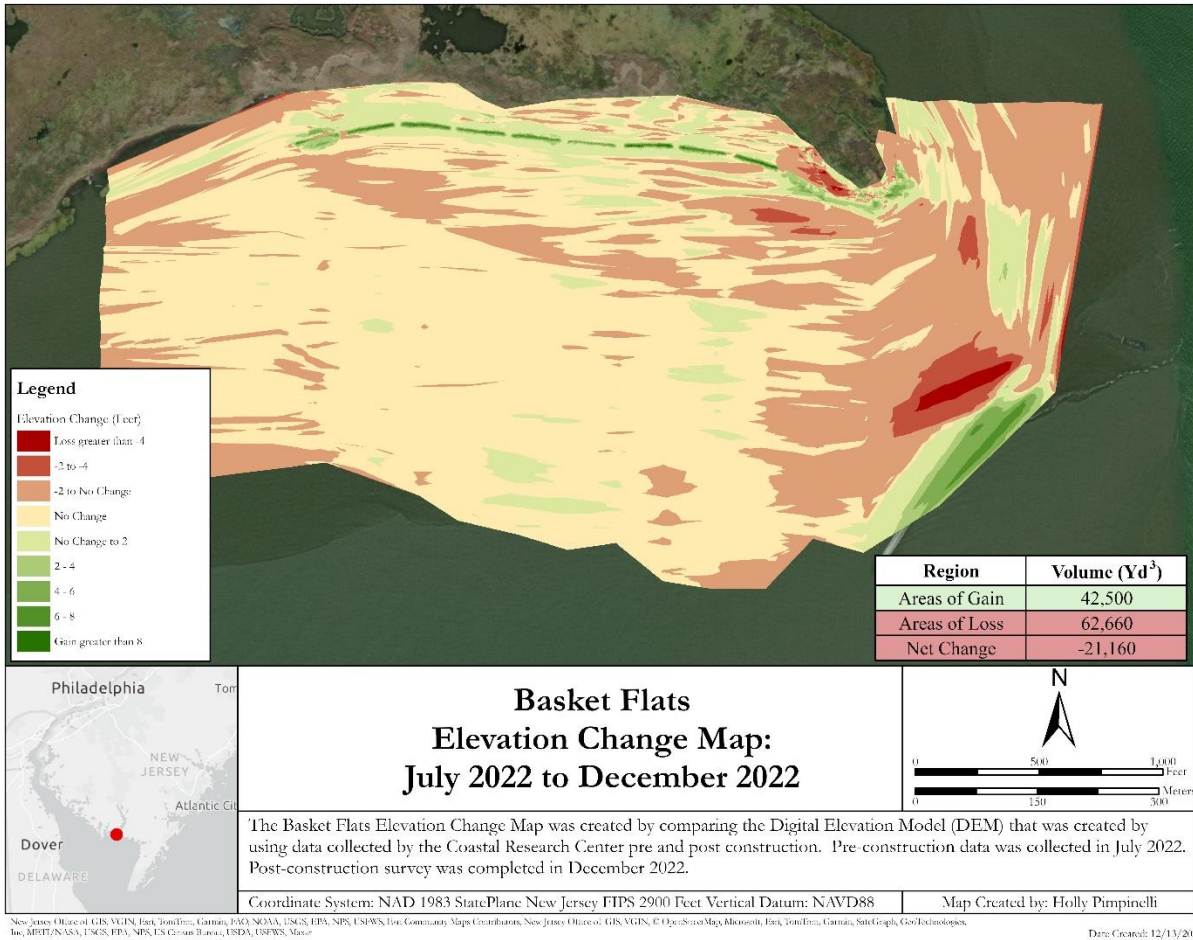
**Figure 19. The July 2022 to December 2022 elevation change maps show the immediate post construction elevation changes within the study area. Regions shaded in green colors are areas of elevation gain while red show areas of elevation loss. Yellow colors and lighter color shades show areas of little to no change in elevation between the preconstruction and post construction surveys. Within the project area the darker green areas represent the installation of the breakwater units and revetment structures along the southern Basket Flats shoreline.**

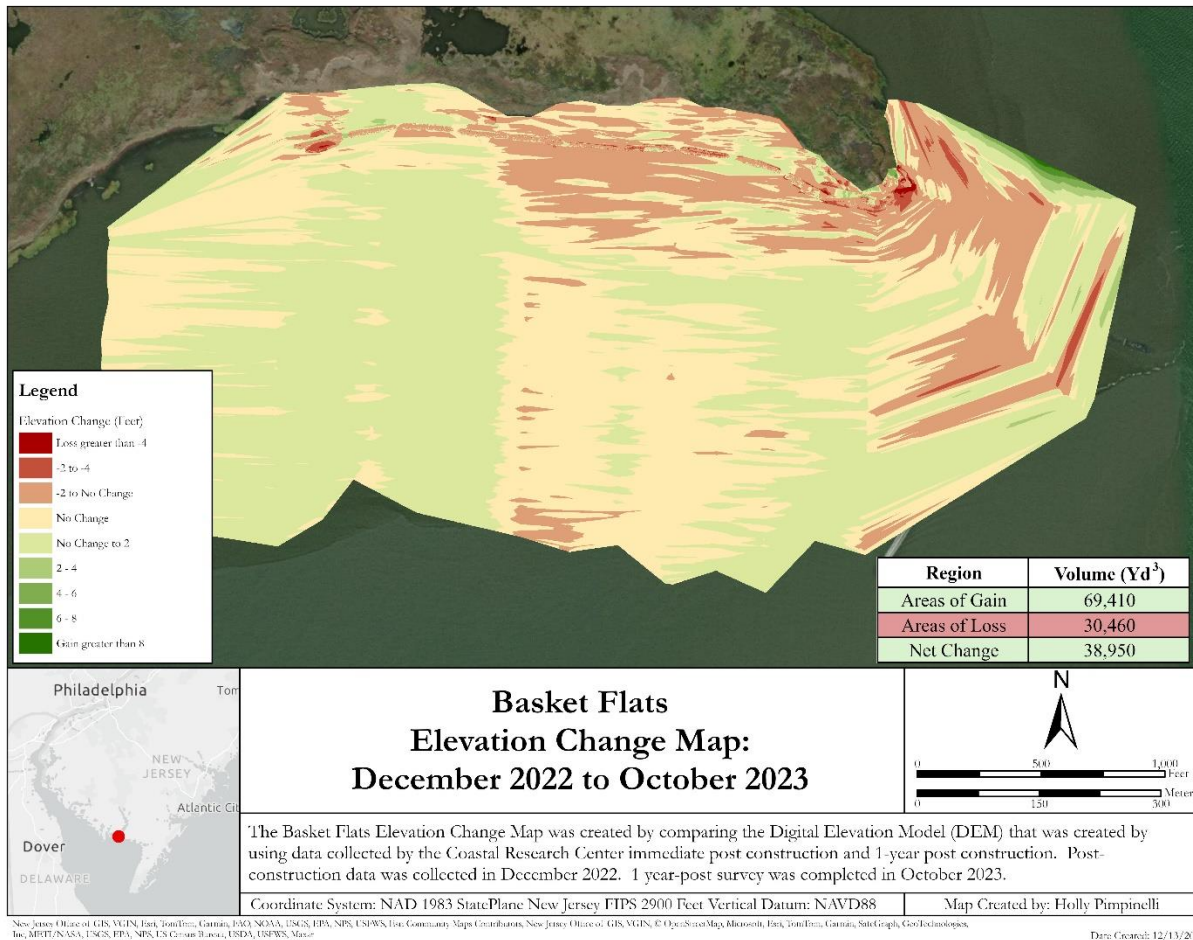
**Figure 20. The December 2022 to October 2023 elevation change maps show the one-year post construction elevation changes within the study area. Regions shaded in green colors are areas of elevation gain while red show areas of elevation loss. Yellow colors and lighter color shades show areas of little to no change in elevation between the preconstruction and post construction surveys. Within the project area the green areas at the west end of the project region represent a volume gain of sediment and modest increases in elevation. Along the breakwater units the crest elevations have shown modest elevation deflation. Despite the modest settlement in crest elevation the breakwater units remained in place as protection for the southern facing shoreline of Basket Flats.**

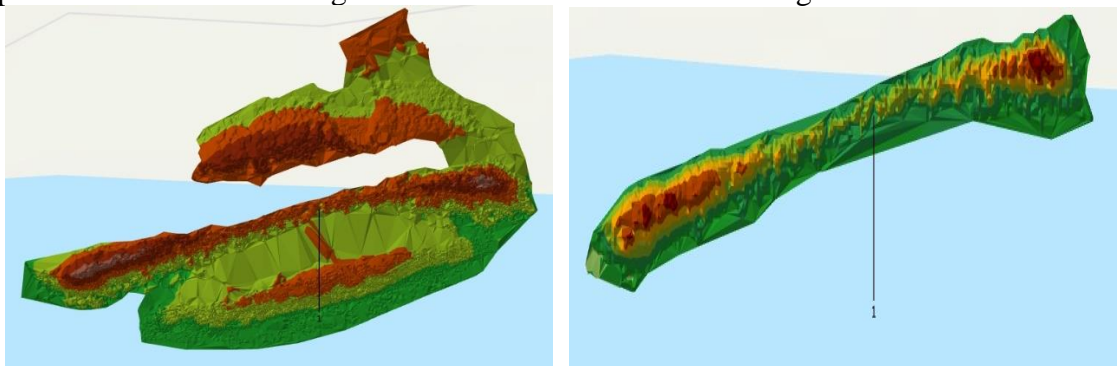
**Figure 21.** These two images show the results of the LiDAR scans at breakwater unit #1 located at the western end of the project area. The left image is the immediate post construction scans and shows the separation of the foundation mattress that shifted from under the unit on both sides creating a depression towards the middle (subaqueous, no data or image). The image on the right is the one-year scan, both ends of the unit remained relatively stable while the mid-section has settled where the foundation mattresses shifted.

- Placing additional stone on the breakwater units, with particular attention to units 6 & 8, where crest elevations are currently below MHW levels.
- Unit #1 will require complete restoration as the foundation is compromised and further loading of stone will likely be unsuccessful at achieving elevation goals.
- Extend the breakwater units around the eastern tip of Basket Flats starting with adding stone onto the sill, unit #10, to raise the elevation to a minimum of at or above the MHW level, preferably to the target elevation of 4 feet NAVD88.
- Continue periodic monitoring of the nearshore and marsh edge platform to document changes and determine long term effectiveness of the breakwater installation.
- Continued LiDAR scans of the units to determine elevation and deformation changes.

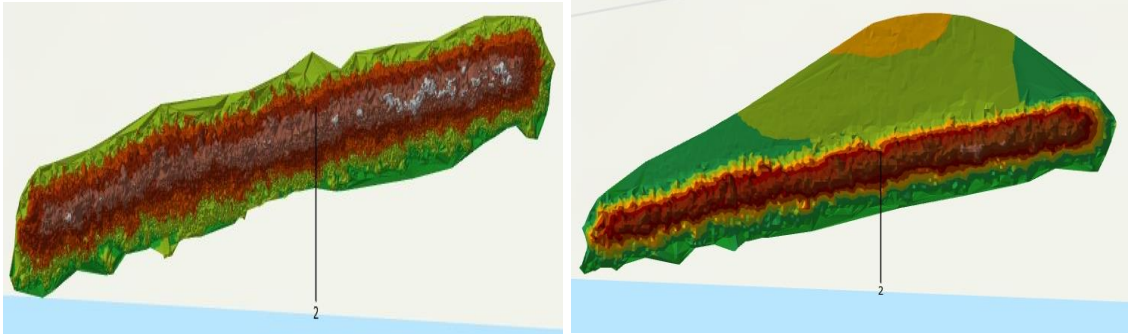
**Figure 22.** These two images show the results of the LiDAR scans at breakwater unit #2 located at the western end of the project area. The left image is of the immediate post construction scans and shows the unit was relatively consistent in elevation across the structure. On the far right the crest elevations are slightly higher (grayish/white). The image on the right is the one-year scan, both ends of the unit remained relatively stable with no indication of major settlement or deformation.

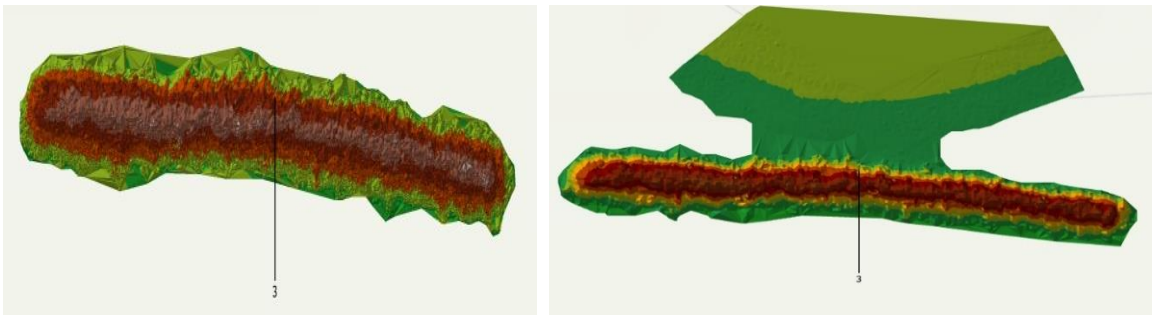
**Figure 23.** These two images show the results of the LiDAR scans at breakwater unit #3 of the project area “as built” and one year later. The left image is of the immediate post construction scans and shows the unit was relatively consistent in elevation across the structure. The image on the right is the one-year scan, the unit has remained relatively stable with no indication of major settlement or deformation.

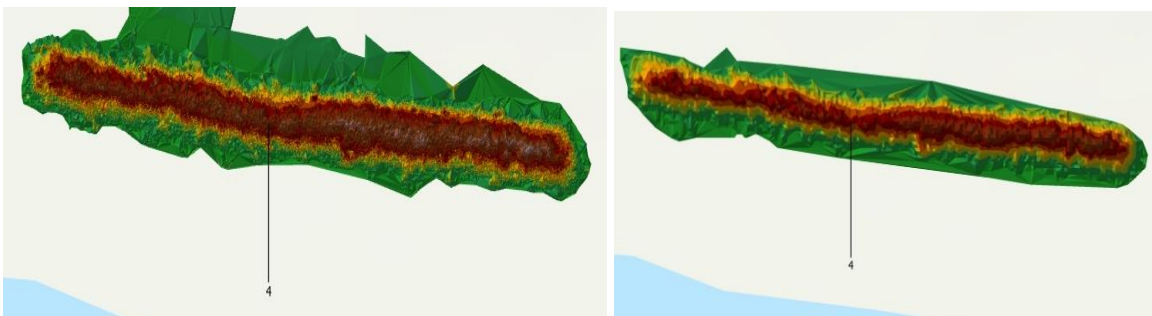
**Figure 24.** These two images show the results of the LiDAR scans at breakwater unit #4 located towards the middle of the project area. The left image is of the immediate post construction scans and shows the unit was relatively consistent in elevation across the structure. The image on the right is the one-year scan, the unit has remained relatively stable with no indication of major settlement or deformation.

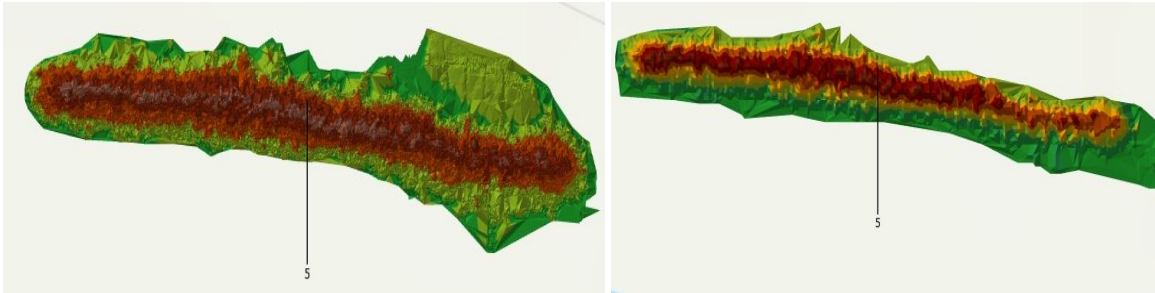
**Figure 25.** These two images show the results of the LiDAR scans at breakwater unit #5 located with the project mid-section. The left image is of the immediate post construction scans and shows the unit was relatively consistent in elevation across the western and middle of the structure. There is evidence that the eastern end is slightly lower in elevation on the crest based on the white color scattering along the crest ridge. The image on the right is the one-year scan, the unit has remained relatively stable with minor settlement along the western and mid-section, the eastern end shows some evidence of modest deformation but within the anticipated engineered design range.

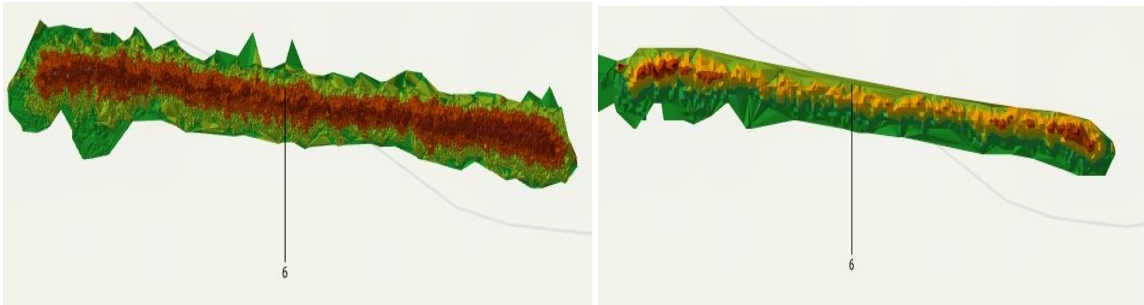
**Figure 26.** These two images show the results of the LiDAR scans at breakwater unit #6 located with the project mid-section. The left image is of the immediate post construction scans and shows the unit was relatively consistent in elevation across the structure. The image on the right is the one-year scan, the unit has adjusted and shows signs of significant settlement in the midsection but is more stable on the ends. There is no indication of scattering of stone along the edge of the units in this image indicating the primary reason for this deformation is elevation settlement.
