American Littoral Society  
Restoring Ecologically Beneficial and Resilient Infrastructure At The  
Mouth of Maurice River, Basket Flats  
Abiotic Physical Monitoring Report for 2023

Stockton University Coastal Research Center

*November 2024*

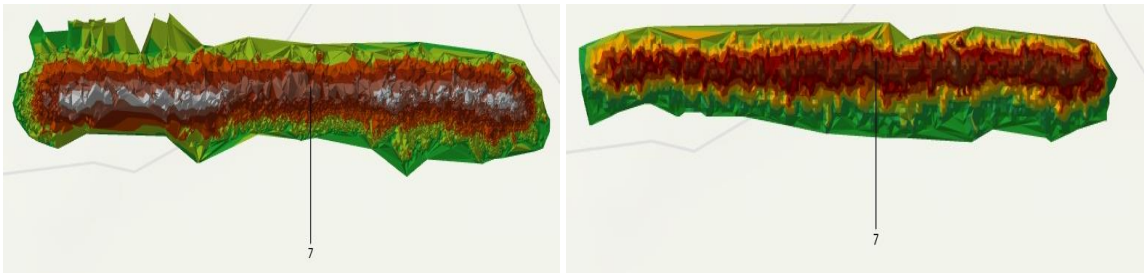
**Figure 27.** These two images show the results of the LiDAR scans at breakwater unit #7 located towards the eastern end of the project area. The left image is of the immediate post construction scans and shows the unit was relatively consistent in elevation across the structure with higher elevations on both ends and slightly lower conditions in the middle of the unit. The image on the right is the one-year scan, the unit has adjusted and shows reduced elevations and signs of settlement across the structure, focused on the ends but remains relatively intact in the center with little deformation of configuration, scattering of stones or loss of structural integrity indicated.

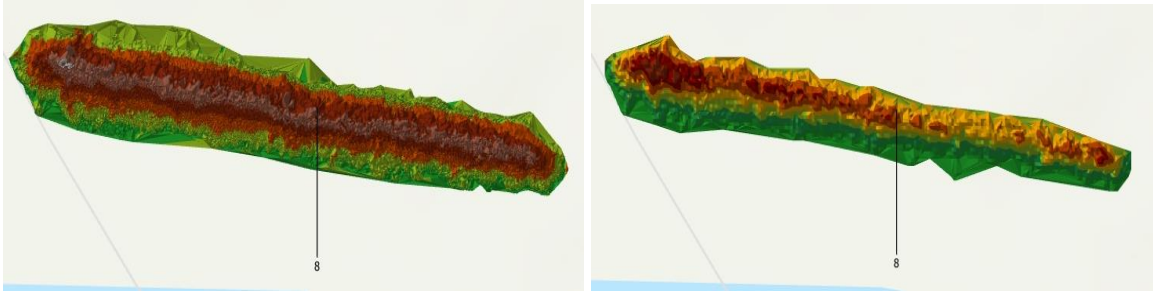
**Figure 28.** These two images show the results of the LiDAR scans at breakwater unit #8 located towards the eastern end of the project area. The left image is of the “As Built” post construction scans and shows the unit was consistent in elevation and width across the structure with uniform elevations along the ridge. The image on the right is the one-year post construction scan. The unit has adjusted and shows signs of settlement across the structure with the worst elevation loss on the eastern (right) end and towards the mid-section. The structure remains functionally intact but with diminished elevation and exposure at times of high tide. The scan does not reveal any scattering of stone with little deformation of the overall configuration. Elevation loss appears to be related to settlement.

- Placing additional stone on the breakwater units, with particular attention to units 6 & 8, where crest elevations are currently below MHW levels.
- Unit #1 will require complete restoration as the foundation is compromised and further loading of stone will likely be unsuccessful at achieving elevation goals.
- Extend the breakwater units around the eastern tip of Basket Flats starting with adding stone onto the sill, unit #10, to raise the elevation to a minimum of at or above the MHW level, preferably to the target elevation of 4 feet NAVD88.
- Continue periodic monitoring of the nearshore and marsh edge platform to document changes and determine long term effectiveness of the breakwater installation.
- Continued LiDAR scans of the units to determine elevation and deformation changes.

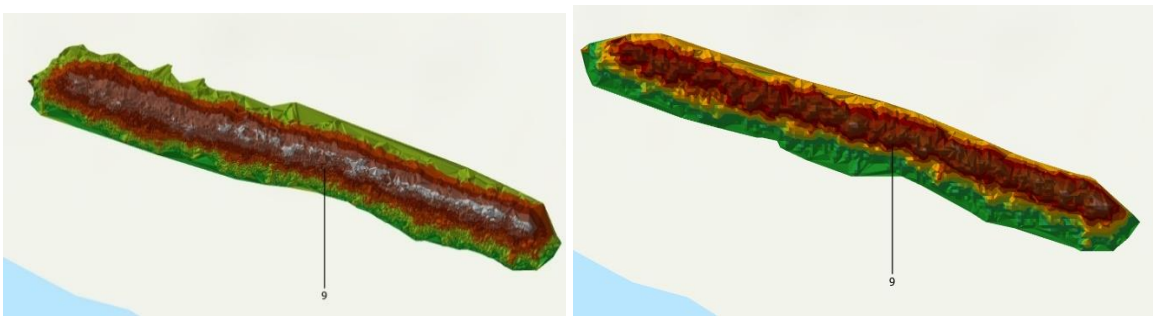
**Figure 29.** These two images show the results of the LiDAR scans at breakwater unit #9 located at the eastern end of the breakwater project area. The left image is of the “As Built” post construction scans and shows the unit was relatively consistent in elevation and width across the structure with slightly higher elevations seen along the mid-section and eastern side of the crest. The image on the right is the one-year post construction scan. The unit shows signs of settlement in crest elevations across the structure but remains within anticipated ranges and in fully functional condition. These scans do not reveal any scattering of stone with little deformation of the overall configuration. The minor elevation loss appears to be related to settlement rather than wave impact deformation.

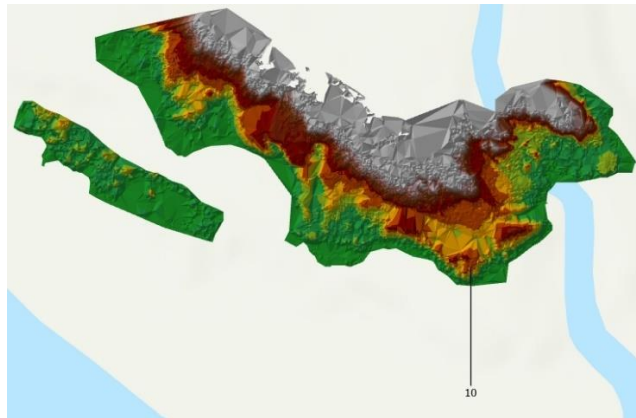
**Figure 30.** The image shows the results of the LiDAR scans at the revetment and sill unit #10 located at the eastern end of the Basket Flats project area. The image shows conditions during the one-year scan. The sill on the left was built at a lower elevation than the breakwater units and not well defined. The revetment edge is the orange to red area, gray is the marsh vegetation. There is an indication of stone scattering along the base of the revetment at the tip. Probably related to construction issues.

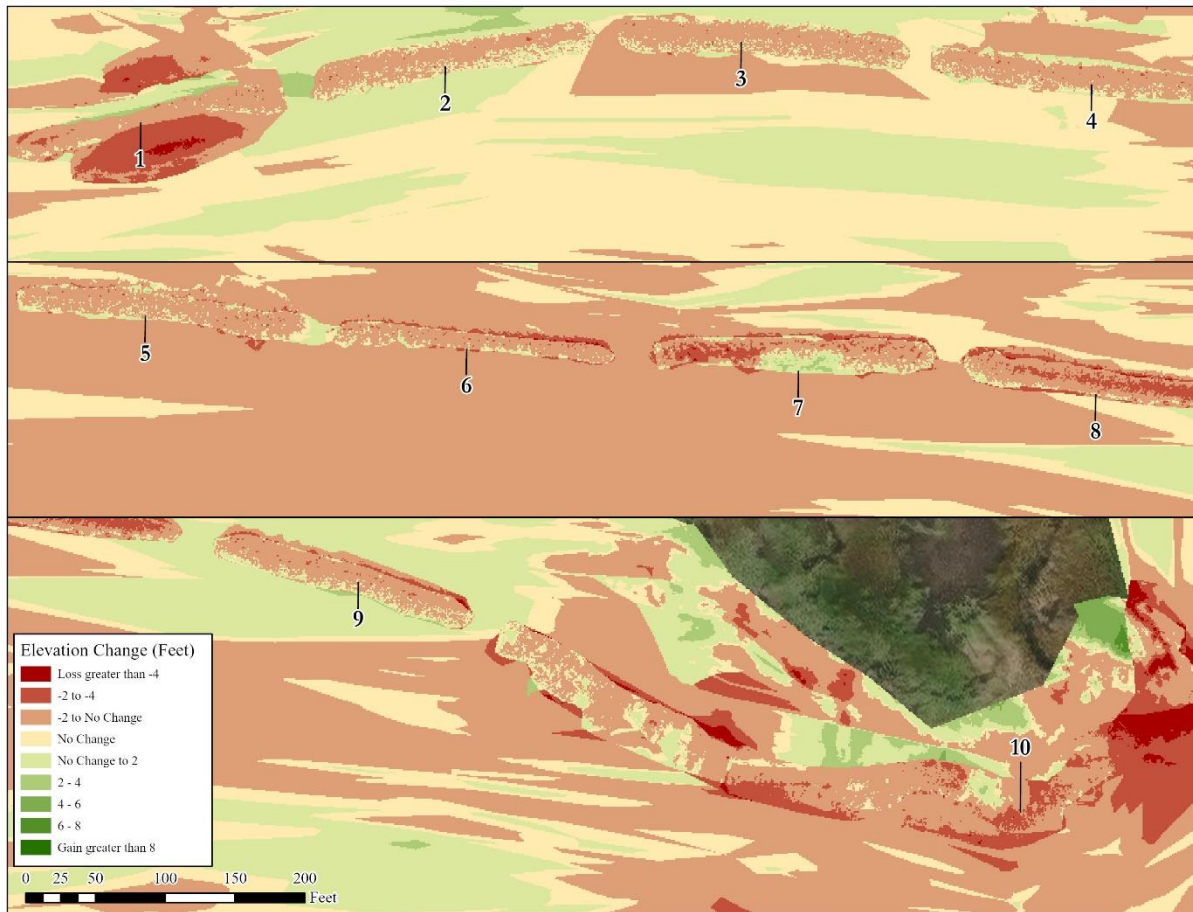
**Figure 31.** The elevation changes show most of the breakwater units remained relatively stable during the first year with most units settling less than 2 feet, well within the anticipated deformation range. There are local exceptions, focused on units 1, 6, 7 & 8. At unit 1, the foundation mattresses that shifted from under the units have settled on either side of the breakwater unit which itself continued to settle and deform beyond the anticipated deformation range. Unit 6 showed some deformation on the landward slope toe while most of the unit was subject to elevation settlement of less than 2 feet. Unit 7 showed a deformation of elevation on the west end in the 2–4-foot range while minor elevation gains in the 2-foot range occurred towards the mid-section of the unit. It is uncertain if this deformation was caused by a shift of stones during the impact of wave climate or another event. The eastern end remained relatively stable with minor elevation loss. Unit 8 also showed elevation settlement along the structures crest line in the 2-foot range and along the edges while the slopes remained relatively stable.

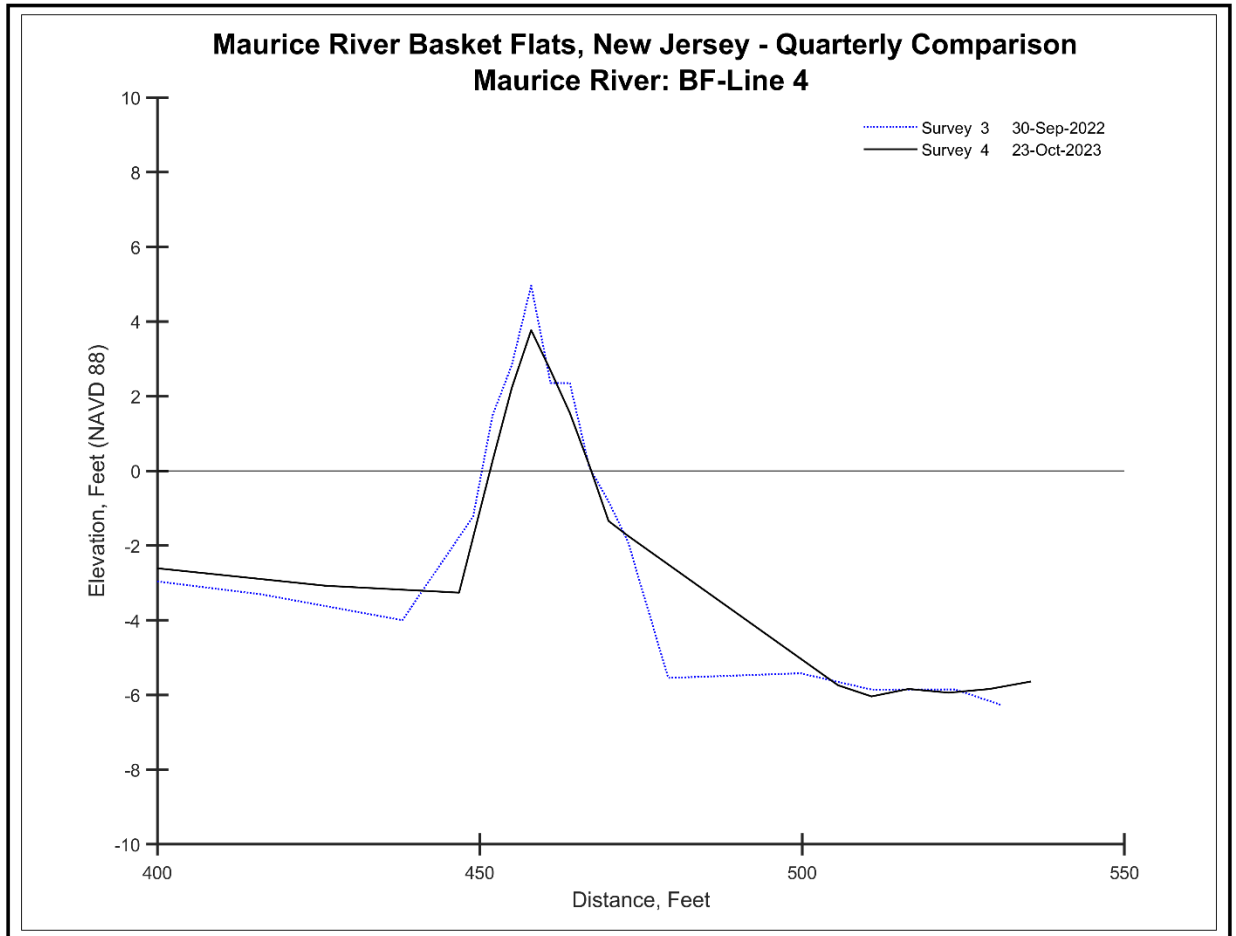
**Figure 32. Line 4 crosses the eastern side of breakwater unit #9. The cross-section compares conditions surveyed and scanned during the “As Built survey (fall 2022) with the survey data collected in fall 2023 one-year post construction. Review of the “As Built” survey shows the crest elevation was above the 4-foot design target elevation at nearly 5 feet NAVD88. One year post construction data shows the crest elevation has settled less than 2 feet in this location but remains at or near the design target elevation (3.75 to 4 feet NAVD88). While there was settlement the general configuration of the breakwater slopes remained intact. There is sediment accumulation along both the landward and seaward base of the units. The slight change in configuration on the unit slopes indicate minor deformation.**

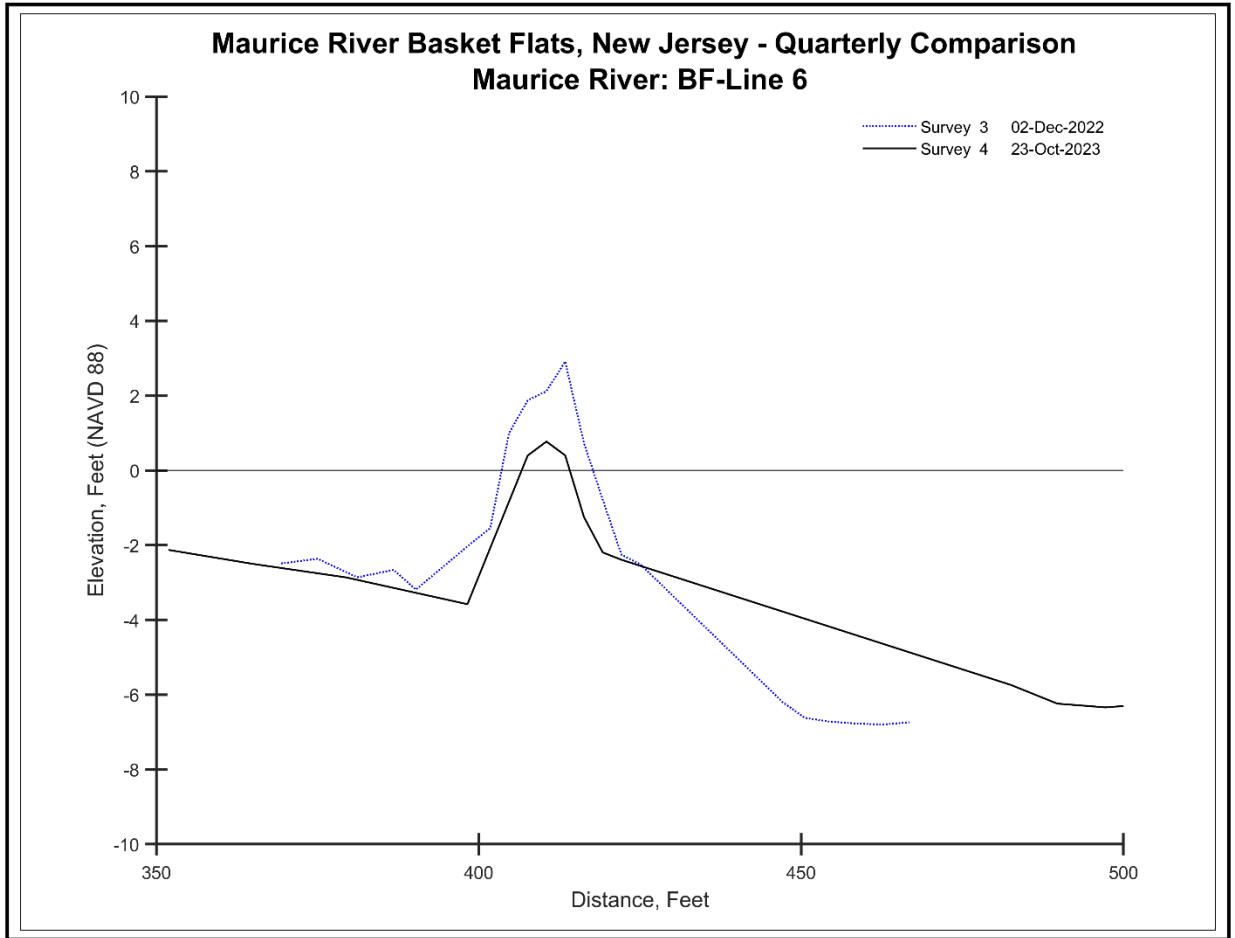
**Figure 33. Line 6 crosses the eastern side of breakwater unit #8. The cross-section compares conditions surveyed and scanned during the “As Built survey (fall 2022) with the survey data collected in fall 2023 one-year post construction. “As Built” surveys show the crest elevation did not achieve the design target elevation of 4 feet NAVD88, maximum crest elevation in this location was 3 feet NAVD88 with just over 2 feet typical. A year later, the maximum crest elevation has settled 2 feet in this location lowered to approximately 1-foot NAVD88. There is a general reduction in the seaward and landward slope configuration of the breakwater unit that may indicate wave influenced deformation in addition to settlement. There is sediment accumulation along the seaward base of the unit with minor scouring along the landward toe of the unit.**

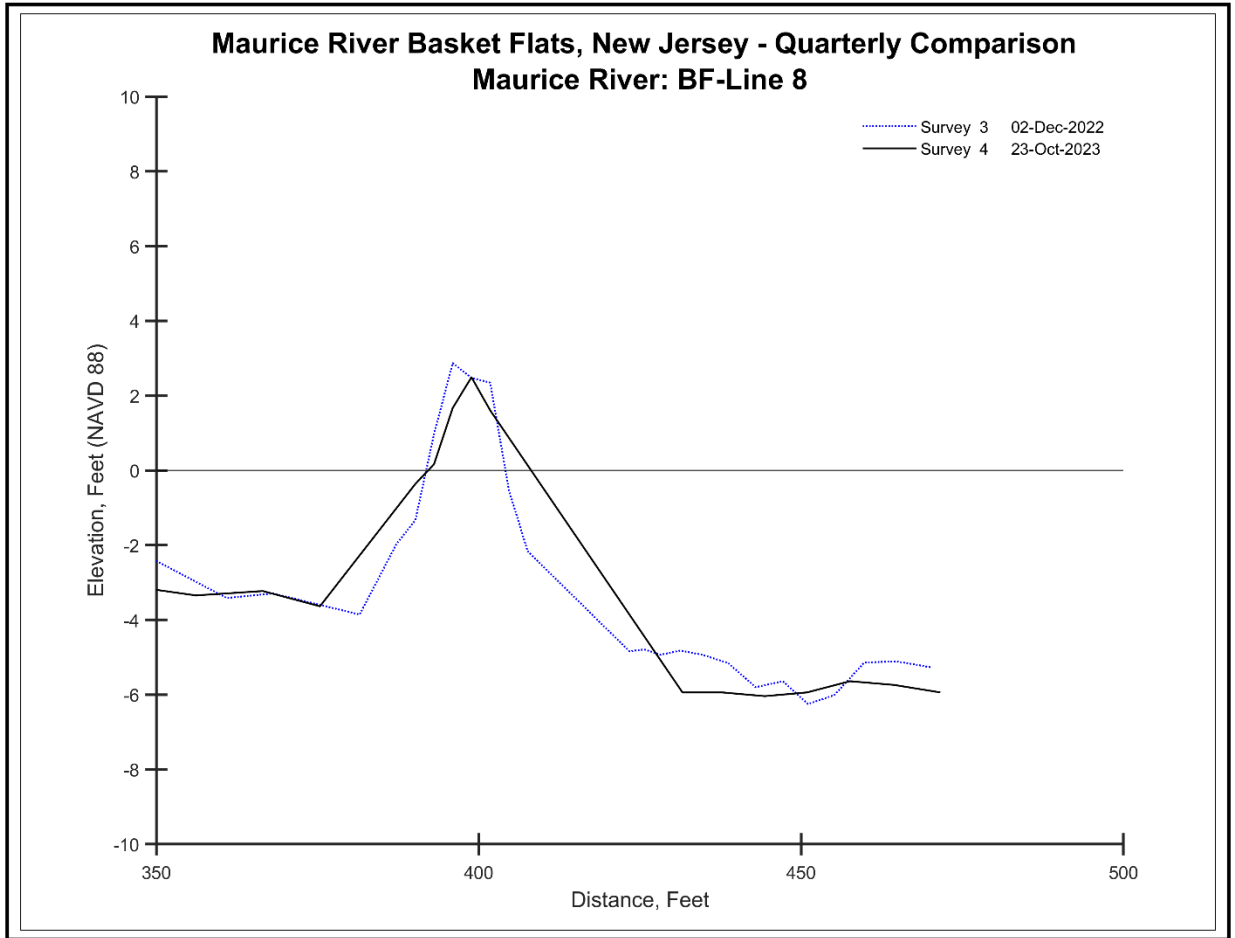
**Figure 34. Line 8 crosses the western edge of breakwater unit #8. The cross-section compares conditions surveyed and scanned during the “As Built survey (fall 2022) with the survey data collected in fall 2023 one-year post construction. Initial survey shows the design target elevation of 4 feet NAVD88 for the crest was not achieved with the peak elevation reaching 3 feet NAVD88. At this location the typical crest elevation was just above MHW (2.43’ NAVD88). One year post construction the peak crest elevation remained near MHW elevation in this location, but the seaward and landward top was reduced in overall width from the “As Built” suggesting some deformation due to wave impacts rather than settlement along this portion of the unit. Along both the landward and seaward slopes there was an increase in width and elevation to the base, likely a combination of sediment accretion and adjustments in rock orientation. There was a modest reduction in the bay floor elevation seaward of the unit and landward.**

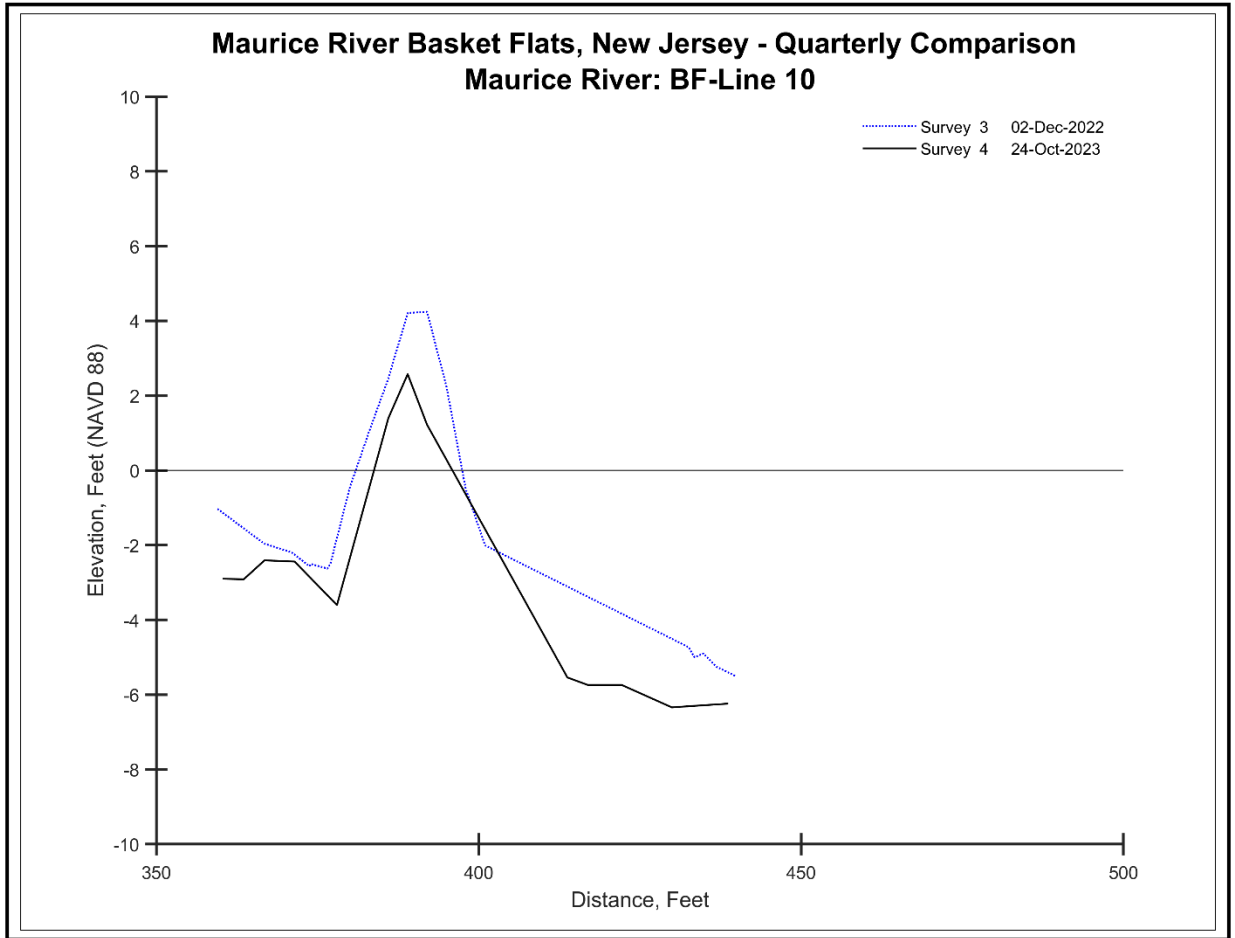
**Figure 35. Line 10 crosses the western edge of breakwater unit #7. The cross-section compares conditions surveyed and scanned during the “As Built survey (fall 2022) with the survey data collected in fall 2023, one-year post construction. The “As Built” survey shows the crest elevation was achieved at the 4-foot NAVD88 target elevation and width. During the year following construction, the crest elevation diminished going from 4 feet NAVD88 to approximately 2.5 feet NAVD88 or just above the local MHW level. The crest width was narrower, and the slopes appear to have deformed along with the crest. On both the landward and seaward bases the bay floor elevation was scoured decreased in elevation in conjunction with the structural settlement.**

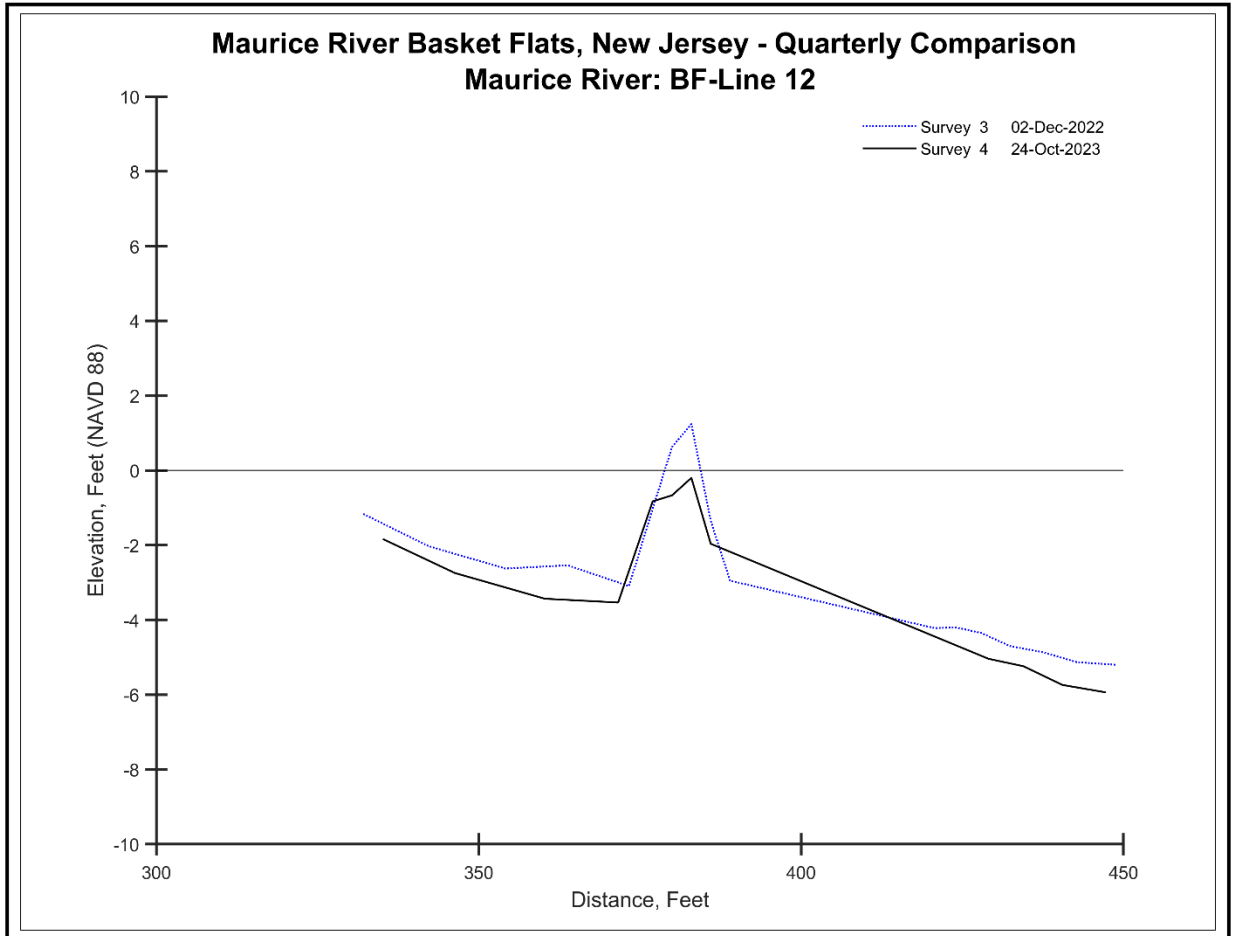
**Figure 36. Line 12 crosses in the western third of breakwater unit #6. The cross-section compares conditions surveyed and scanned during the “As Built survey (fall 2022) with the survey data collected in fall 2023, one-year post construction. The “As Built” survey indicates the maximum crest elevation achieved during installation was at approximately 1.75 feet NAVD88, well below the design elevation of 4 feet NAVD88. A year later the crest elevation continued to settle losing an additional 2 feet and by fall 2023 was just below the zero NAVD88 datum. On both the landward and seaward sides the slopes remained stable below the zero datum with some sediment accumulation along the seaward base of the unit. Unfortunately, the lower crest elevation allows for more wave energy to be transmitted across the unit especially during higher tides and appears to have resulted in scouring nearshore where the bottom elevation deflated from fall 2022 to fall 2023. The wave attenuation functionality of this structure has been impaired by the crest elevation deficit both “As Built” and due to settlement overtime. Elevation and width of this structure will need to be monitored for further settlement and deformation over time.**

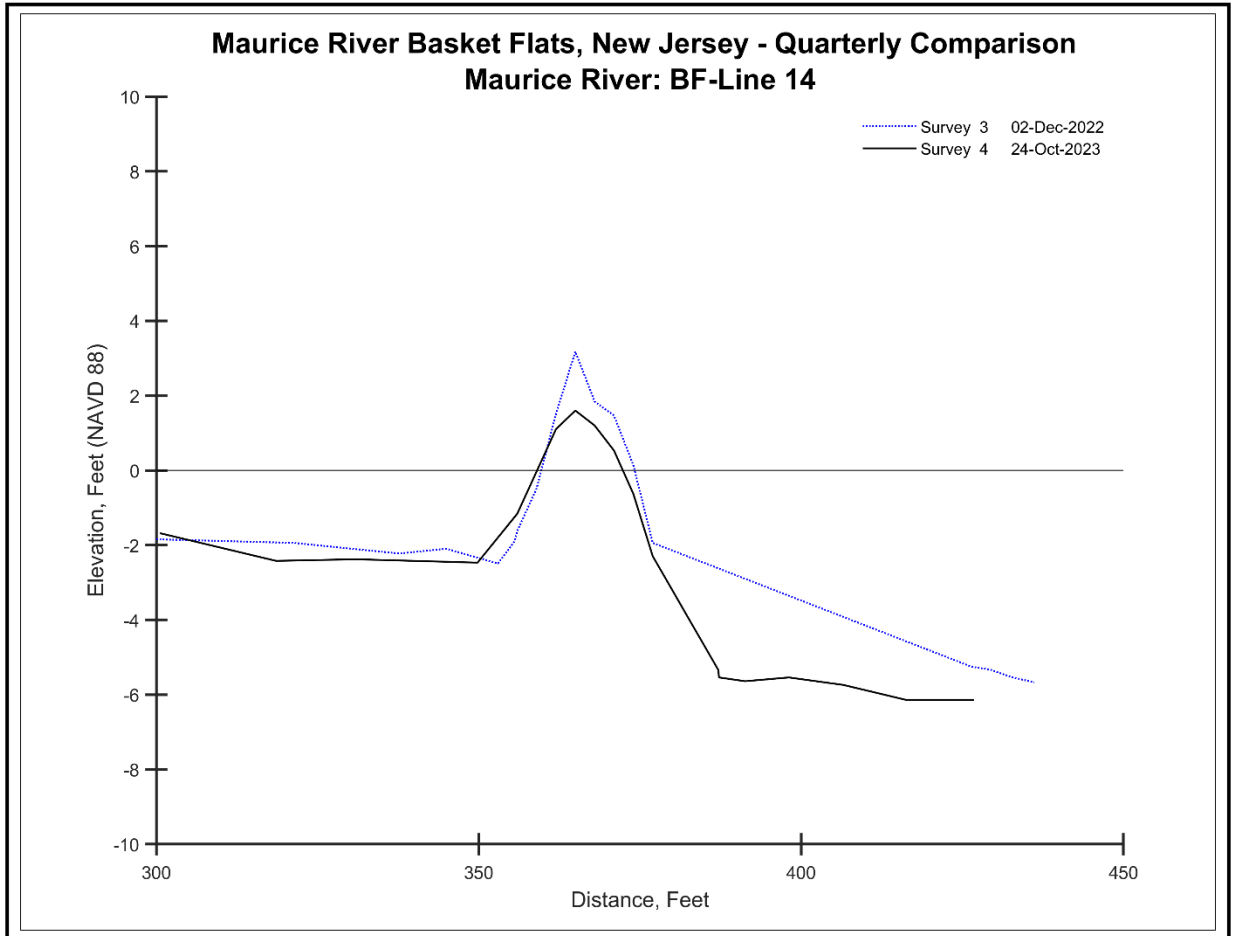
**Figure 37. Line 14 crosses near the middle of breakwater unit #5. The cross-section compares conditions surveyed and scanned during the “As Built survey (fall 2022) with the survey data collected in fall 2023, one-year post construction. “As Built” data shows the crest elevation was below the 4-foot design elevation with the maximum peak at between 3 to 3.25 feet NAVD88. The crest elevation during the year decreased nearly 1.5 feet to just under 2 feet NAVD88 or below current MHW (2.43’ NAVD88) levels. While the crest settled the seaward slope showed minor deformation while the landward slope showed minor expansion likely caused by a shift in stone as anticipated in the engineering design of the units. Seaward of the unit, sediment was scoured along the base of the structure deflating the bay floor elevation. Landward of the structure nearshore elevation deflation was minimal.**

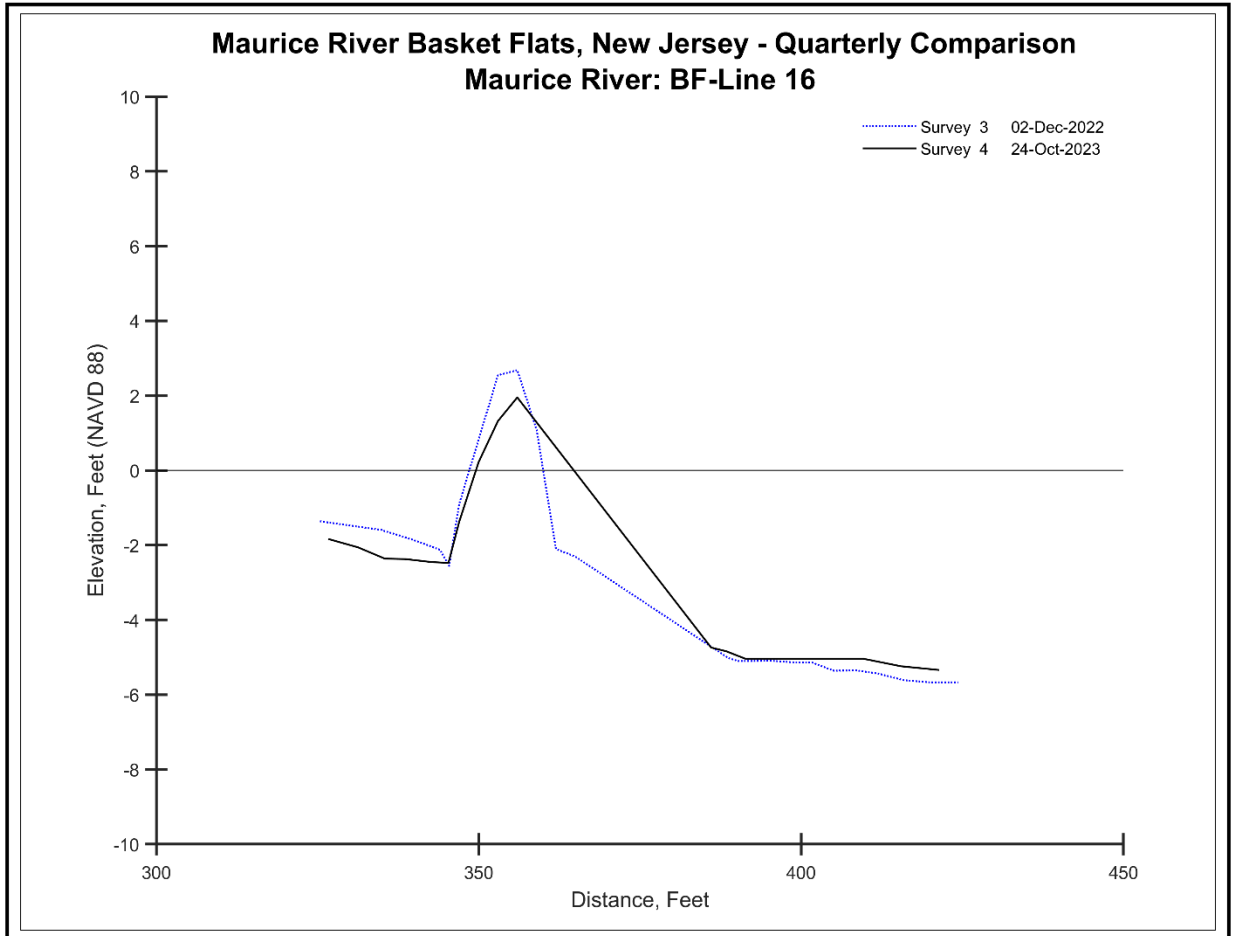
**Figure 38. Line 16 crosses the mid-section of breakwater unit #4. The cross-section compares conditions surveyed and scanned during the “As Built survey (fall 2022) with the survey data collected in fall 2023, one-year post construction. The “As Built” crest elevation was approximately 3 feet NAVD88 or one foot below the design target elevation of 4 feet NAVD88. By fall 2023, the crest elevation was reduced by nearly a foot to just above 2 feet NAVD88. This crest elevation is just below the MHW (2.43’ NAVD88) level but still provides significant wave attenuation benefits through most of the tidal range. The crest width is narrower a year after installation indicating some deformation, but the landward slope was stable in configuration. There is deflation of the nearshore elevation, indicating minor scouring adjacent to the landward base of the unit. Along the seaward slope there was significant sediment accumulation during the year following installation. It is uncertain if any stone displacement is covered by this sediment accretion.**

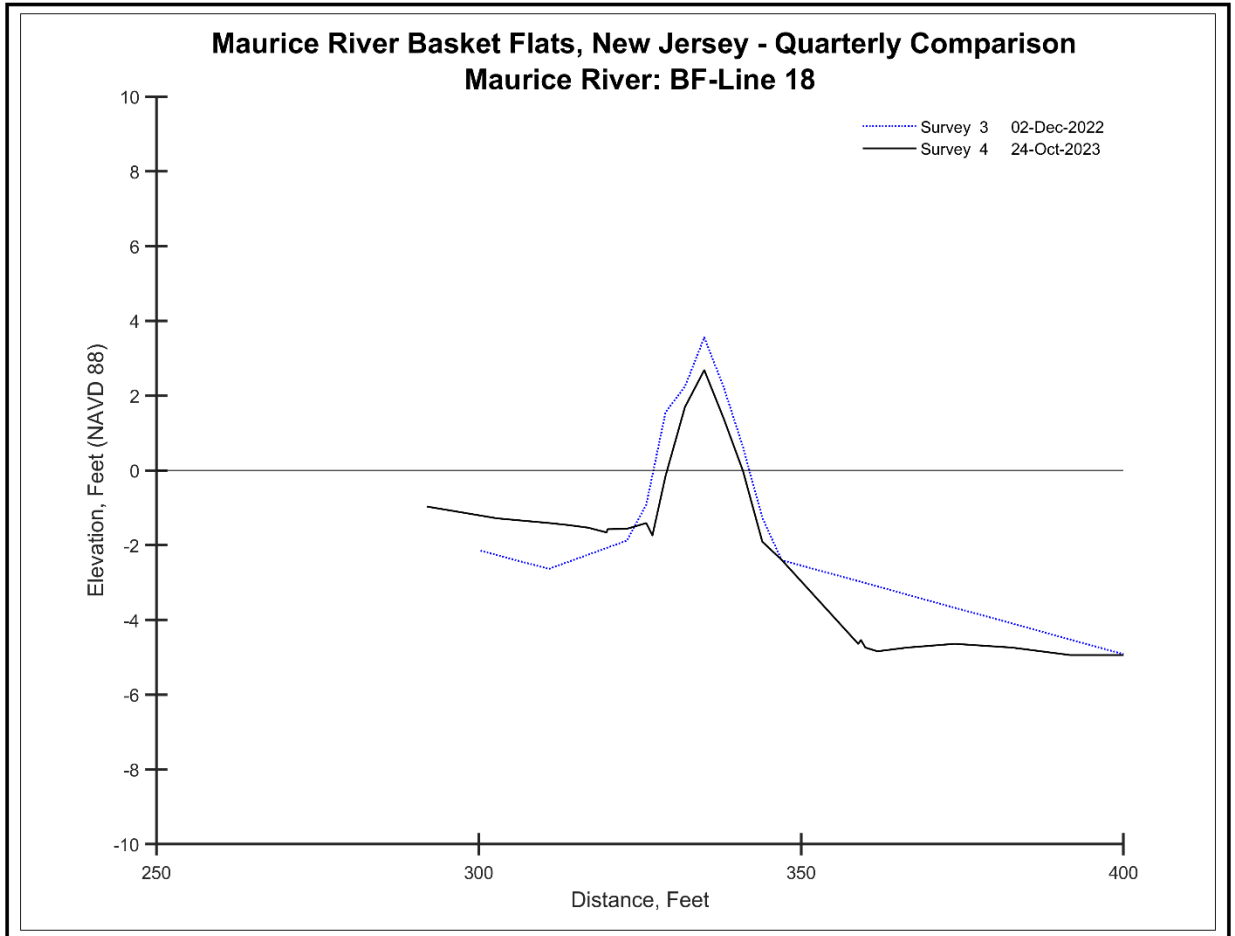
**Figure 39. Line 18 crosses the mid-section of breakwater unit #3. The cross-section compares conditions surveyed and scanned during the “As Built survey (fall 2022) with the survey data collected in fall 2023, one-year post construction. The “As Built” crest configuration shows the design target elevation of 4-foot NAVD88 was achieved. By fall 2023, the crest elevation was reduced by nearly a foot to approximately 3 feet NAVD88. This crest elevation is still above the MHW (2.43’ NAVD88) level and provides significant wave attenuation benefits. The crest and slope width are narrower a year after installation indicating some deformation. There is significant elevation inflation of the nearshore leeward of the breakwater, it is uncertain how much stone if any was covered by the sediment accretion in this region. Seaward of the unit there was elevation deflation of the bay floor due to scouring adjacent to the seaward base of the unit.**

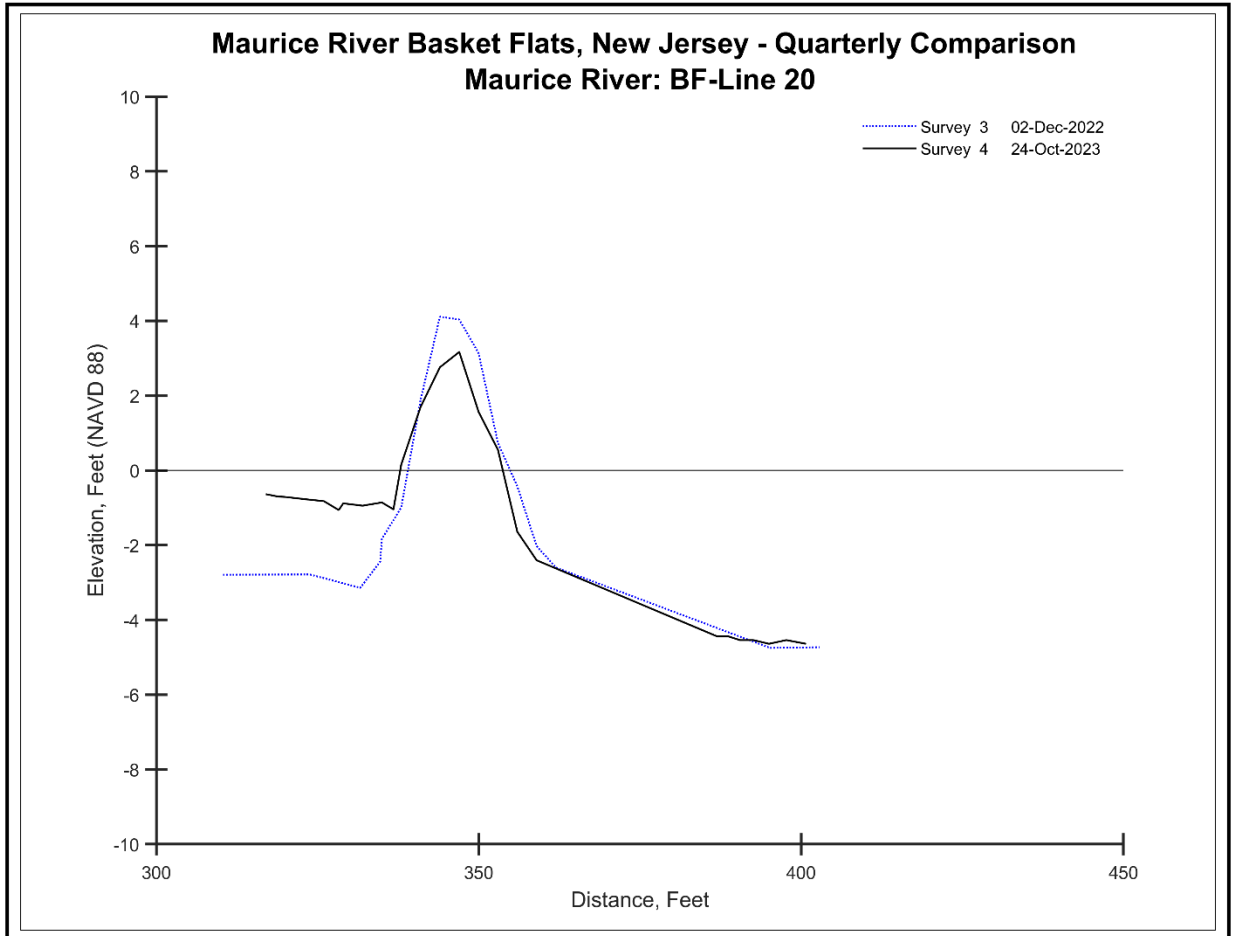
**Figure 40. Line 20 crosses the eastern side of breakwater unit #2. The cross-section compares conditions surveyed and scanned during the “As Built survey (fall 2022) with the survey data collected in fall 2023, one-year post construction. The “As Built” crest elevation shows the full 4-foot NAVD88 design target elevation and crest width was achieved at this location. By fall 2023, the crest elevation was reduced by nearly a foot to approximately 3 feet NAVD88 while the crest width was narrower indicating some deformation along the crest in addition to settlement. This crest elevation is still well above the MHW (2.43’ NAVD88) level and provides significant wave attenuation benefits. The unit slopes remained largely intact a year after installation with some minor deformation along the seaward slope and expansion along the landward base. There is significant elevation inflation (2 feet) of the nearshore leeward of the breakwater as sediment accumulated. On the seaward side, the bay floor elevation adjacent to the base of the unit was stable with little or no changes in elevation.**

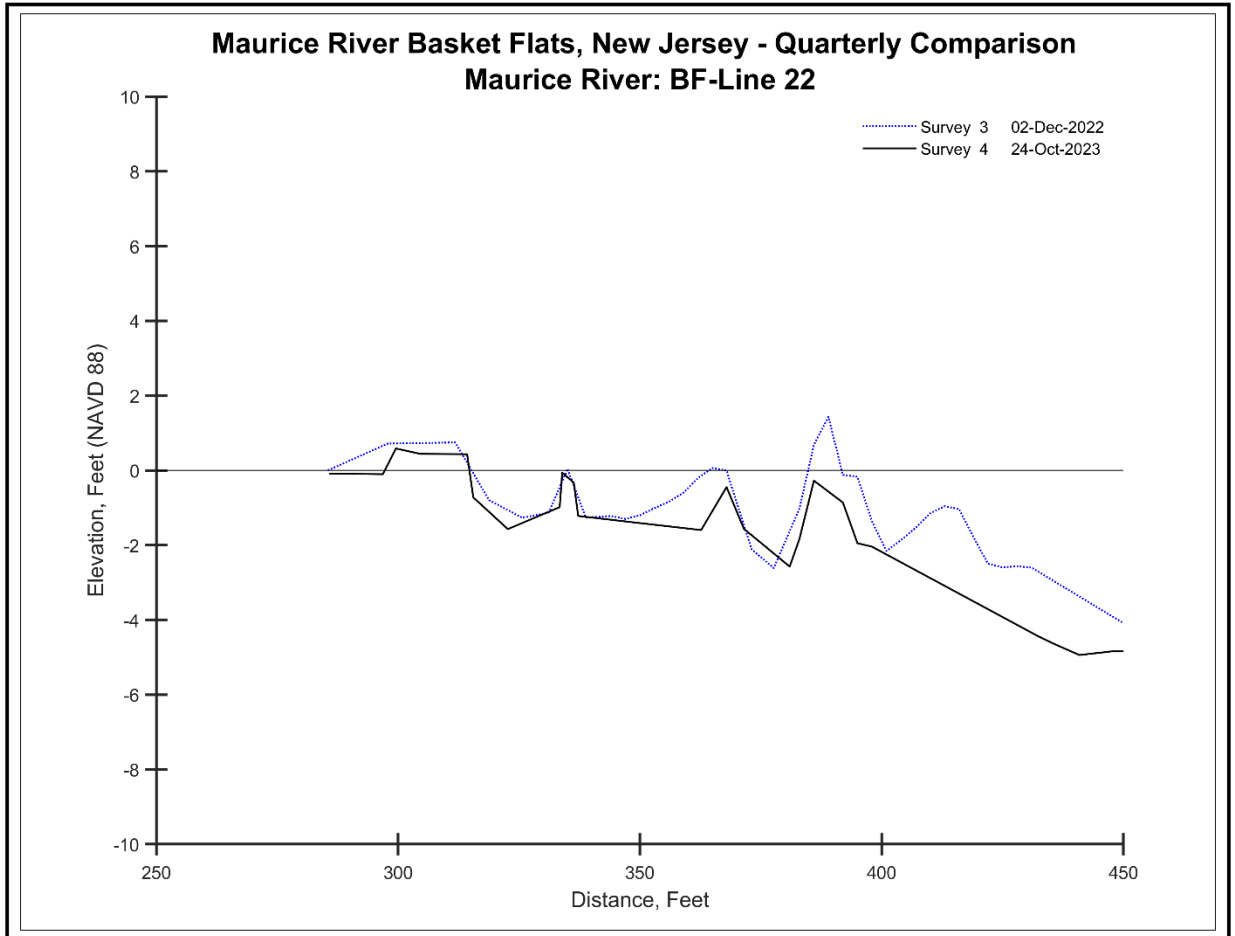
**Figure 41. Line 22 crosses the eastern side of breakwater unit #1. The cross-section compares conditions surveyed and scanned during the “As Built survey (fall 2022) with the survey data collected in fall 2023, one-year post construction. The “As Built” survey shows the crest design target elevation was never achieved as the foundation mattresses shifted and the breakwater stones settled rapidly below the design elevation. The result was the unconsolidated structure with differential peak elevations and width. Fortunately, the western end of the unit was more intact but still well below the design target elevation. By fall 2023, the unit elevation showed continued settlement with the worst rates occurring on the seaward side of the unit. On the seaward side, sediment was scoured and the bay floor elevation deflated along the seaward base of the unit.**

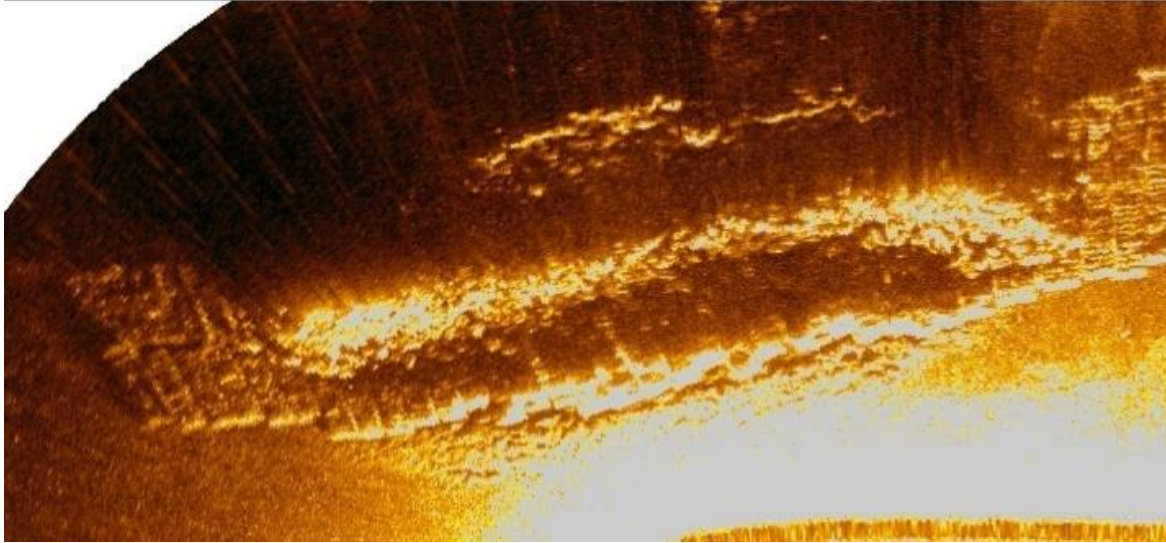
**Figure 42. Breakwater 1 is located at the northwest end of the Basket Flats project area. The side scan image shows the structure below the water level. The rows of rectangular foundation mattresses are visible with the rock breakwater located towards the center of the image. Bright colors in the image are representative of higher elevations with more light refraction while the darker regions are caused by the shadows cast. The water levels landward of each structure is too shallow to operate a vessel preventing scans along the leeward side.**

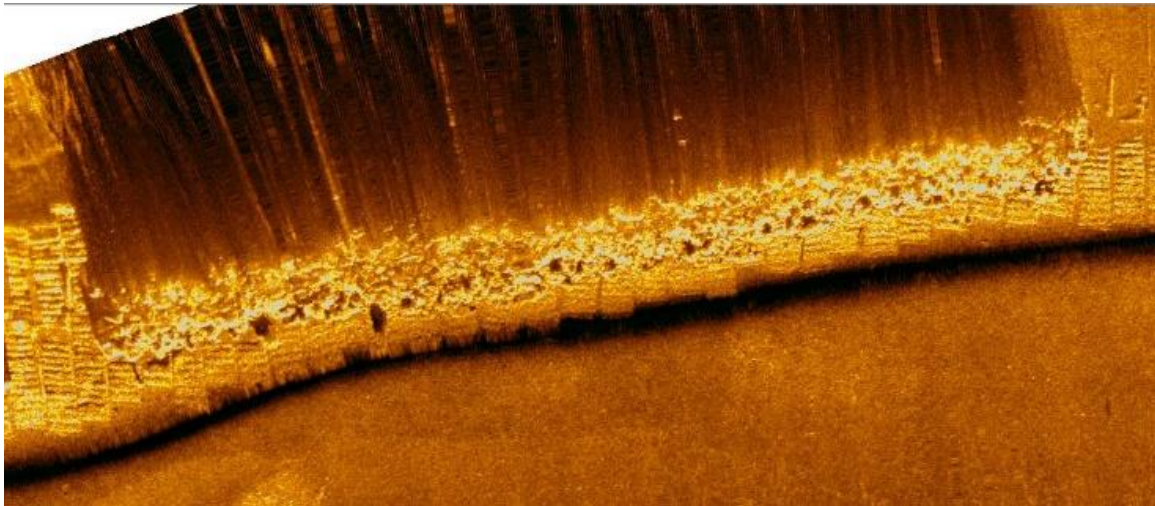
**Figure 43. Breakwater 2 is located to the east of unit 1 along the Basket Flats project area. The side scan image shows the rows of rectangular foundation mattresses remain intact below the rock breakwater located towards the center of the image. Bright colors in the image are representative of higher elevations with more light refraction while the darker regions are caused by the shadows cast off the rock breakwater structure.**

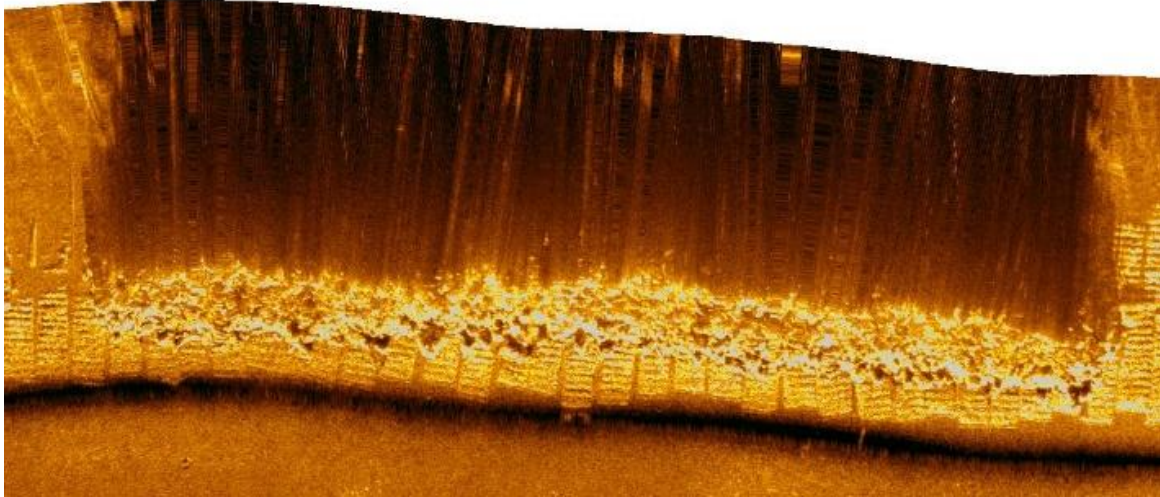
**Figure 44. Breakwater 3 is located to the east of unit 2 along the Basket Flats project area. The side scan image shows the rows of rectangular foundation mattresses remain intact but there is evidence of minor separation between adjacent mattress units. The breakwater rocks remain in place towards the center of the image with little evidence of deformation or scattering of rocks. Bright colors in the image again are representative of higher elevations while the darker regions are caused by the shadows cast off the rock breakwater structure.**

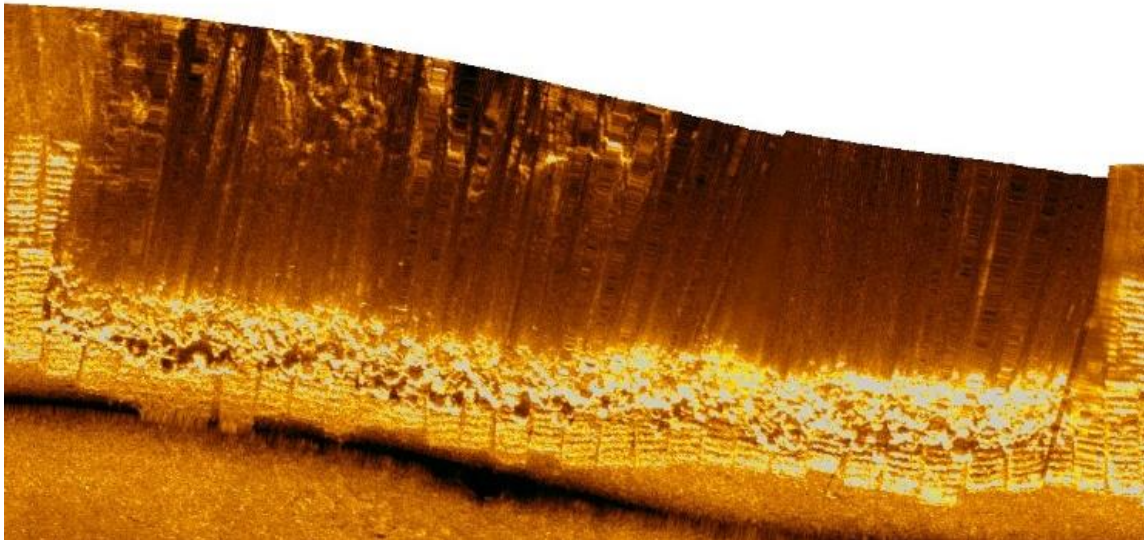
**Figure 45. Breakwater 4 is located to the east of unit 3 along the Basket Flats project area. The side scan image shows the rows of rectangular foundation mattresses remain largely intact as originally placed. The breakwater rocks also remain in place towards the center of the image with little evidence of deformation or scattering of rocks of the units. Bright colors in the image again are representative of higher elevations while the darker regions are caused by the shadows cast off the rock breakwater structure.**

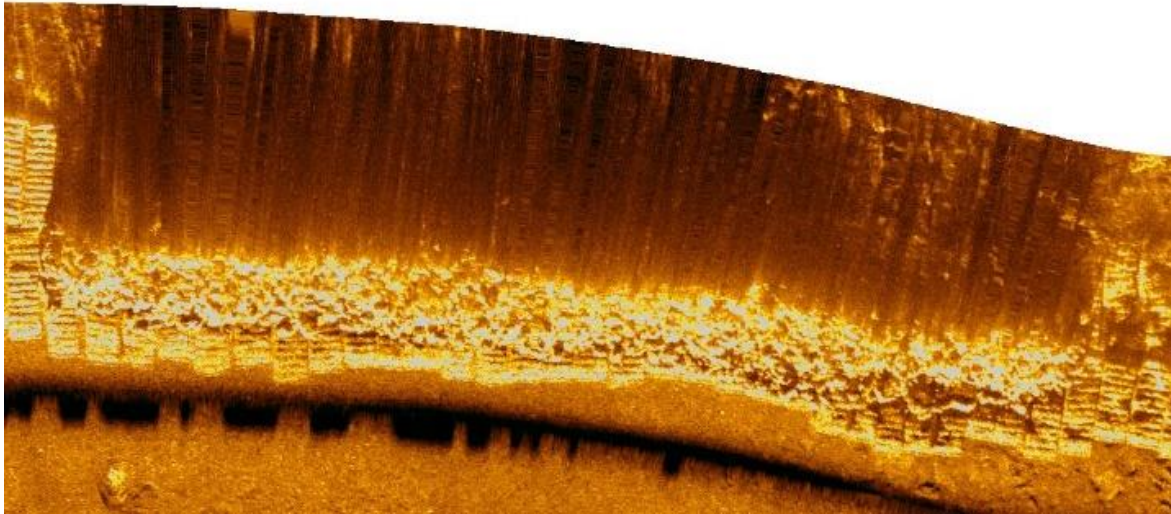
**Figure 46. Breakwater 5 is located to the east of unit 4 towards the mid-section of the Basket Flats project area. The side scan image shows the rows of rectangular foundation mattresses remain tightly together and intact as originally placed. The breakwater rocks towards the center and right of the unit appear to show evidence of r scattering of rocks off the units towards the seaward edge of the mattresses. Bright colors in the image again are representative of higher elevations while the darker regions are caused by the shadows cast off the rock breakwater structure.**

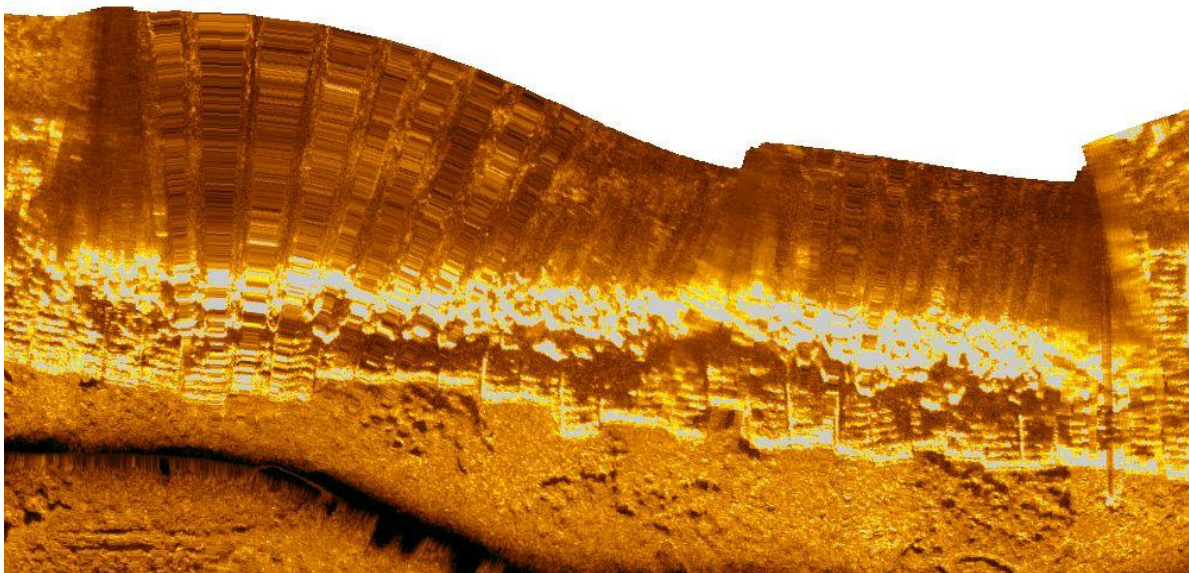
**Figure 47. Breakwater 6 is located to the east of unit 5 towards the mid-section of the Basket Flats project area. The side scan image shows the rows of rectangular foundation mattresses remain tightly together and intact as originally placed. The breakwater rocks remain in place and show no evidence of scattering of rocks off the units or deformation of the structure. Bright colors in the image again are representative of higher elevations while the darker regions are caused by the shadows cast off the rock breakwater structure.**
