American Littoral Society  
Restoring Ecologically Beneficial and Resilient Infrastructure At The  
Mouth of Maurice River, Basket Flats  
Abiotic Physical Monitoring Report for 2023

Stockton University Coastal Research Center

*November 2024*

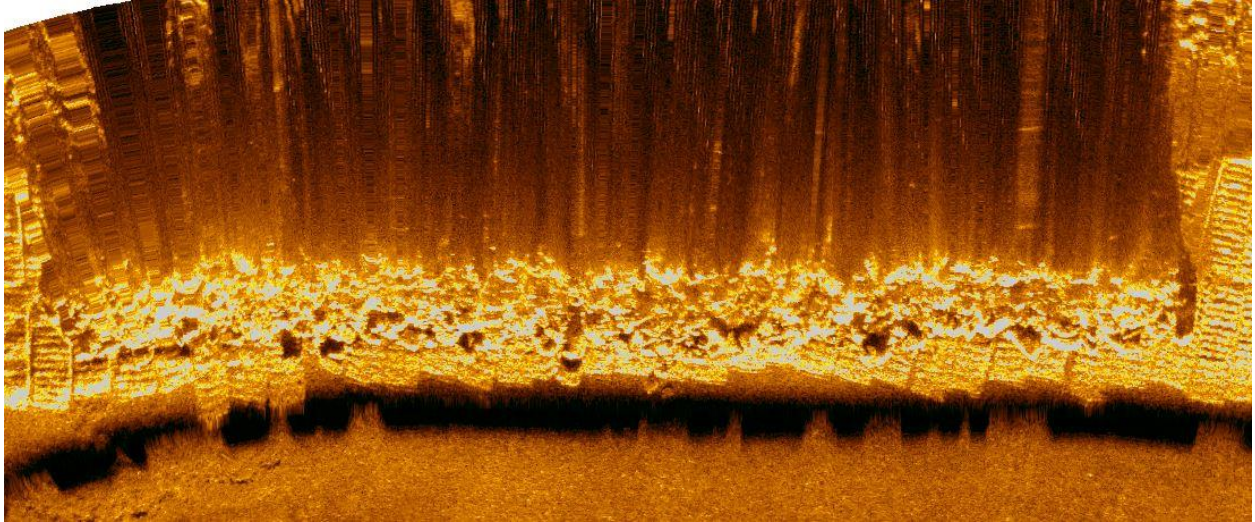
**Figure 48.** Breakwater 7 is located to the east of unit 6 towards the eastern section of the Basket Flats project area. The side scan image shows the rows of rectangular foundation mattresses remain tightly together and intact as originally placed. The breakwater rocks remain in place with some evidence of rock scattering in the midsection along the seaward base, and show no evidence of scattering of rocks off the units or deformation of the structure. Bright colors in the image again are representative of higher elevations while the darker regions are caused by the shadows cast off the rock breakwater structure.

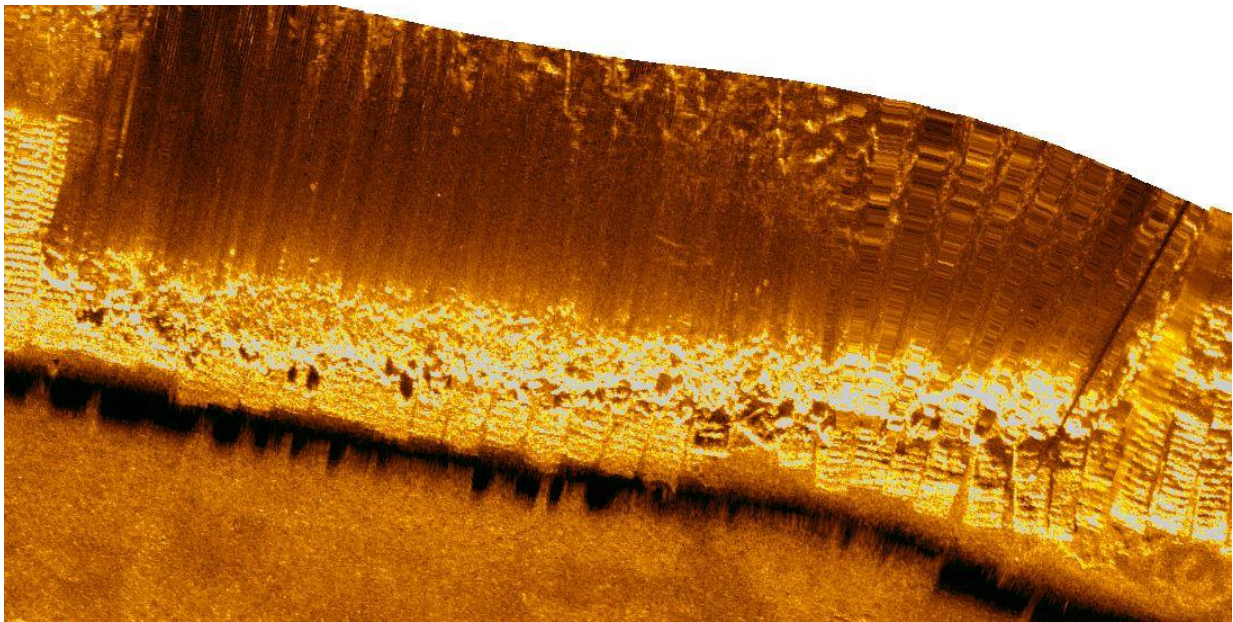
**Figure 49.** Breakwater 8 is located near the east end of the Basket Flats project area. The side scan image shows the rows of rectangular foundation mattresses on the left side remain tightly together and intact as originally placed. Towards the center right there are a few rows that appear to have been placed offset towards the land and have separated. The breakwater rocks remain in place with minor evidence of rock scattering off the units. Bright colors in the image again are representative of higher elevations while the darker regions are caused by the shadows cast off the rock breakwater structure.

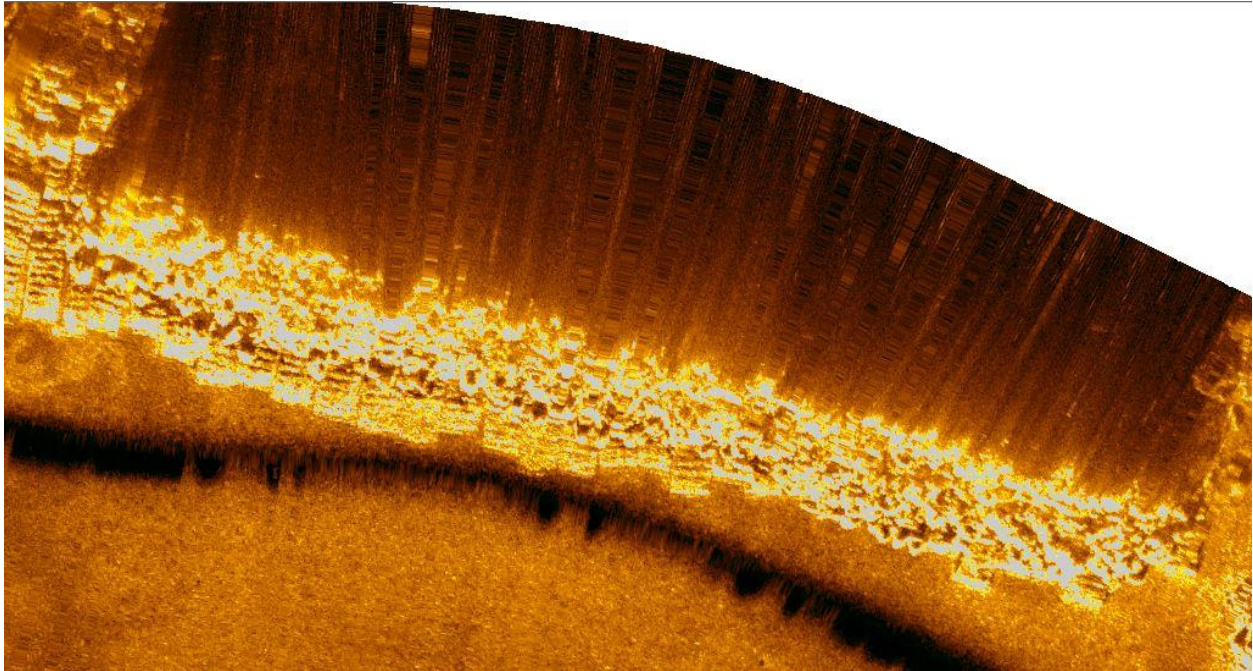
**Figure 50.** Breakwater 9 is located at the east end of the Basket Flats breakwater project area. The side scan image shows the rows of rectangular foundation mattresses remain tightly together and intact as originally placed. The breakwater rocks remain largely in place but show evidence of rock scattering off the units or deformation along the eastern end of the structure. Bright colors in the image again are representative of higher elevations while the darker regions are caused by the shadows cast off the rock breakwater structure.

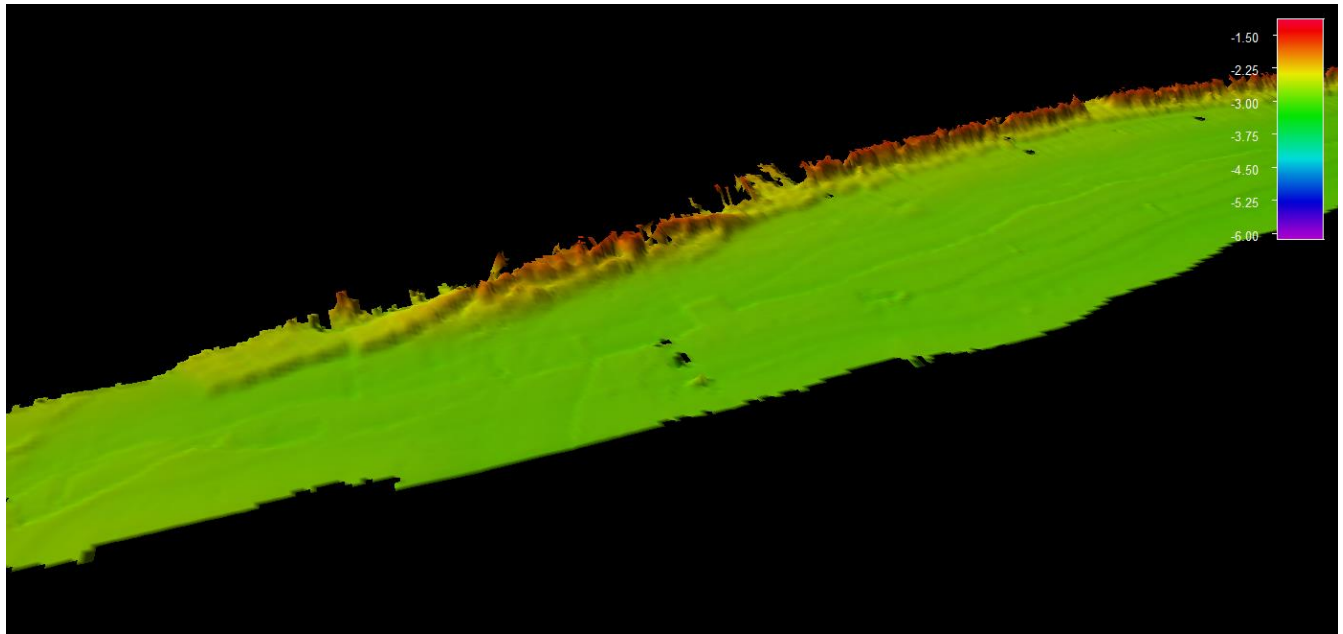
Figure 51. Shows the spatial relationship between Breakwater unit #1 and #2 (left to right) with a portion of unit #3 visible in the upper right corner. Brownish to red colors indicate the higher portions of the breakwater but none exceed -1.5 feet NAVD88 due to limitations of the multi beam recording elevations below the water surface. Green colors indicate the bay floor bottom while yellow are the foundation mattresses. Unit #2 is very uniform in elevation across the structure while Unit #1 has some elevation deflation on the seaward slope along the western (left) side of the unit.

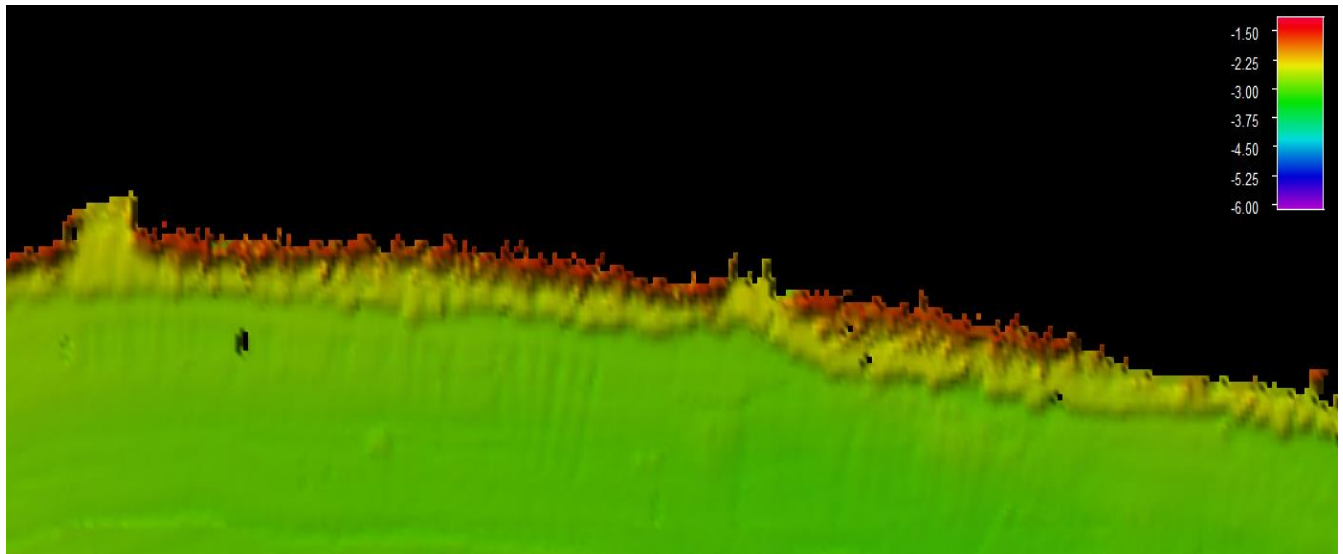
Figure 52. Shows the spatial relationship between Breakwater unit #3 and #4 (left to right). Brownish to red colors indicate the higher portions of the breakwater, none exceed -1.5 feet NAVD88 due to limitations of the multi beam recording elevations below the water surface. Green colors indicate the bay floor bottom while yellow are the foundation mattresses and gaps between the units. Unit #3 is very uniform in elevation across the structure while unit #4 has some elevation deflation on the seaward slope along the eastern (right) side of the unit.

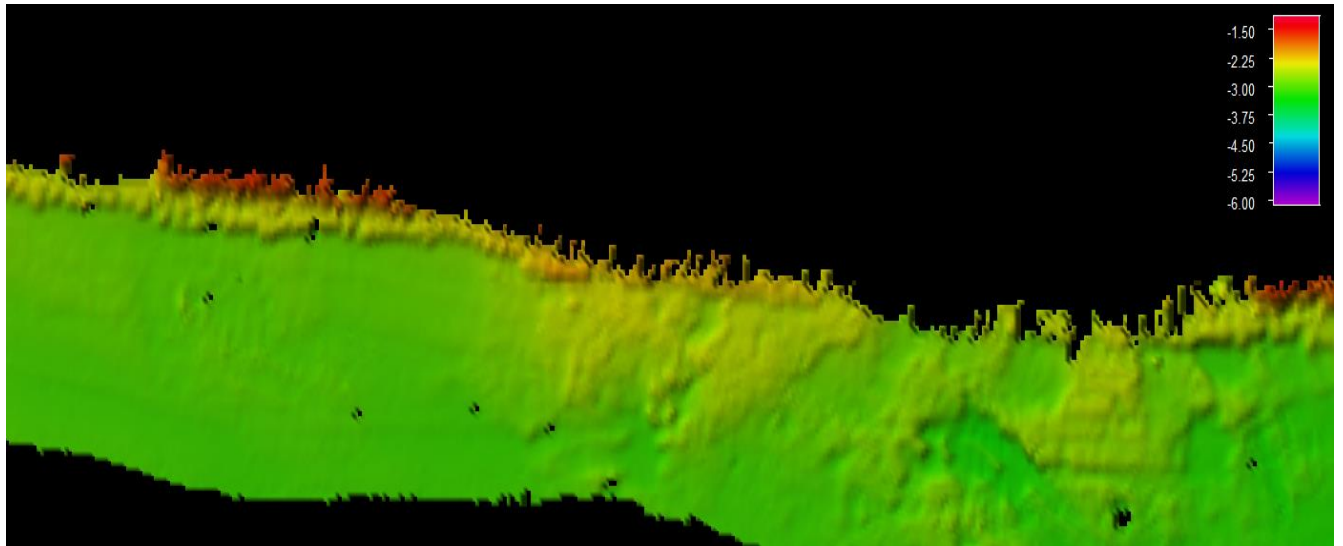
Figure 53. Shows the spatial relationship between Breakwater unit #5 and #6 (left to right). Brownish to red colors indicate the higher portions of the breakwater on unit #5. Unit #6 is mostly yellow in color indicating deflation on the seaward slope. Green colors indicate the bay floor bottom while yellow are the foundation mattresses and gaps between the units. Seaward of Unit #6 there is an extension of yellows indicating slightly higher elevation than the surrounding bay floor. The side scan image of unit #6 confirms the presence of this pattern. This pattern may be caused by shifted stones, misplaced stones or another surface unconformity.

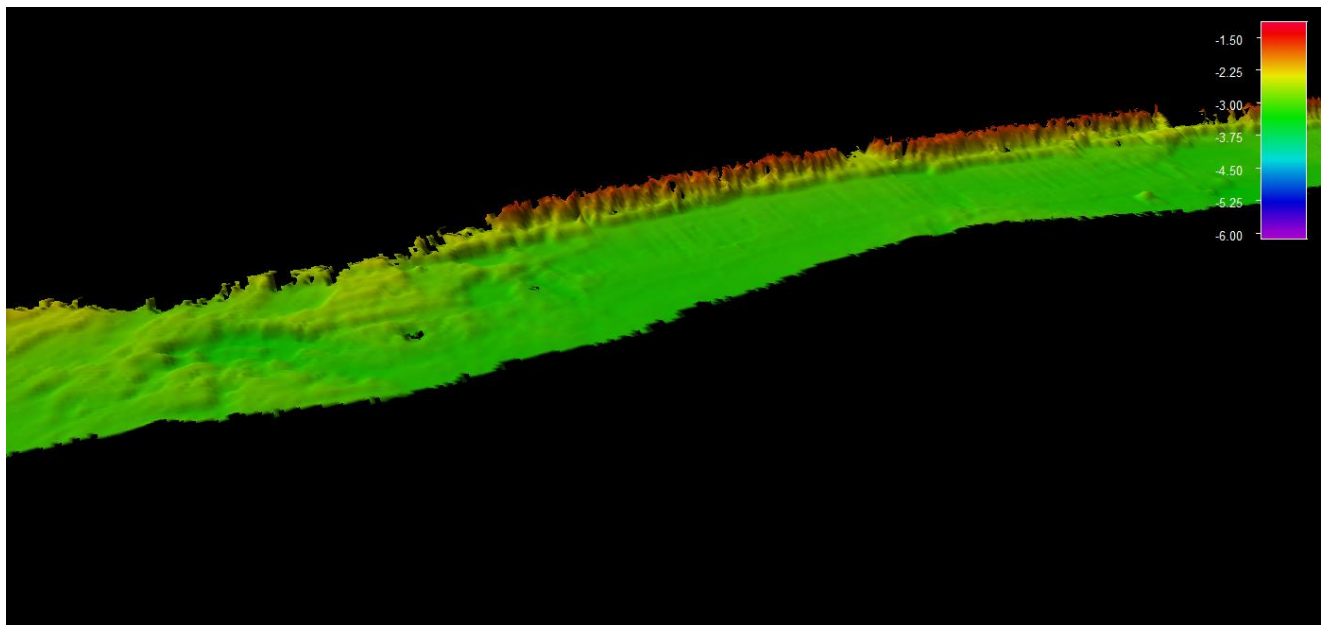
Figure 54. Shows the spatial relationship between Breakwater unit #7 and #8 (left to right center) to the far right a portion of breakwater 6 is included with the unconformity on the bay floor. The bay floor seaward of units 7 and 8 is more consistent in elevation as are the seaward slope elevations of each breakwater. Brownish to red colors again indicate the higher portions of the breakwater seaward slope with yellow typically indicating the foundation mattress below the rocks and in the gaps between units.
