Year 1 Post-Construction Monitoring Report

**Pochin Place / Indian River Creek Stormwater Basin
Hampton, Virginia**

**Prepared for:
The City of Hampton**

November 2021

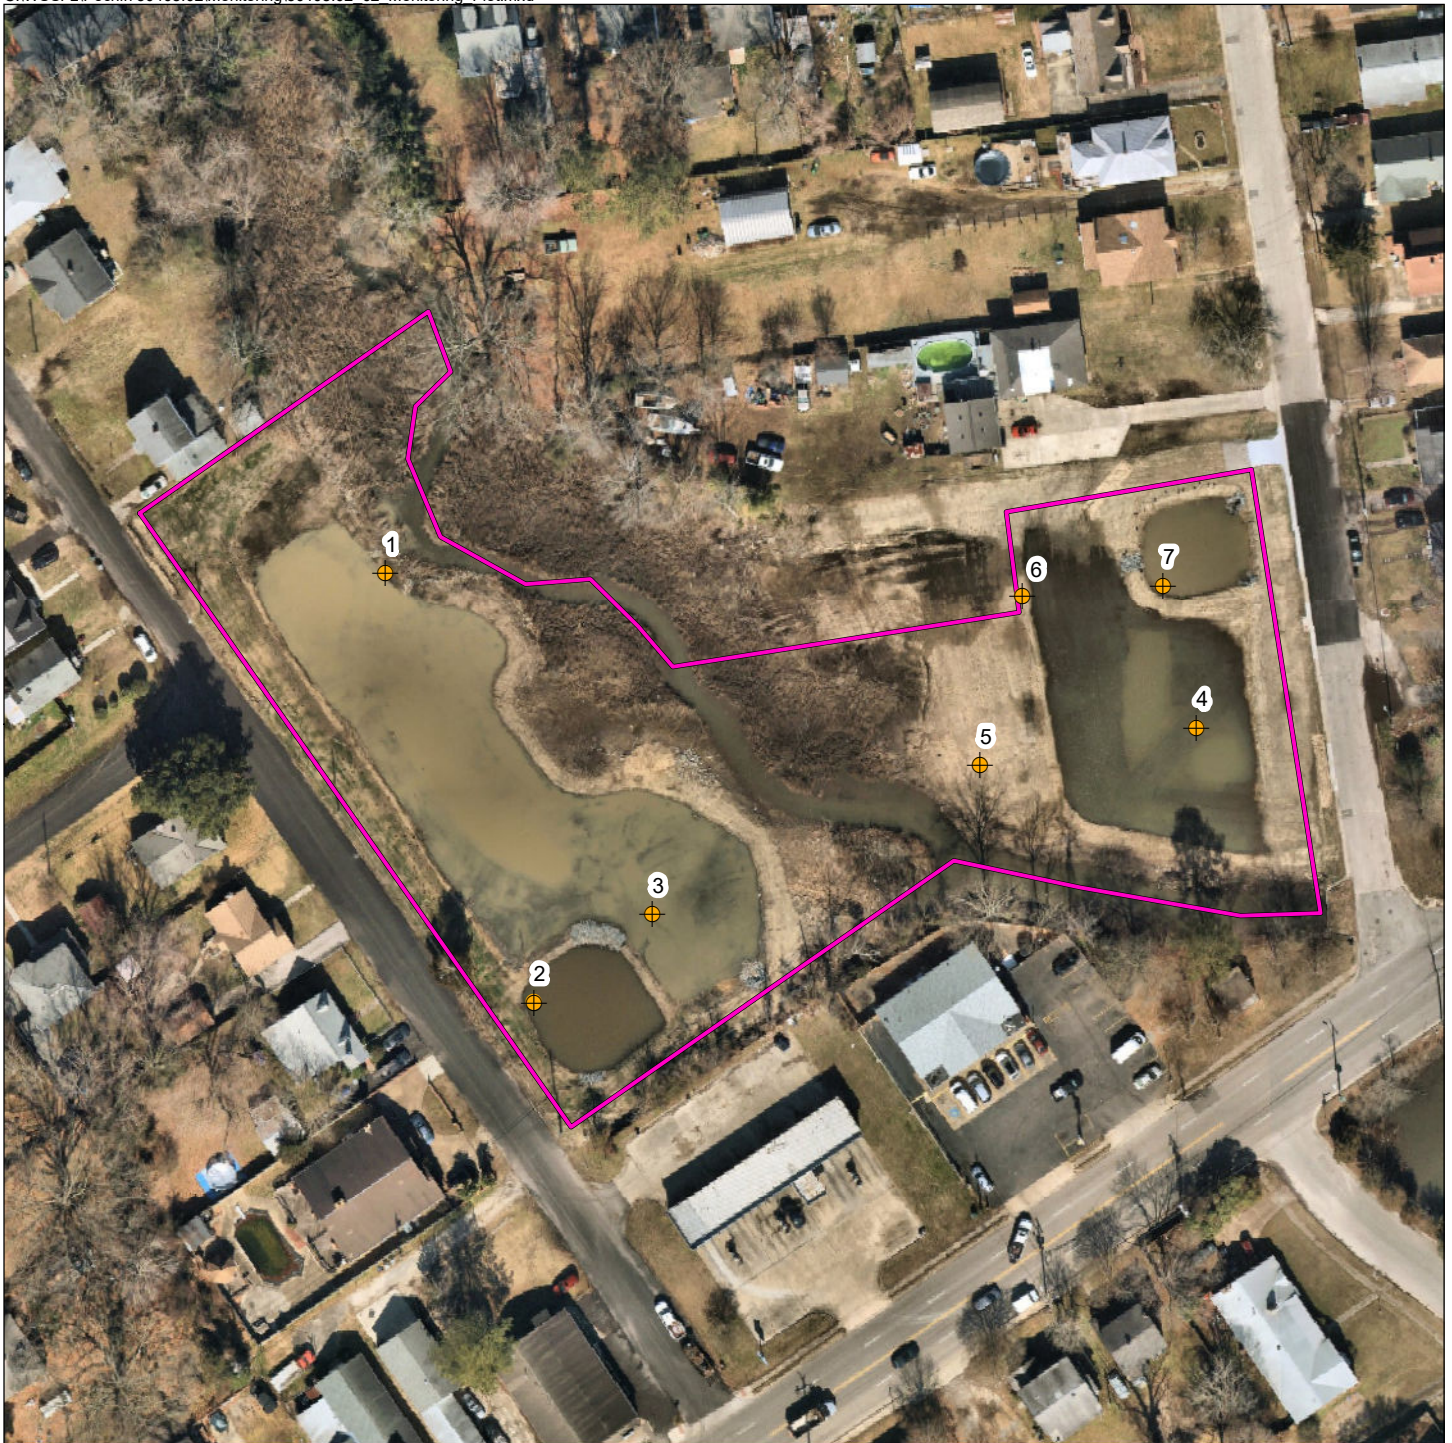
Monitoring Plots
Pochin Place
WSSI #30408.02

WSSI revisited the seven (7) monitoring plots previously established during the pre-construction monitoring event. The location of each plot is shown on **Exhibit 2**. The plots are 1m² and the center of each plot was marked by a wooden survey stake.

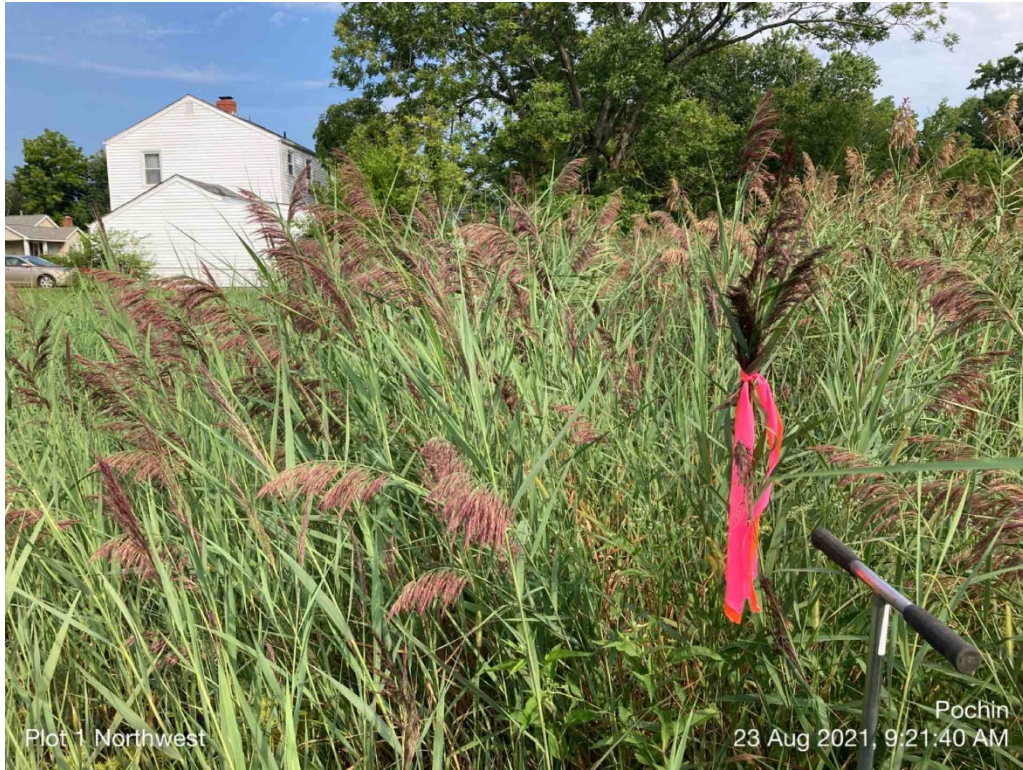
1. Monitoring Plot 1 facing northwest.

Non-tidal wetland vegetation has become established at plots 1, 2, and 4. Tidal wetland vegetation is dominant in plots 5 and 6. Plots 3 & 7 did not have any vegetation present while station 4 had very little (Table 2). The lack of vegetation at these monitoring plots is due to higher than anticipated water levels. The elevation of all monitoring plot locations decreased as anticipated as a result of the construction (Tables 2 & 3).
