Basket Flats Final Grant Report

Theo Diehl, Stephanie Feigin, Larry Niles

Wildlife Restoration Partnerships LLC, Greenwich, NJ

December 2024

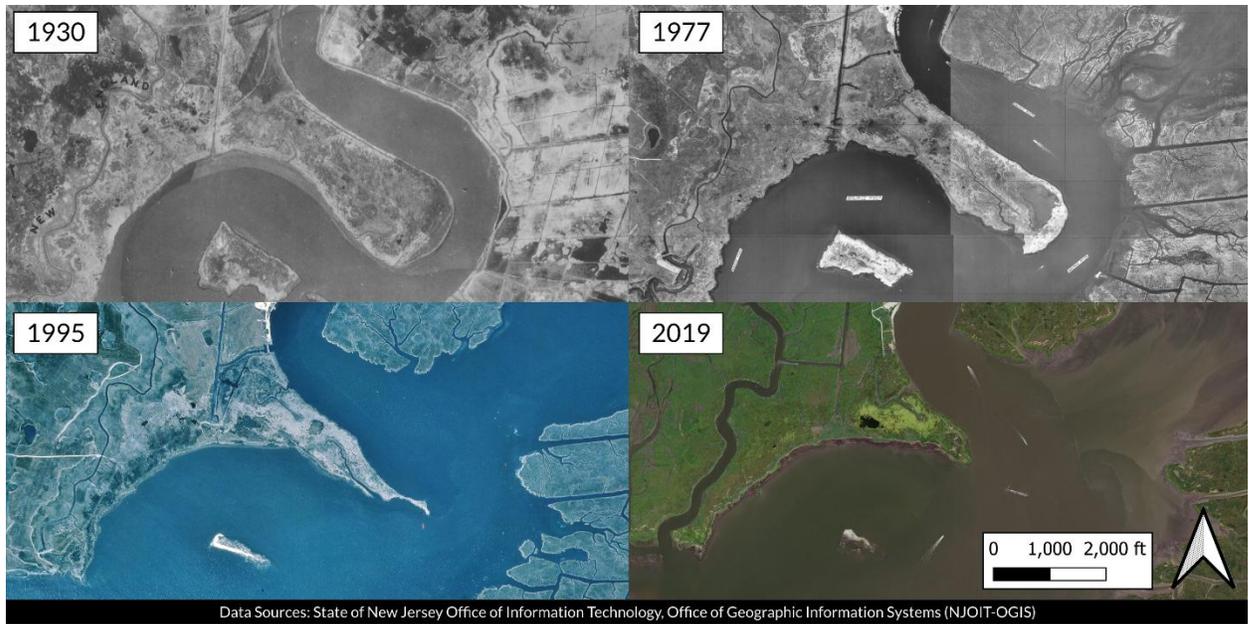
Basket Flats has long protected Bivalve by acting as a physical barrier from the full wave energy of the Delaware Bay. As demonstrated by historical imagery in Figure 2, the peninsula has been steadily decreasing in size over the last century. The trajectory of decline facing the peninsula threatens to weaken or eliminate its ability to shelter Bivalve from severe coastal erosion. Over the years, several projects were proposed to help stabilize the peninsula but did not materialize. In 1998, the New Jersey Department of Environmental Protection placed sunken barges to act as breakwaters along the tip of the peninsula, but this ultimately failed in stemming the peninsula’s decline.

Figure 2: As seen here, Basket Flats has been on a continual trajectory towards erosion over the last century. Imagery obtained via the NJ Office of Information Technology, Office of GIS (NJOGIS) and USDA-FPAC-BC Aerial Photography Field office.

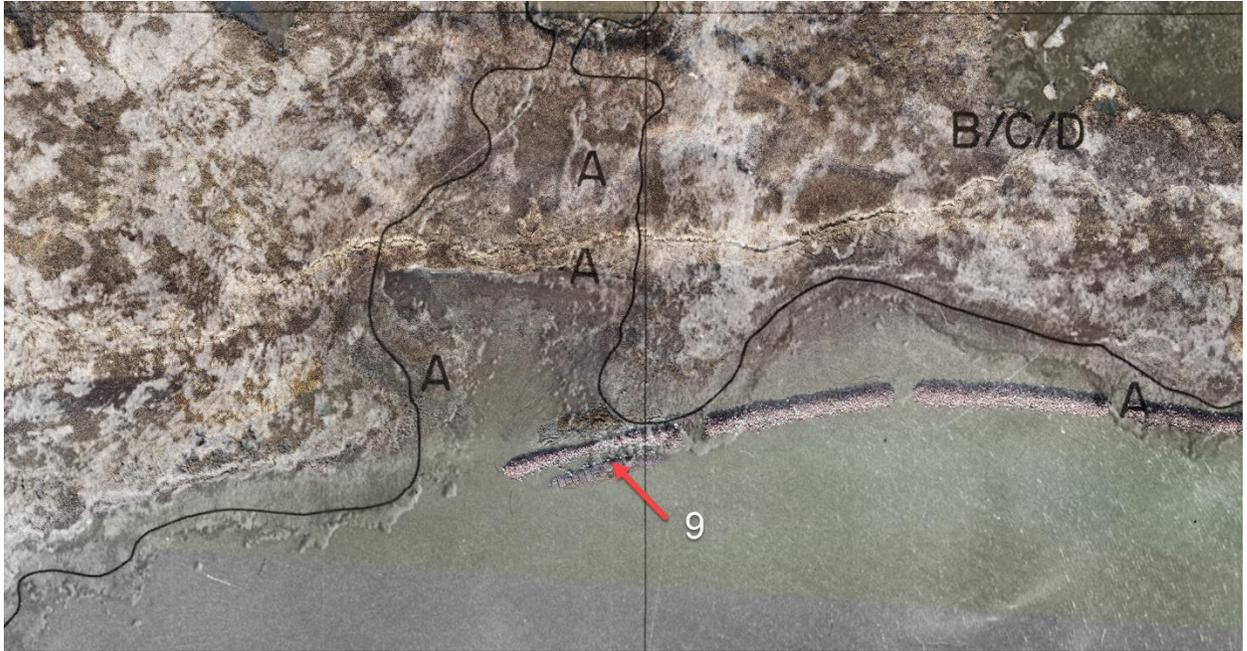
Early in the monitoring process, it became clear that breakwaters 9, 3, and 2 were experiencing more rapid settling than the other structures. Comparison with historical aerial imagery indicates that this could be influenced by drainages that ran through the former marsh at these locations. Figures 5 and 6 show an overlay of 1970 Wetlands (NJOGIN) aerial imagery onto 2023 drone imagery of the breakwater structures. There is an apparent correlation between the breakwaters that experienced more significant settling and the presence of former drainages. Drainages in salt marshes tend to be muddy, soft, and unstable, which could explain why a breakwater constructed over a former drainage would not hold its vertical position as well. Breakwater 9's dramatic settling shortly after construction seems to correlate with the wider extent of the former drainage underlying it. Sediments within this area would likely be even less stable than the areas with smaller drainages.

Figure 5: 1977 NJ Wetlands imagery overlaid onto 2023 drone imagery, demonstrating that breakwater 9's significant initial sinking behavior may be related to its position over a former drainage.

This information was helpful, not only to elucidate the causes of changes in elevation as they occurred during the monitoring period, but to help inform future restoration projects. With the

gained experience that breakwaters placed on former drainages may suffer greater elevation loss, breakwater placement can now be better planned to avoid such areas.
