Leque 1st-year Post-Restoration Tidal Marsh Monitoring Report

14 June 2021

W. Gregory Hood
Skagit River System Cooperative, LaConner, WA

prepared for
Washington Department of Fish and Wildlife

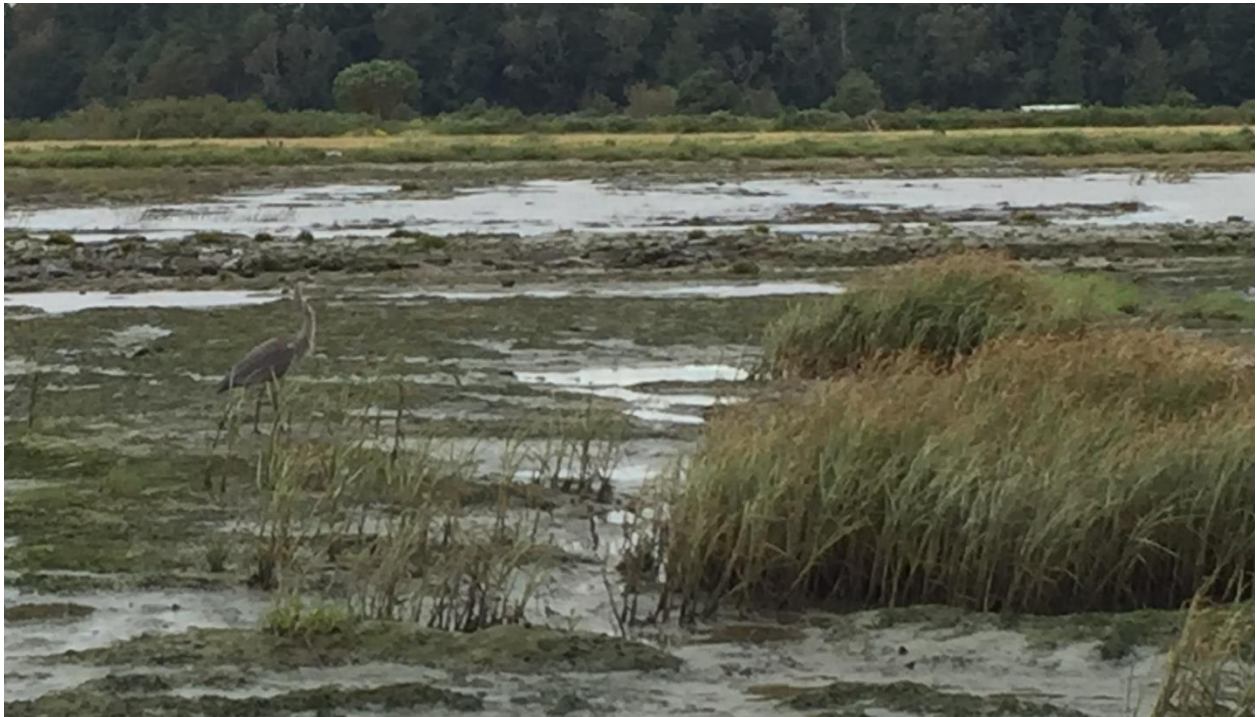
Great Blue Heron in patchily vegetated, Bolboschoenus maritimus, marsh one year after restoration.

One of the most visually striking aspects of the Leque restoration site is the currently patchy vegetation colonization of the site. Bare ground predominates while patches of *Bolboschoenus* intermittently border tidal channels and *Cotula* is scattered at slightly lower elevations in the southern half of the Leque restoration site. Even so, the observed colonization of *Bolboschoenus* is a hopeful augury for the second year of site recovery. It seems likely that *Bolboschoenus* will continue to spread to match predictions of the vegetation model (Fig. 2, upper middle frame) of site dominance by this species. This prediction was borne out in the nearby zis a ba restoration site by the second year after site restoration, a stunningly rapid rate of vegetation establishment. It would be equally amazing if this feat were repeated for the Leque restoration site. The rapid colonization of the zis a ba site has been attributed to extensive excavation of tidal channels on that site, which diverts the energy of tidal exchange from sheet flow on the marsh surface to channelized flow in tidal channels. The lowered tidal energy on the marsh is thought to improve seed settlement and germination (Hood 2019). Since extensive tidal channel excavation also occurred on the Leque site, we should see similarly rapid vegetation recovery on the Leque site, if this hypothesis on the role of tidal energy dissipation in vegetation colonization is correct. Thus, a second year (or more) of vegetation monitoring is critical to test this hypothesis.

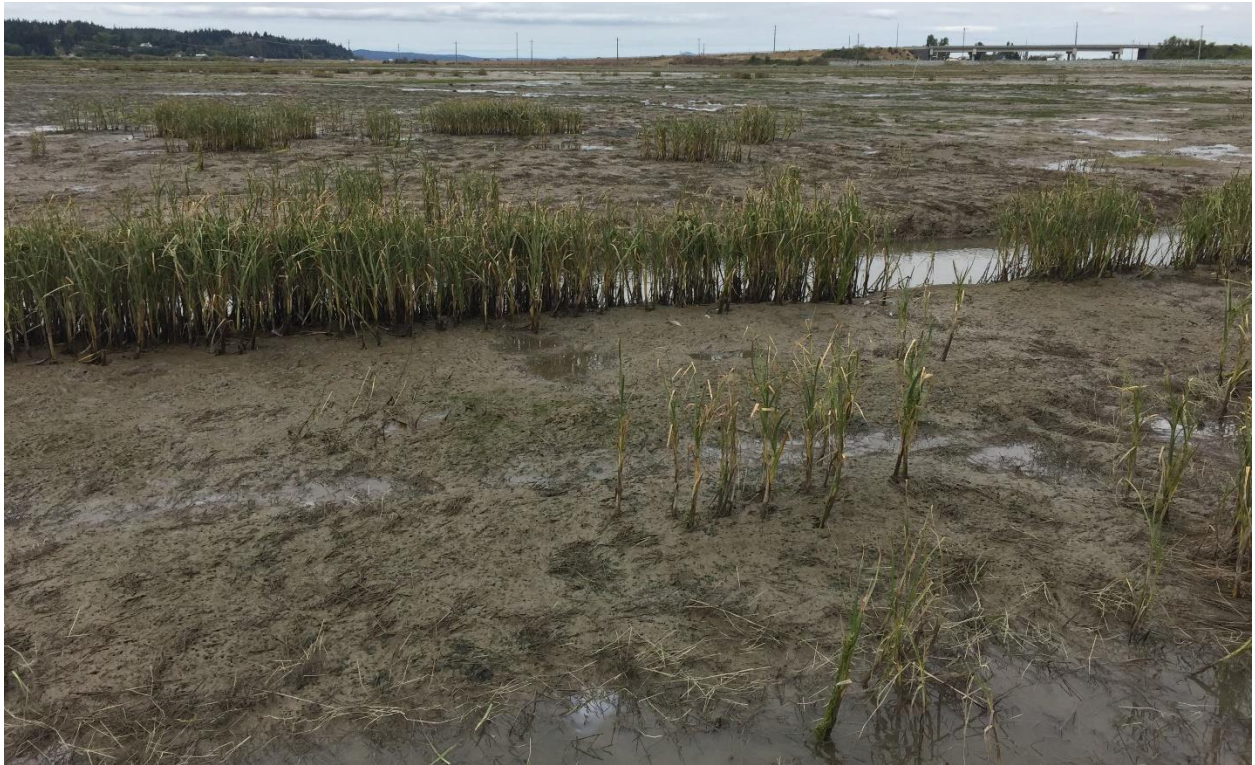
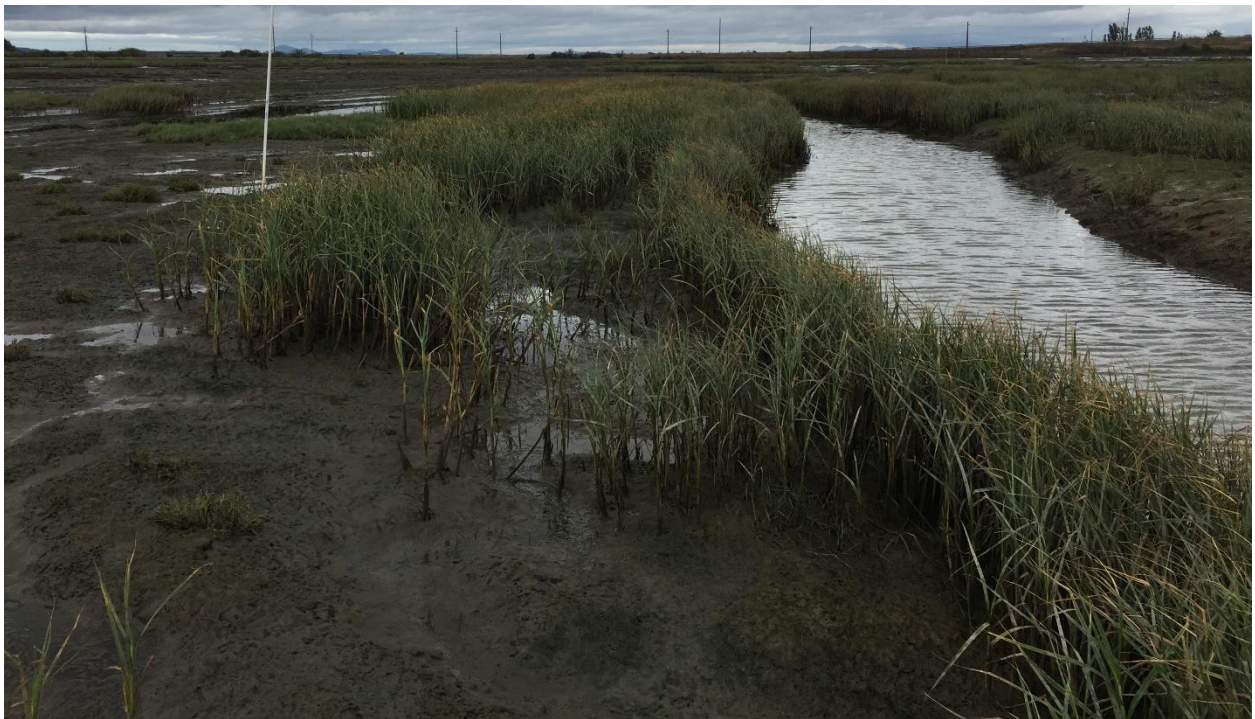
Figure 3. Two views of *Bolboschoenus maritimus*, showing typical occurrence along the margins of tidal channels.

Bare ground was distributed relatively evenly throughout the site, but *Cotula* occurred mostly in the southern, lower-elevation half of the site (70 of 81 sample points, or 86%) (Fig. 2, lower left frame). *Bolboschoenus* tended to be associated with tidal channel banks (Fig. 3), suggesting seeds or other propagules were brought onto the site with the flood tide and dropped on the nearby marsh surface. *Bolboschoenus* was particularly abundant in large patches in the north-central portion of the site, also along the margins of several tidal channels in this area. Other, less common species, were also associated with channel margins (24 of 35 sample points, or 69%), suggesting they too were brought onto the site by the flood tide.
