Leque 2nd-year Post-Restoration Tidal Marsh Monitoring Report

12 December 2021

W. Gregory Hood Skagit River System Cooperative, LaConner, WA

prepared for Stillaguamish Tribe Natural Resources & Washington Department of Fish and Wildlife

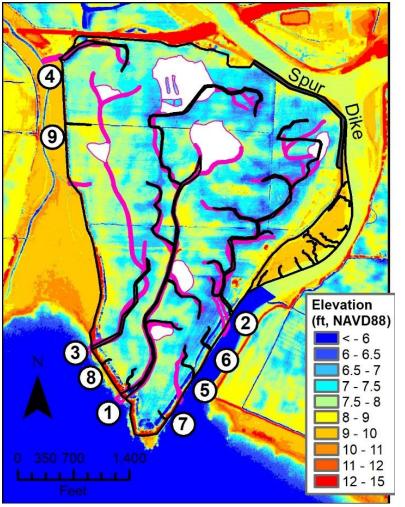
Figure 1. Location of excavated tidal channels (pink) and ponds (white) within the Leque restoration site, compared to conceptual plan channels (black outline polygons). Numbers identify conceptual plan channels at their outlets. The background image represents a lidar-derived DEM and shows that planned channels were located in topographic lows.

Tidal channel excavation resembled the conceptual planform design developed prior to restoration, but there were some significant alterations of the original design (Fig. 1). Three of the smallest channels (numbers 6, 7, and 8) were not excavated. Two others (numbers 5 and 9) were moved slightly to the south. One (number 3) was made much longer than planned. The six excavated channels amounted to a total channel area of 4.10 ha (10.13 ac) and total channel length of 6,580 m (21,589 ft). These values are greater than those of the conceptual design plan (Table 1). Overall, the total area of restored tidal channels was 19% greater than originally planned, while total channel length was 12% greater. Perhaps the most notable departure from the original channel design was a last minute decision to excavate large, shallow ponds. Their excavation was required to make up for a cut/fill imbalance, but they were also thought to be capable of providing habitat for waterfowl and fish. The excavated ponds were all connected to the excavated tidal channels to allow drainage on low tides. Their area was more than twice the area of the restored tidal channels, and amounted to about 8% of the total restoration site area. The area of the shallow pans (incidental, unvegetated, topographic depressions that tend to pond water to depths of a few inches at low tide; Fig. 2) was comparable to that of the restored tidal channels.

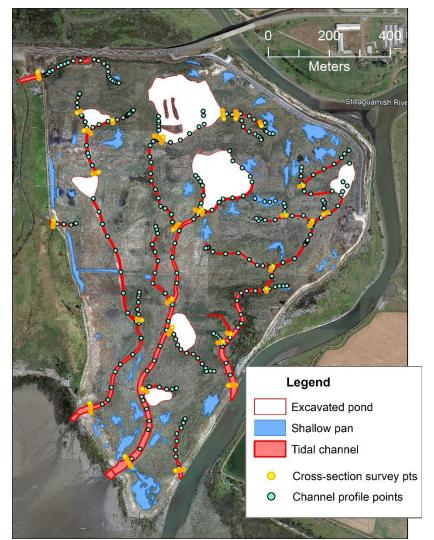
Figure 2. Location of channel cross-section and profile survey points relative to channels and ponds.

Tidal channel cross-sections and profiles were surveyed in July 2021 and their locations are shown in Figure 2. Channel evolution through deepening, shoaling, or lengthening will be evaluated in the future by comparison with repeated channel cross-section and profile surveys. The excavated tidal channels had clay bottoms and sides, so further erosion leading to deepening or lengthening, if it occurs, is likely to be a very slow process. Incidental shallow pans, bare of vegetation and retaining a few centimeters of water at low tide, were observed in the field and in the 2020 aerial photos. If the sediments were more erodible, these would be areas likely to support headcutting of additional tributary channels.

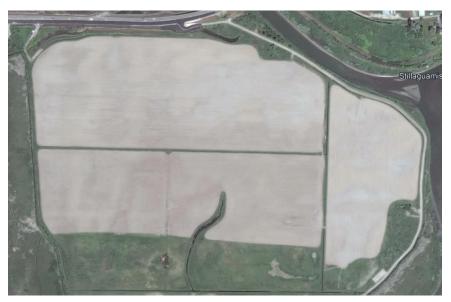
Figure 3. North half of the Leque restoration site two years prior to restoration, showing typical farmed (tan) and fallow (green, grassy) fields.

Two years prior to restoration, the Leque site consisted of farmed grain fields, planted by the Washington Department of Fish and Wildlife to attract waterfowl, and sometimes fallow grass fields (Fig. 3). Field reconnaissance during this time showed that the grass fields consisted of non-native, pasture grasses typical of Western Washington, such as *Elymus repens* (quackgrass), *Lolium perenne* (ryegrass), *Agrostis stolonifera* (bentgrass) in wetter areas, *Dactylis glomerata* (cat grass), and the pasture weed (unpalatable to cattle), *Holcus lanatus* (velvet grass). With the exception of *Agrostis stolonifera* in occasional small patches, none of these grasses have persisted after site restoration to tidal inundation.

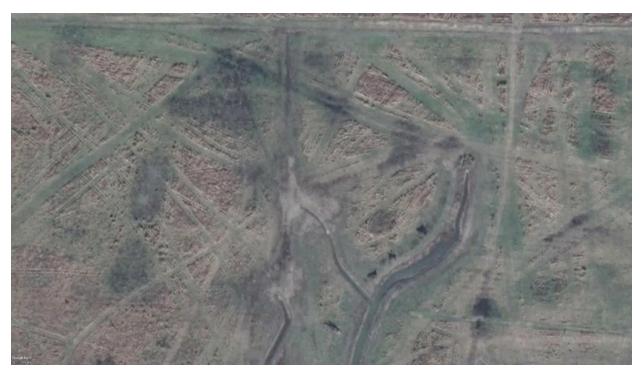
Figure 4. Extensive crisscrossing of tracks of heavy equipment on the Leque restoration during early stages of channel and pond excavation. Vegetation was mostly obliterated by the end of construction.

In the year prior to dike breaching, there was extensive disturbance of the site by heavy, tracked machinery and dump trucks involved in excavation of tidal channels. The intensity of this disturbance is only lightly hinted at in Figure 4. Field visit during the peak of construction showed that the site was bare throughout as a result of intense construction activity involving excavation of 12.5 ha (31 acres) of tidal channels and ponds. Typical saltmarsh vegetation was nowhere visible on the site, so current vegetation (see below) is not a legacy of prior land use.

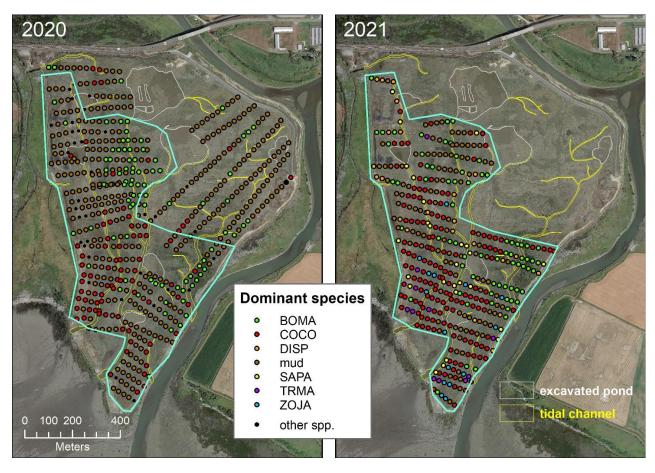
Figure 5. Dominant vegetation at RTK-GPS point samples. BOMA = *Bolboschoenus maritimus*; COCO = *Cotula coronopifolia*; DISP = *Distichlis spicata*; SAPA = *Sarcocornia pacifica*; TRMA = *Triglochin maritima*; ZOJA = *Zostera japonica*.

Two years after site restoration, the Leque Island site is just beginning to be recolonized by vegetation. Most of the site still consists of bare ground. To maximize sampling efficiency, vegetation sampling avoided large areas devoid of vegetation. A portion of the area sampled in 2020 was not sampled in 2021, because it was 80% bare in 2020 and appeared similarly bare in 2021. In the sampled area common to both years (light blue polygon in Fig. 5), bare ground comprised 56% of the 2020 vegetation survey, but only 26% of the 2021 vegetation survey, which indicates a 52% decrease in bare ground (Table 2). The decrease in bare ground was due primarily to a doubling in the occurrence of the non-native weed, *Cotula coronopifolia* (brass buttons), as well as significant increases in the native species, *Distichlis spicata* (saltgrass), *Sarcocornia pacifica* (pickleweed), and *Triglochin maritima* (seaside arrowgrass), as well as the non-native eelgrass, *Zostera japonica*, which was found in shallow marsh surface pans. The predicted dominant species for this site was *Bolboshoenus maritimus* (maritime bulrush), which in both years accounted for 18% of the sampled vegetation points in the common survey area. There was no evident increase in this species from 2020 to 2021, so colonization of the Leque restoration site by this species is much slower than at the nearby zis a ba restoration site.

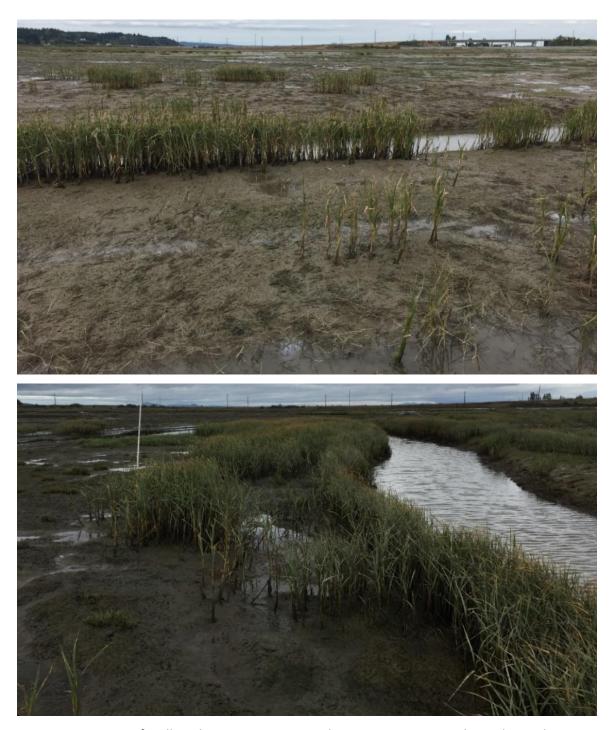
Figure 6. Two views of *Bolboschoenus maritimus*, showing occurrence along channel margins.

During field surveys, *B. maritimus* appeared to be associated with tidal channel banks, though not exclusively (Fig. 6). Plots of the frequency distributions of the distances of *Bolboschoenus*, *Sarcocornia*, *Distichlis*, and *Cotula* from channel banks initially appeared to support this field observation by showing an exponential decline in occurrence frequency with distance from the channel network for almost all species (*Triglochin* and *Zostera* were too infrequently observed to meaningfully plot their frequency distributions). However, when the frequency distributions for all sample points regardless of species present was similarly plotted as a control, it was shown that all sample plots, collectively, had a similar exponential decline in occurrence frequency with distance from the channel network (Fig. 7). This is an indication that the channel network is well dispersed throughout the site, so that few areas of marsh are far from the network; most are near the channels.

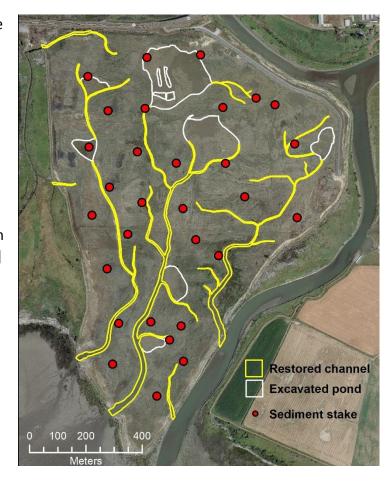
Figure 8. Location of Leque restoration sediment stakes.

Sediment stakes have been installed in the restoration site (Fig. 8), and will be monitored on an annual basis at the end of each water-year. Five stakes are located in three excavated ponds, with three stakes in the largest pond. One stake is located in one of the deeper shallow pans. The remaining 24 stakes are dispersed throughout the marsh surface.

Because sediment stakes were only installed this year, it is too soon to describe any results. However, we can anticipate testing the following hypotheses in the future following many years of annual sediment stake measurements: [1] accretion is correlated with proximity to tidal channels (i.e., tidal channels are the primary source of sediment); [2] accretion is negatively correlated with elevation (consistent with theory); [3] accretion rate is comparable to the current rate of sea level rise (given sufficient sediment supply accretion rates can accelerate with increasing rates of sea level rise, so current sea level rise rates are the appropriate comparison).
