NICHOLLS
STATE UNIVERSITY

**Monitoring and Evaluation of Constructed Marsh Terraces and Marsh Creation
Projects in South Louisiana**

Final Report

24 June 2022

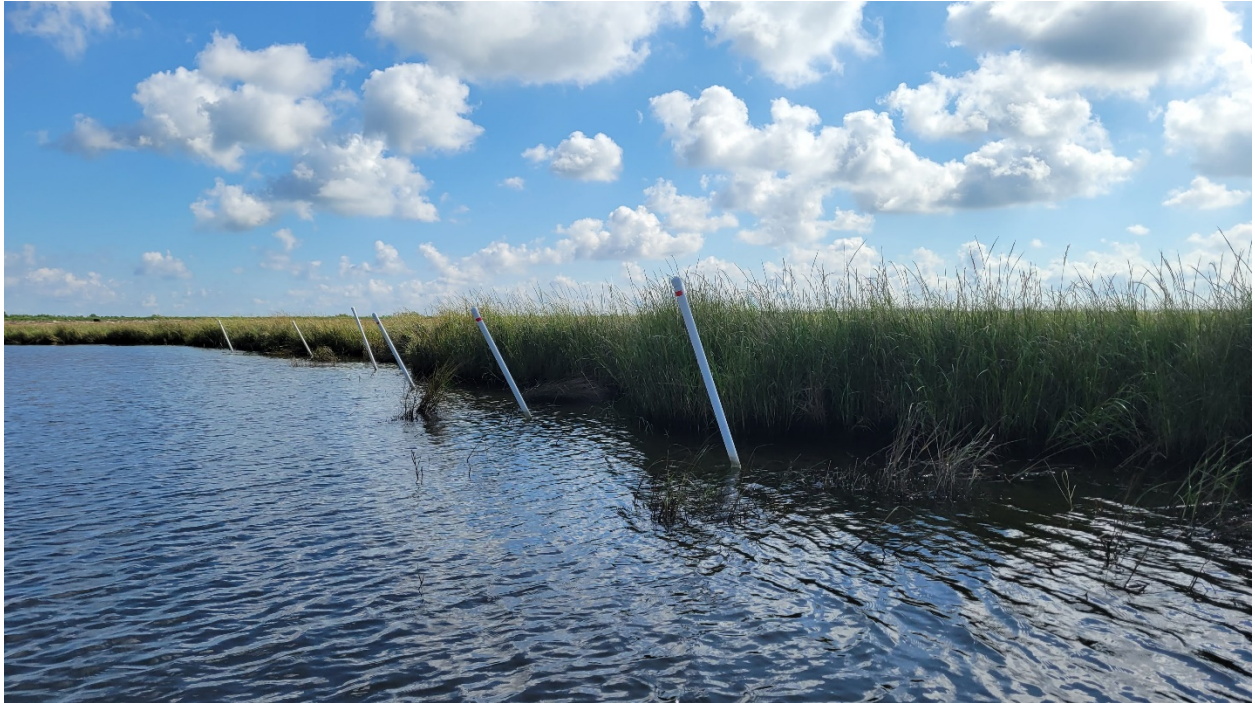
Figure 1. Vertical PVC poles mark the bank where the Cajun Corals were placed. All structures were completely submerged on 7 October 2021, Golden Meadow site.

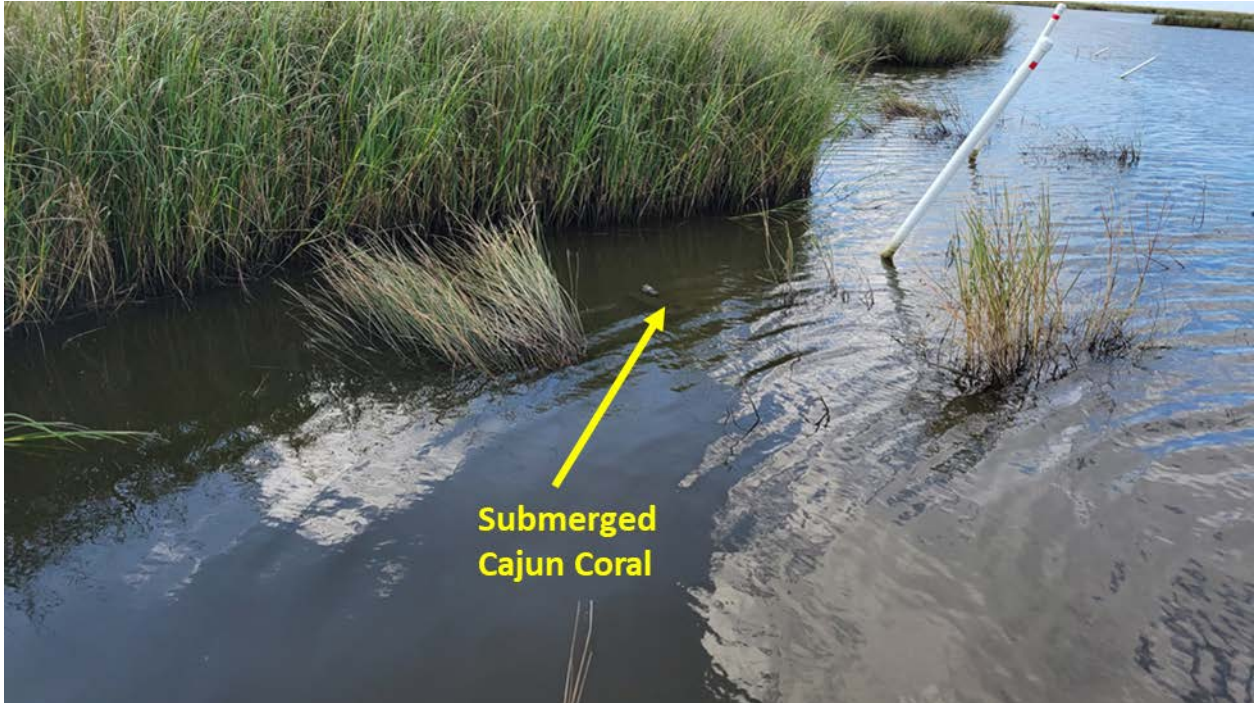
Figure 2. A single Cajun Coral submerged below the water surface on 7 October 2021, Golden Meadow site.

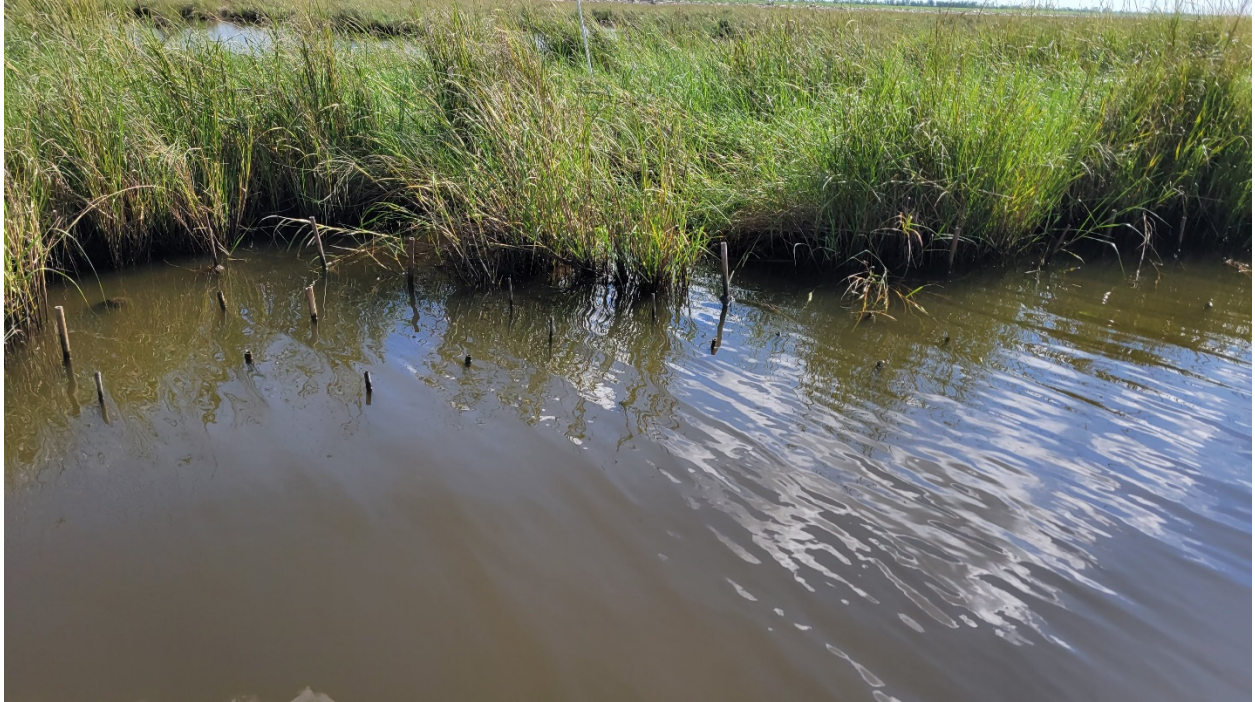
Figure 3. The tops of poles of Oyster Stakes just above the water surface on 7 October 2021, Golden Meadow site.

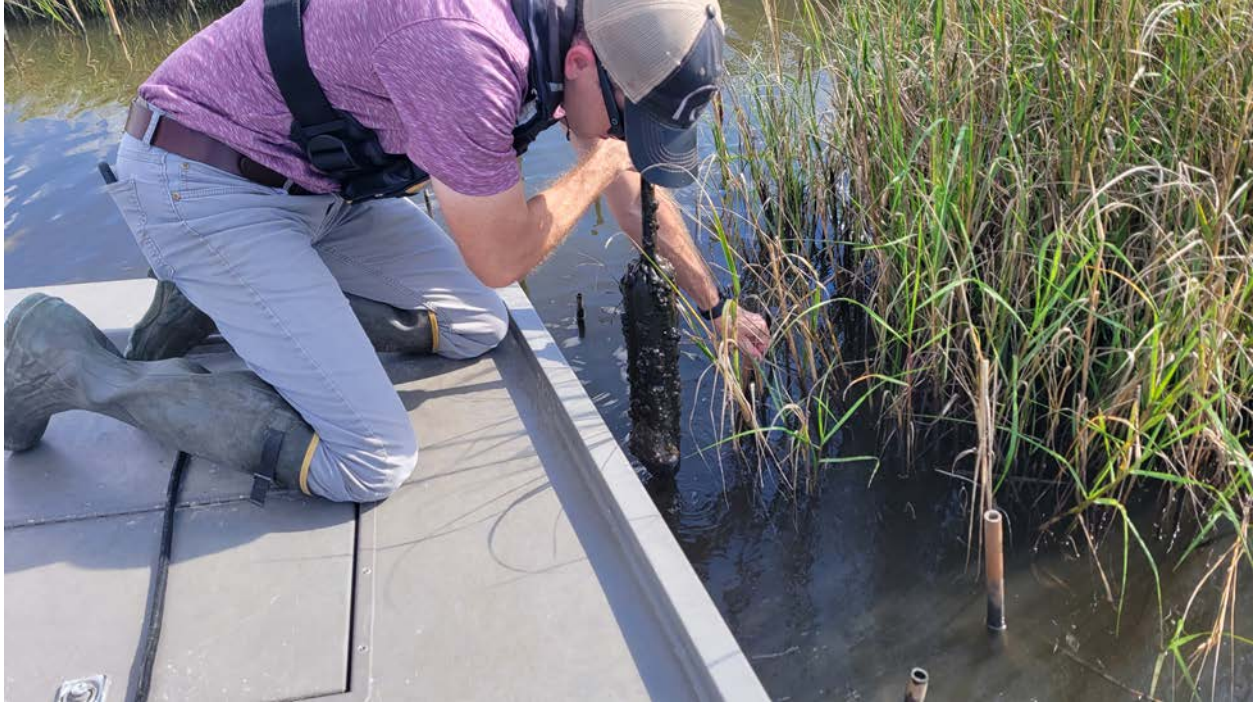
Cajun Coral and Oyster Stakes were installed to promote oyster reef development so that a living reef would be established and provide long-term protection for the adjacent marsh. We made a preliminary visit on 7 October 2021 to the Golden Meadow site and observed that the Cajun Coral were completely submerged and only the tops of the poles of the Oyster Stakes were visible (Figures 1 through 3). We visually observed oysters and barnacles growing on the Oyster Stakes (Figure 4) and were able to feel by hand that the Cajun Coral structures supported oysters and barnacles.

Figure 4. Newly removed Oyster Stake with visible oysters and barnacles on 7 October 2021, Golden Meadow site.

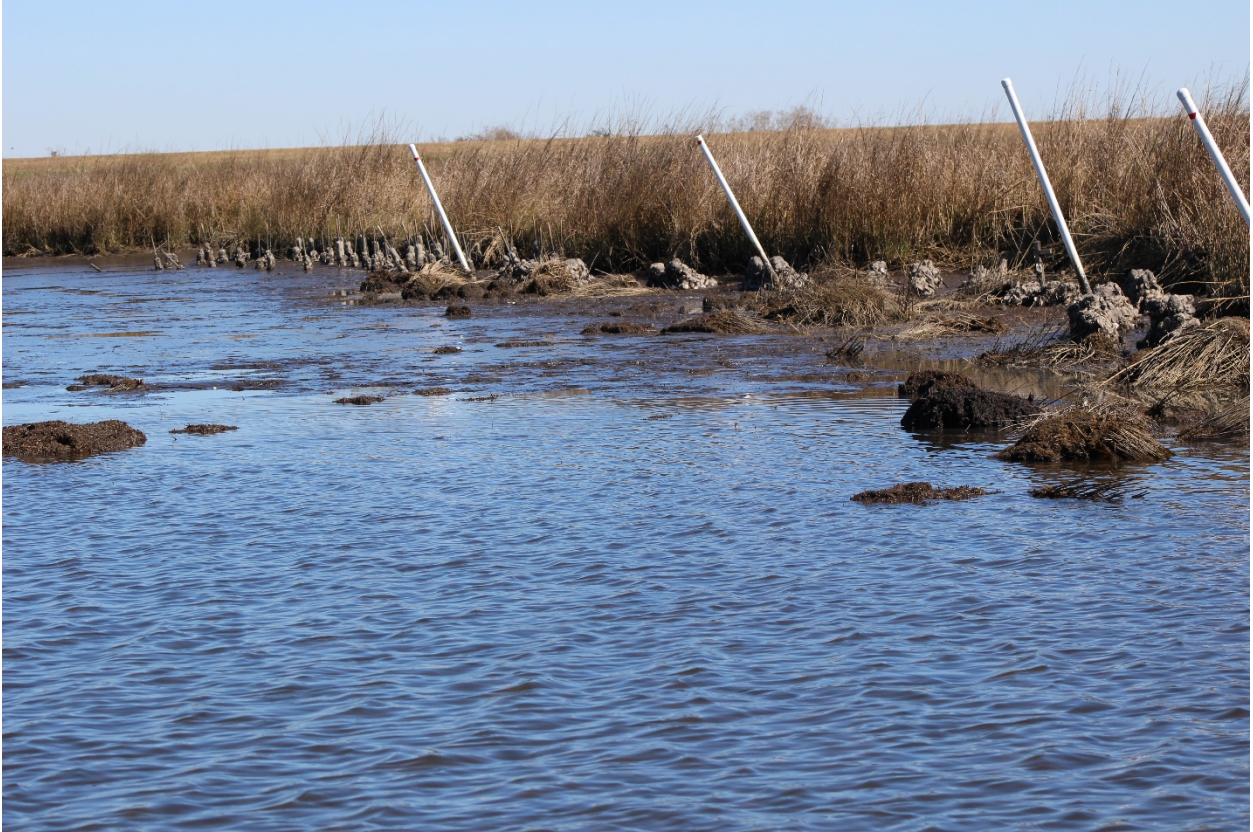
We made the Winter site visit on 29 January 2022 to evaluate the structures, but the tides were extremely low and the majority of the Cajun Corals and Oyster Stakes were completely exposed (Figure 5). Although some Cajun Coral structures and Oyster Stakes were below the surface of the water, water levels were too shallow to approach by boat (Figures 6 through 8). Because we were not able to access the structures, we used photography to document the presence of oysters *Crassostrea virginica* and barnacles (Class Cirripedia) on the structures. We observed oysters and barnacles attached to all of the Cajun Corals (Figures 6 and 8 through 11). Some Cajun Corals were heavily populated by oysters (Figure 10). We observed oysters and barnacles attached to the overwhelming majority of Oyster Stakes (Figures 7, 12 and 13). However, the density of oysters appeared to be lower on the Oyster Stakes than on the Cajun Coral.

Figure 5. Cajun Corals and Oyster Stakes were completely exposed on 29 January 2022, Golden Meadow site.

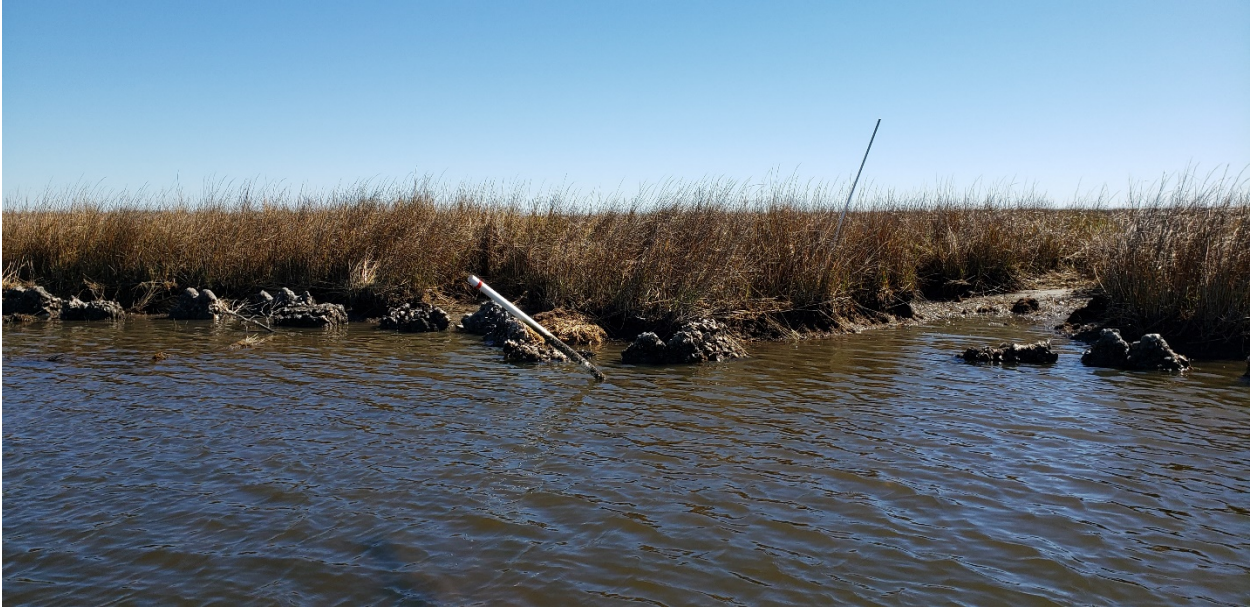
Figure 6. Cajun Corals in shallow water on 29 January 2022, Golden Meadow site.

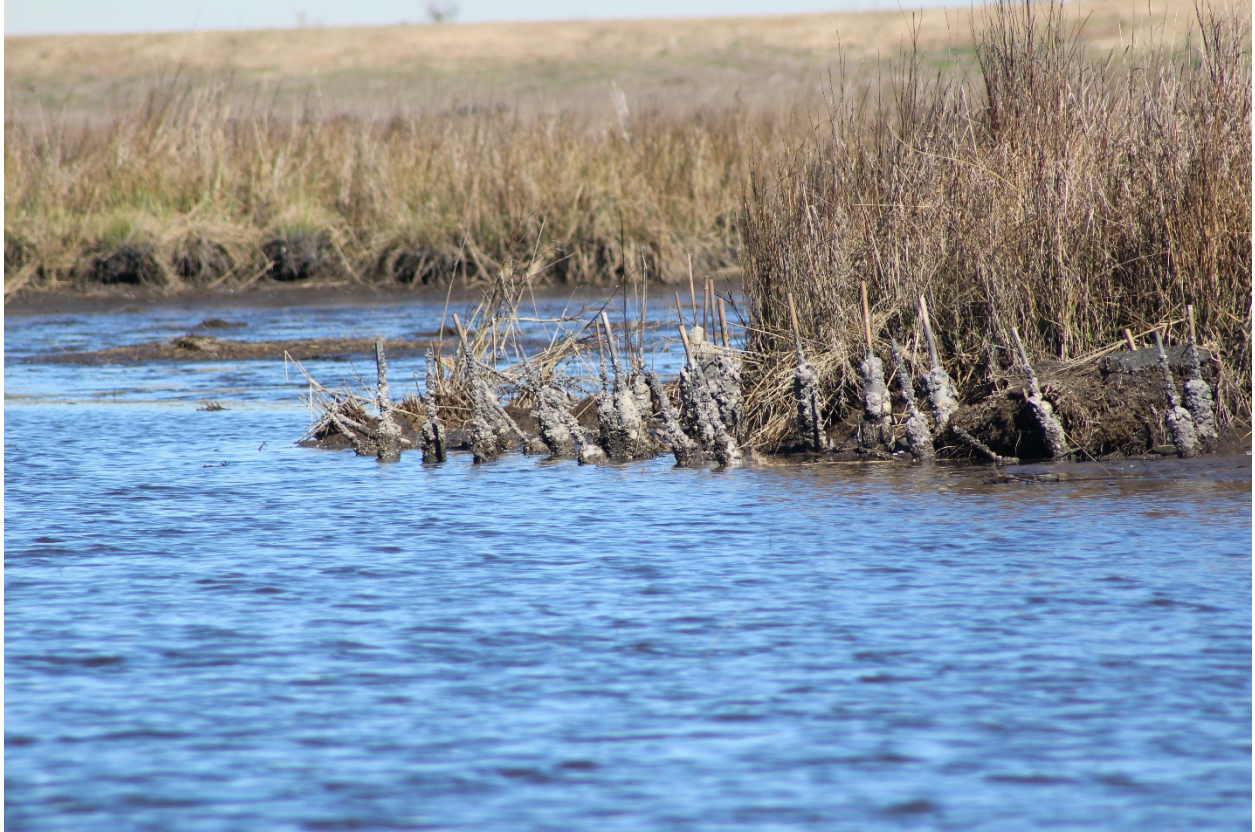
Figure 7. Oyster Stakes in shallow water on 29 January 2022, Golden Meadow site.

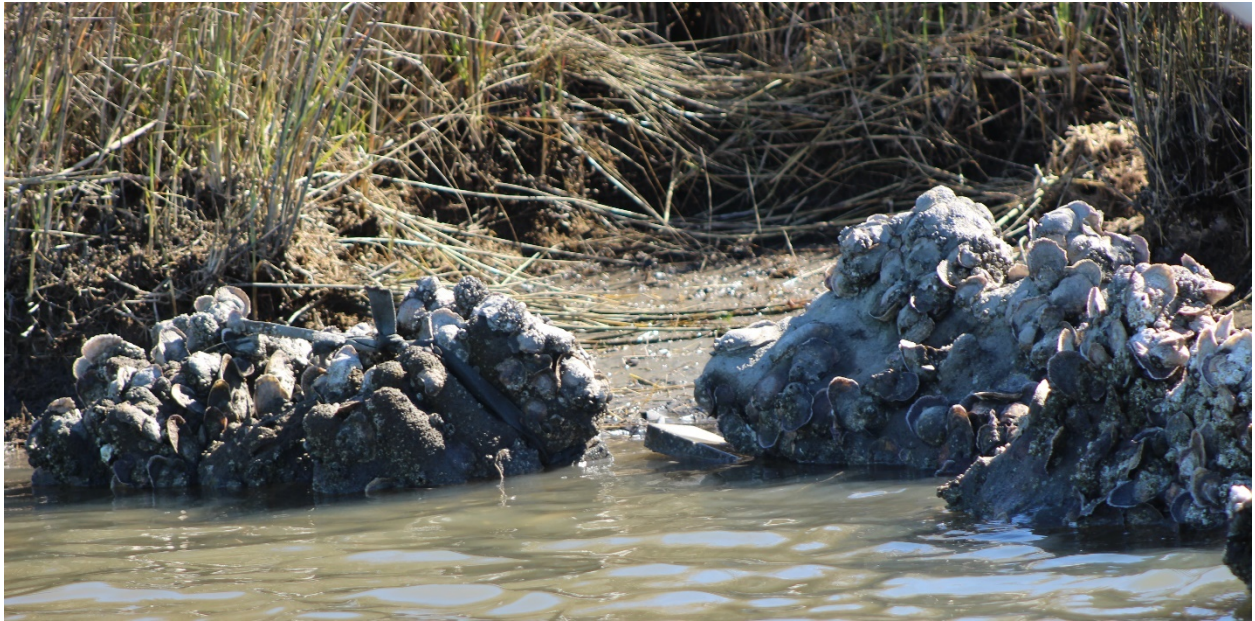
Figure 8. Cajun Corals in water too shallow to approach with a boat on 29 January 2022, Golden Meadow site.

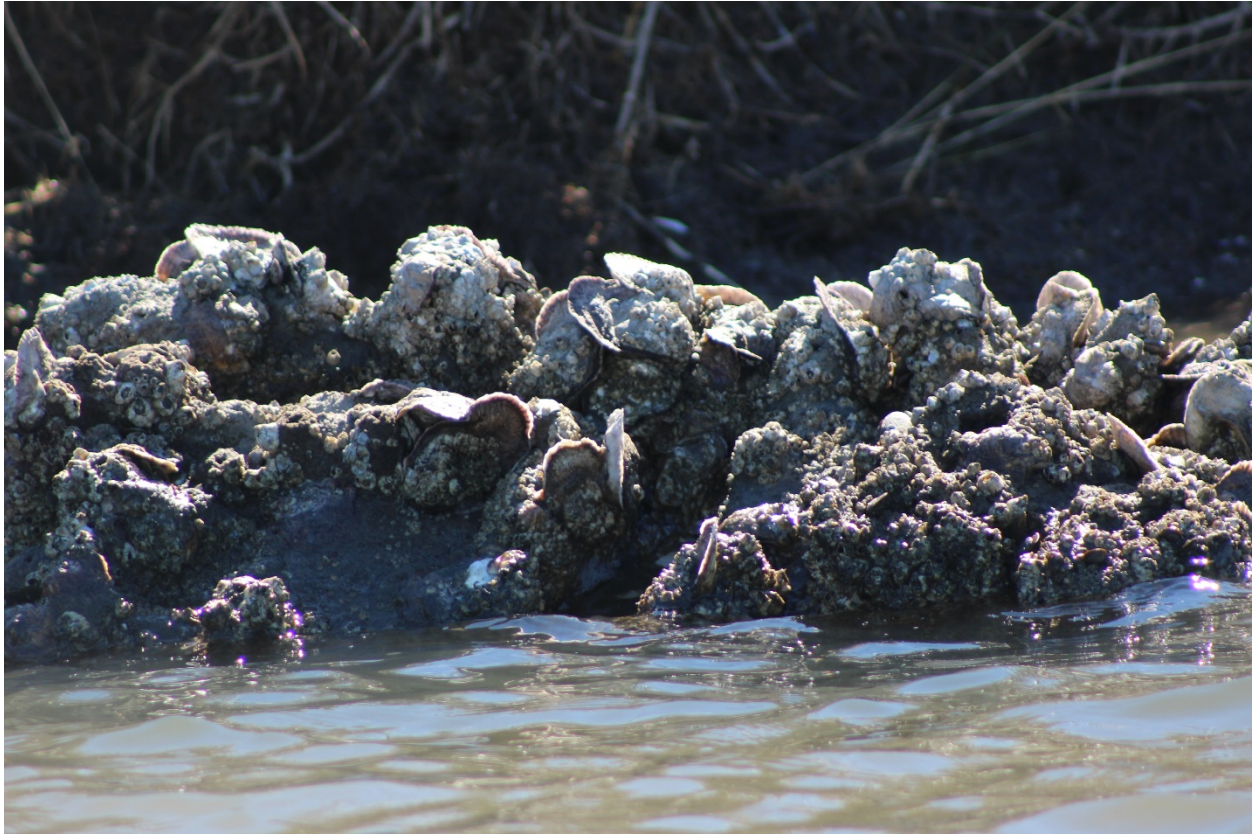
Figure 9. Dense growth of oysters and barnacles on a single Cajun Coral on 29 January 2022, Golden Meadow site.

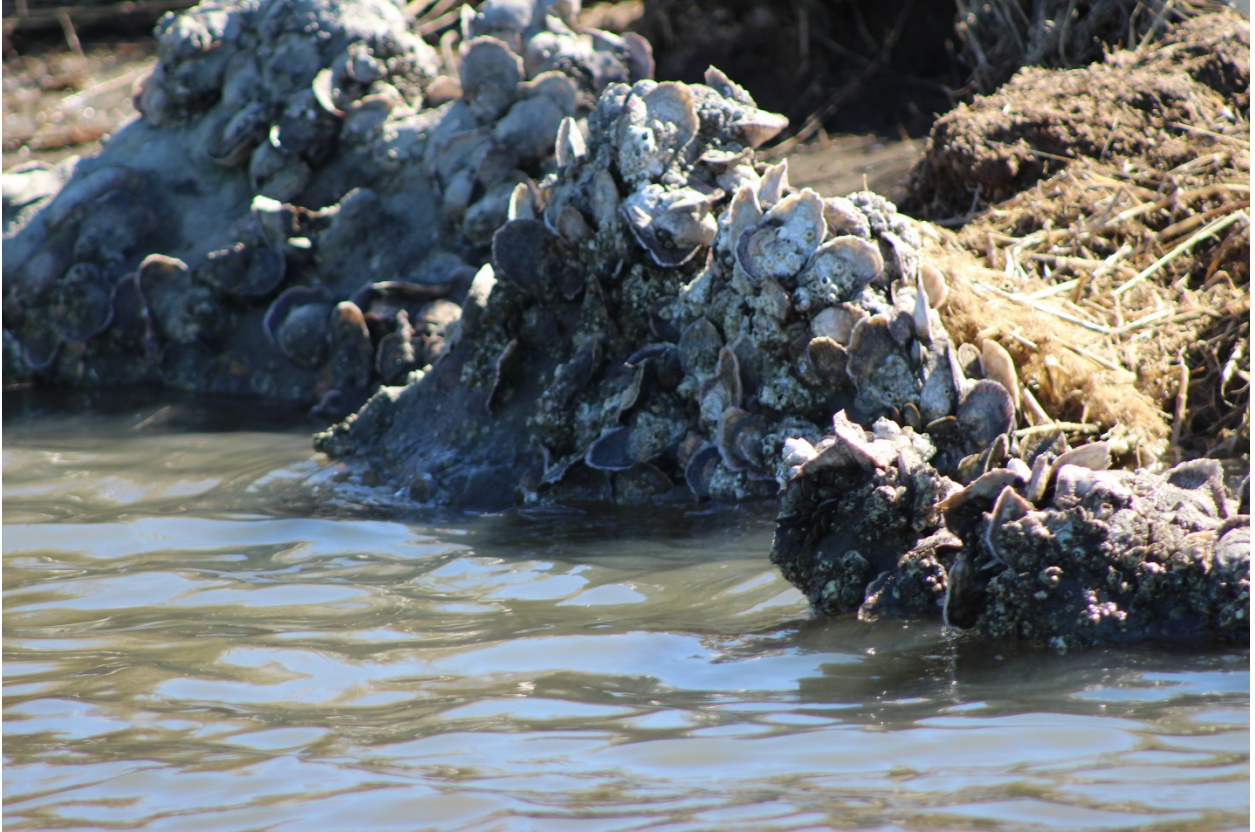
Figure 10. Dense oyster and barnacle growth on Cajun Corals on 29 January 2022, Golden Meadow site.

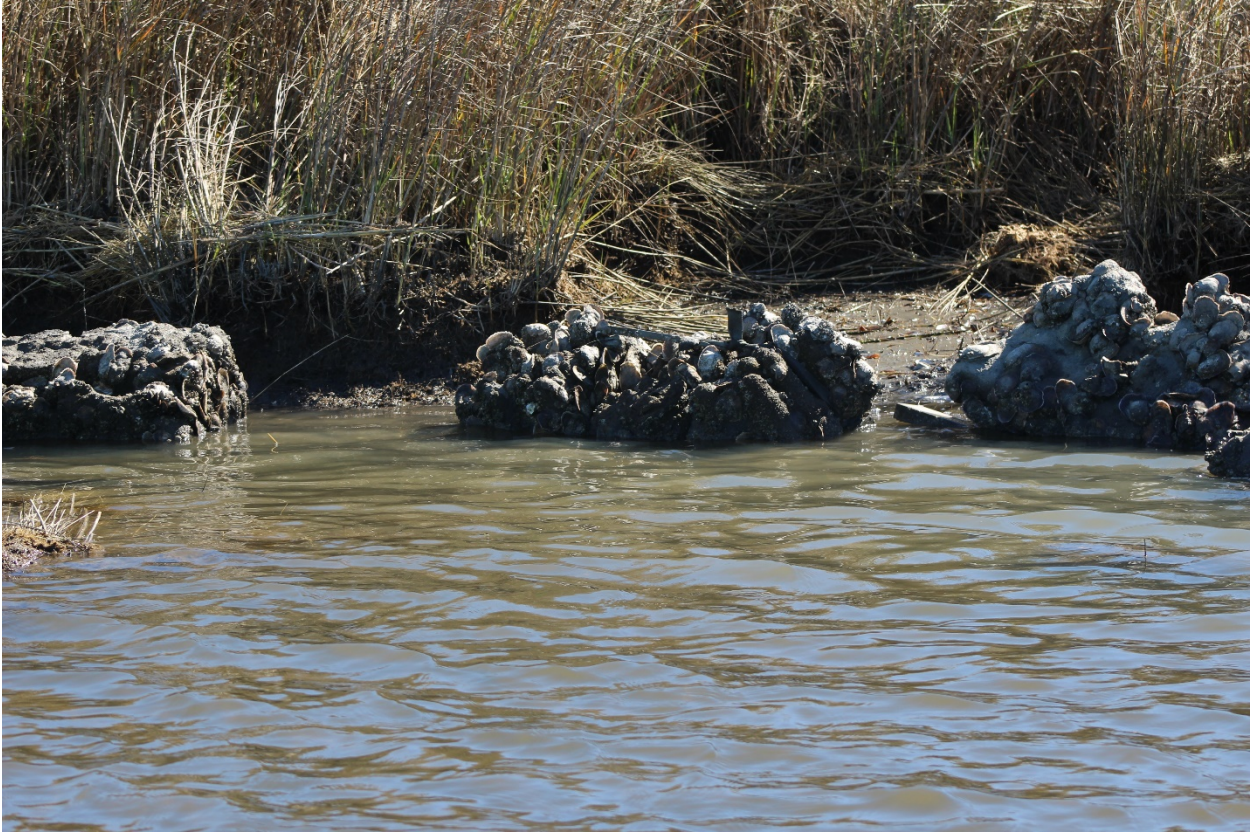
Figure 11. Oyster and barnacle growth on Cajun Corals on 29 January 2022, Golden Meadow site.

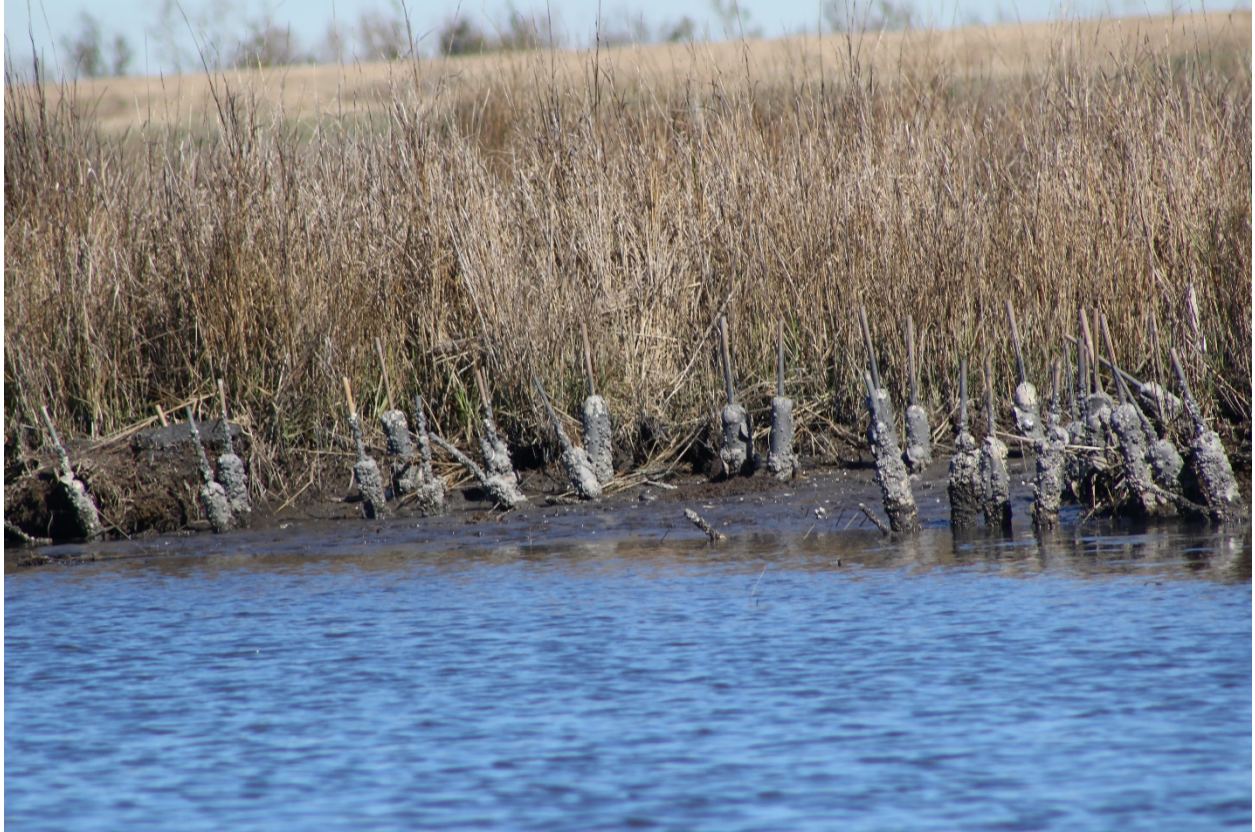
Figure 12. Oyster and barnacle growth on Oyster Stakes on 29 January 2022, Golden Meadow site.

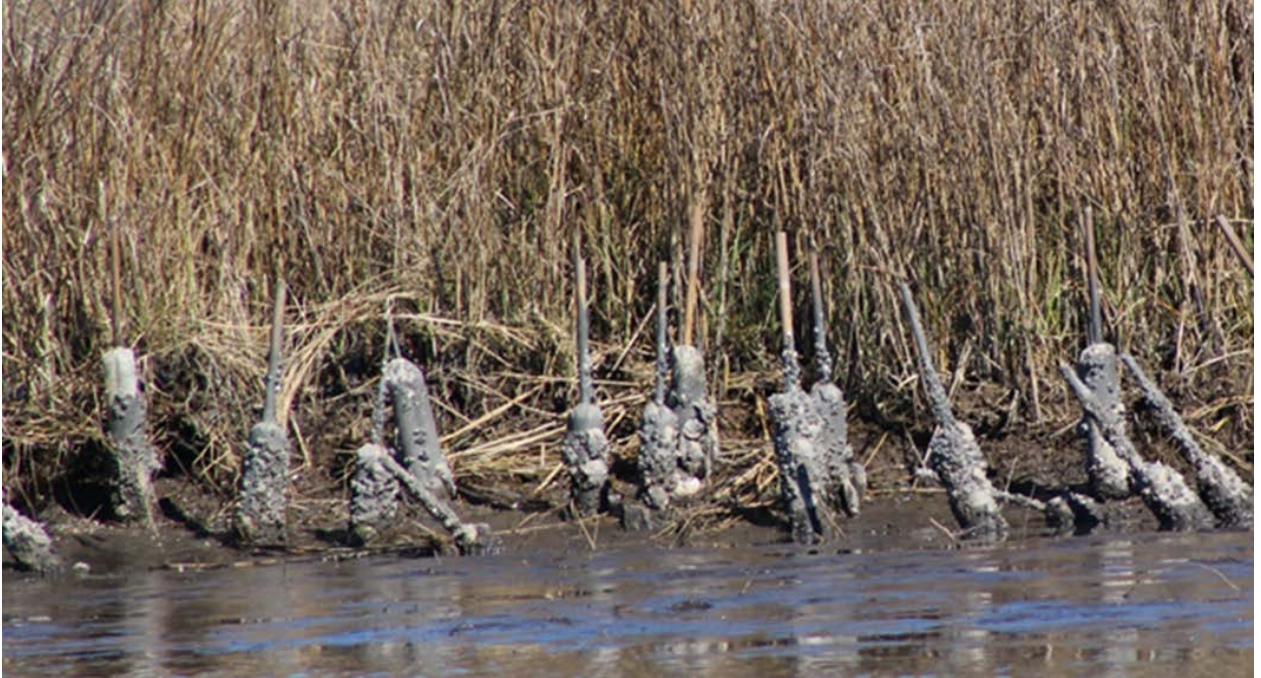
Figure 13. Oyster and barnacle growth on Oyster Stakes on 29 January 2022, Golden Meadow site.

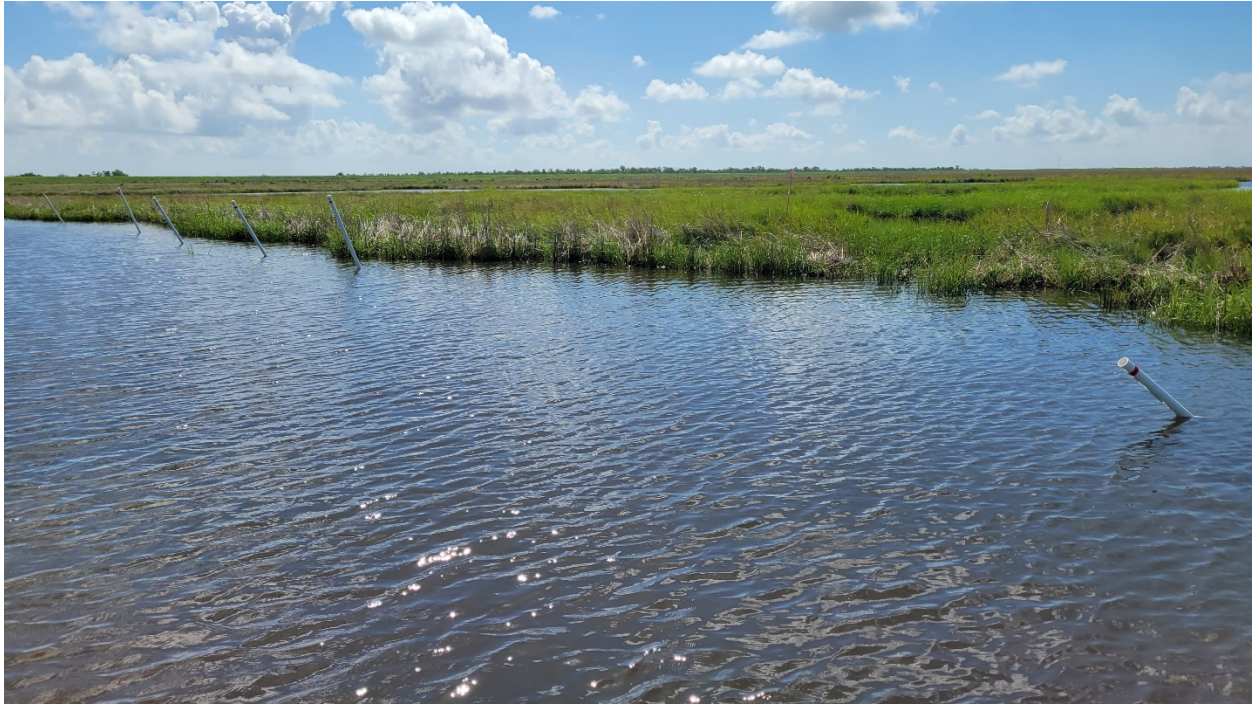
We made the Summer site visit on 1 June 2022 to evaluate oyster and barnacle growth on the Cajun Corals and Oyster Stakes. The tide was relatively high and all of the Cajun Corals were submerged (Figures 14 and 15). We measured the submerged depth of 12 Cajun Corals and the mean (\pm SE) was 25 ± 1.3 cm below the water surface. We also confirmed by touch the presence of oysters and barnacles on all 12 Cajun Corals that were evaluated.

Figure 14. Vertical PVC poles mark the bank where Cajun Corals were placed. All structures were completely submerged on 1 June 2022, Golden Meadow site.

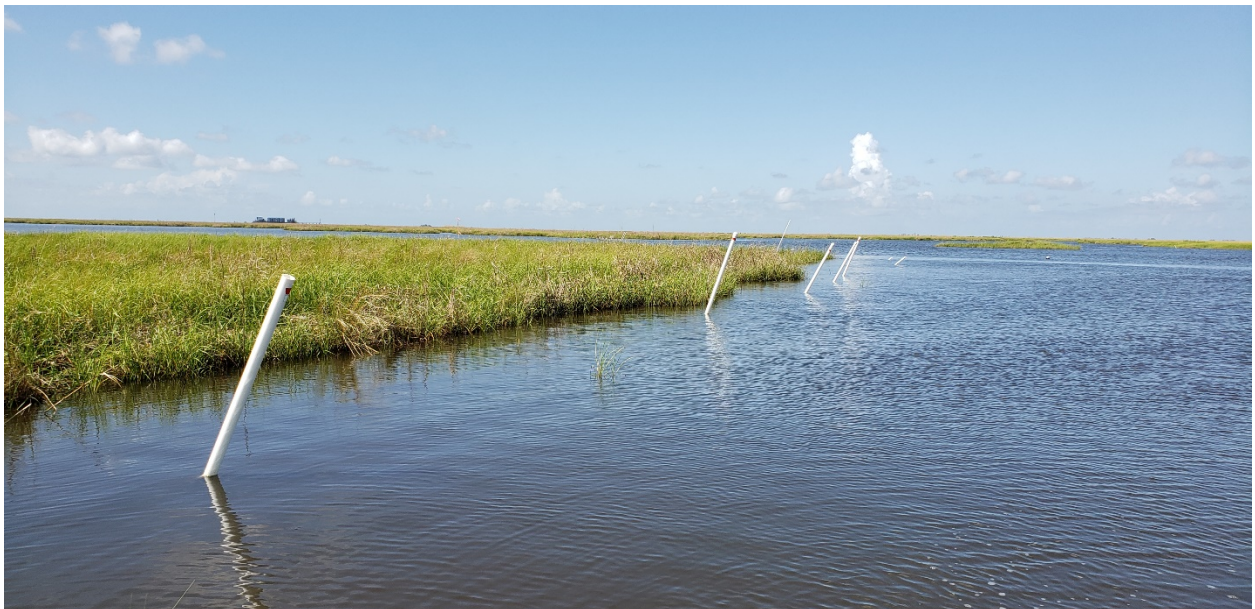
Figure 15. Vertical PVC poles mark the bank where Cajun Corals were placed. All structures were completely submerged on 1 June 2022, Golden Meadow site.

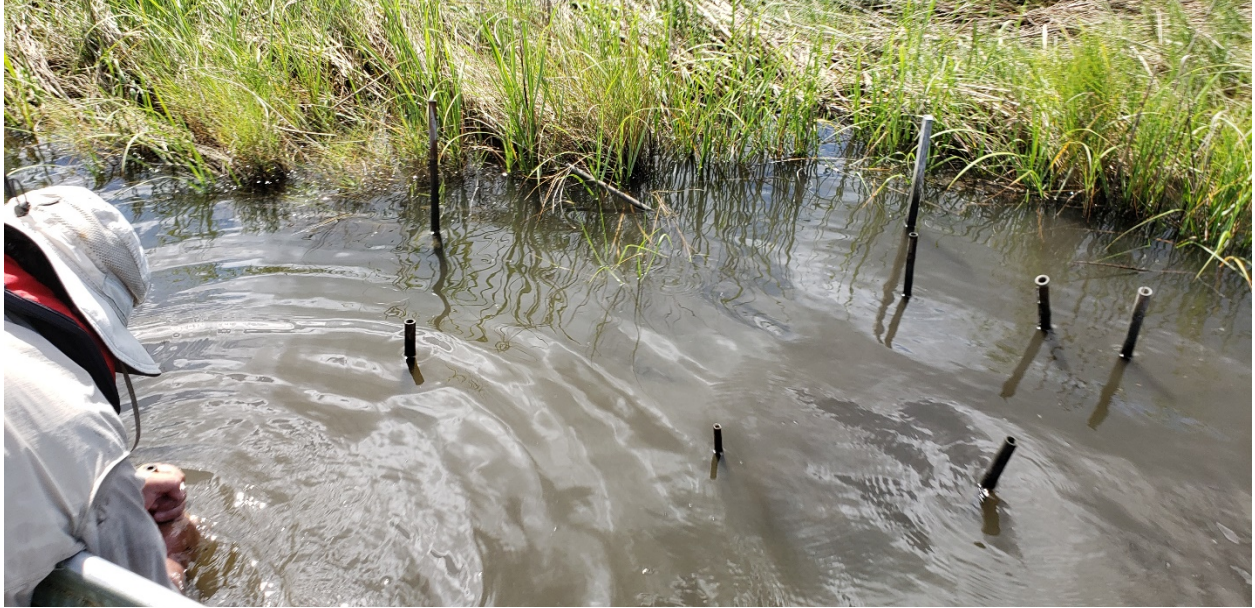
The tops of the poles of all Oyster Stakes were above the water surface, but the settlement substrates designed to attract oysters were all submerged (Figures 16 and 17). All 45 Oyster Stakes evaluated had oysters and barnacles attached (Figure 18), and several Oyster Stakes had large oysters attached (Figure 19). We observed an oyster settlement pattern related to the amount of the lower end of the settlement substrate that subsided into the sediment or was buried by sediment and the amount of the upper end of the settlement substrate that was exposed at low tide. For example, some settlement substrates had dead oysters or empty shells attached to the lower end and live oysters attached to the upper end (Figure 20) or middle region of the settlement substrates (Figure 21). It appears that oysters

Figure 16. Oyster stakes with only the tops of the poles exposed above the water on 1 June 2022, Golden Meadow site.

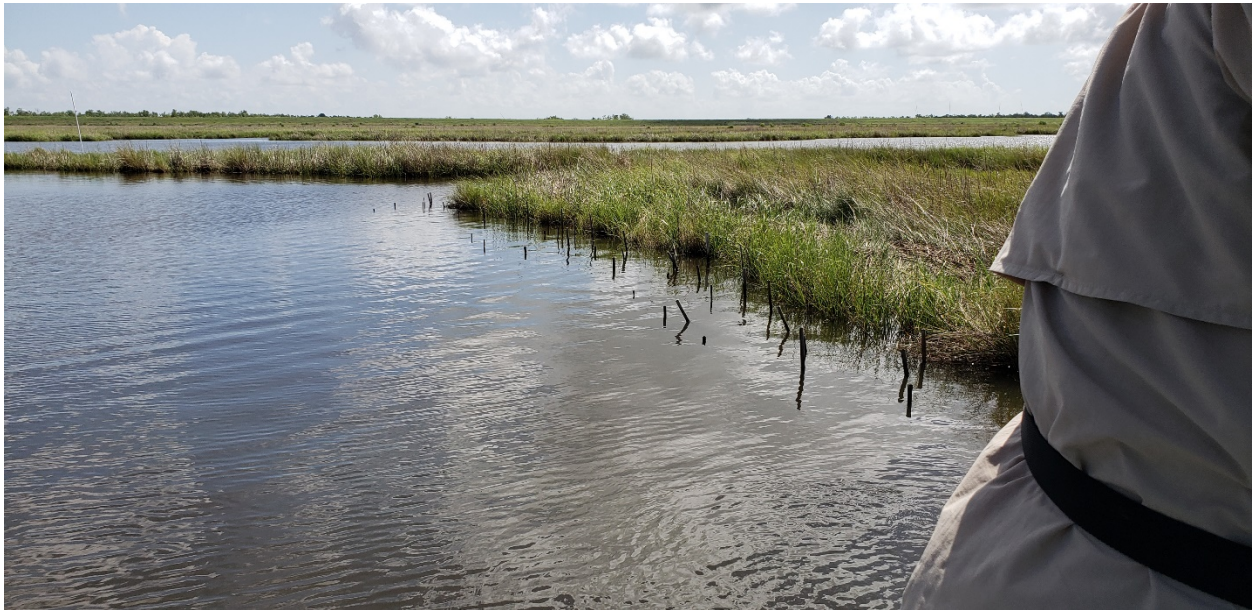
Figure 17. Oyster stakes with only the tops of the poles exposed above the water on 1 June 2022, Golden Meadow site.

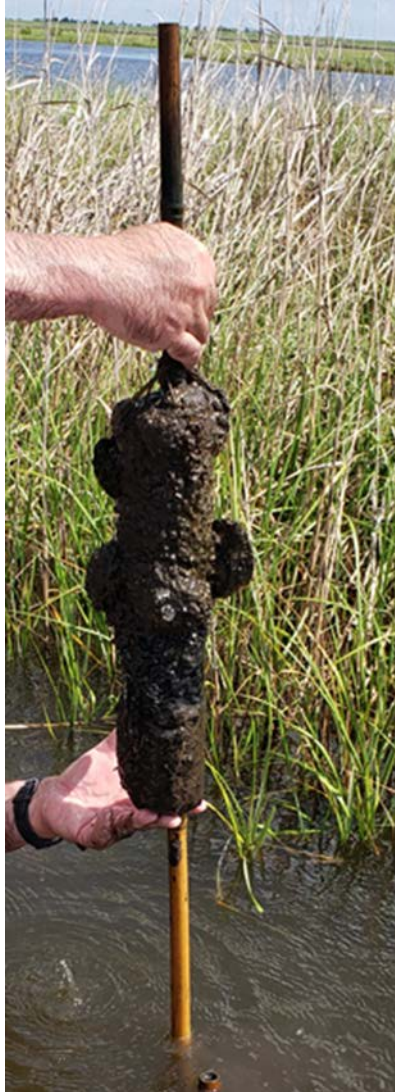
Figure 18. An Oyster Stake with attached oysters and barnacles on 1 June 2022, Golden Meadow site.

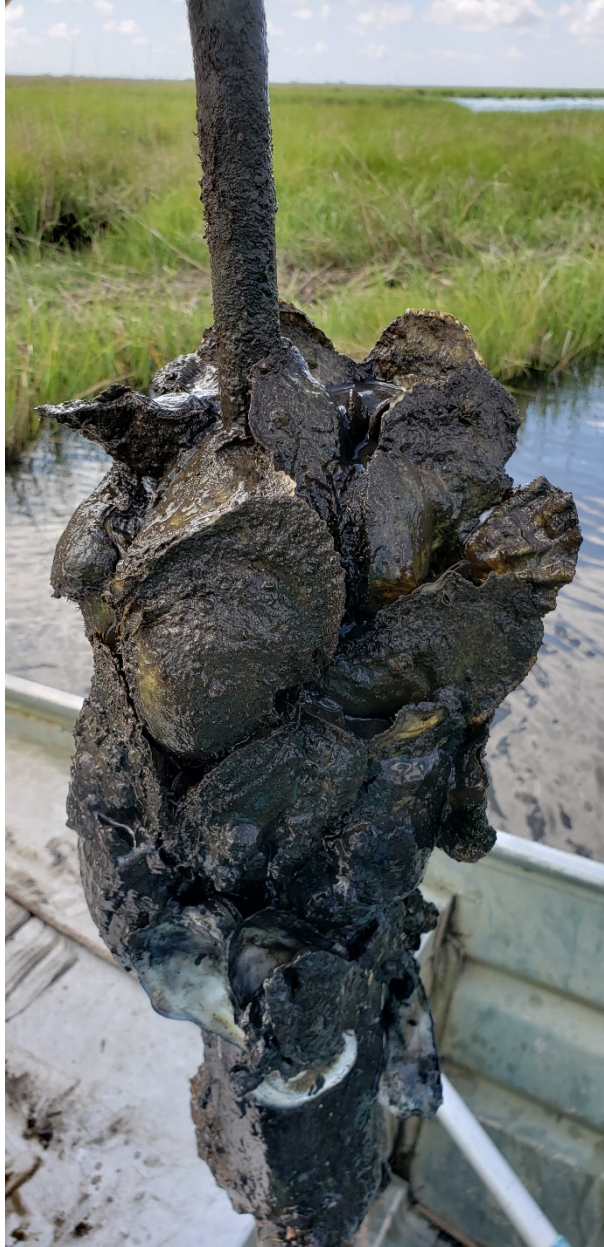
Figure 19. Large oysters on an Oyster Stake on 1 June 2022, Golden Meadow site.

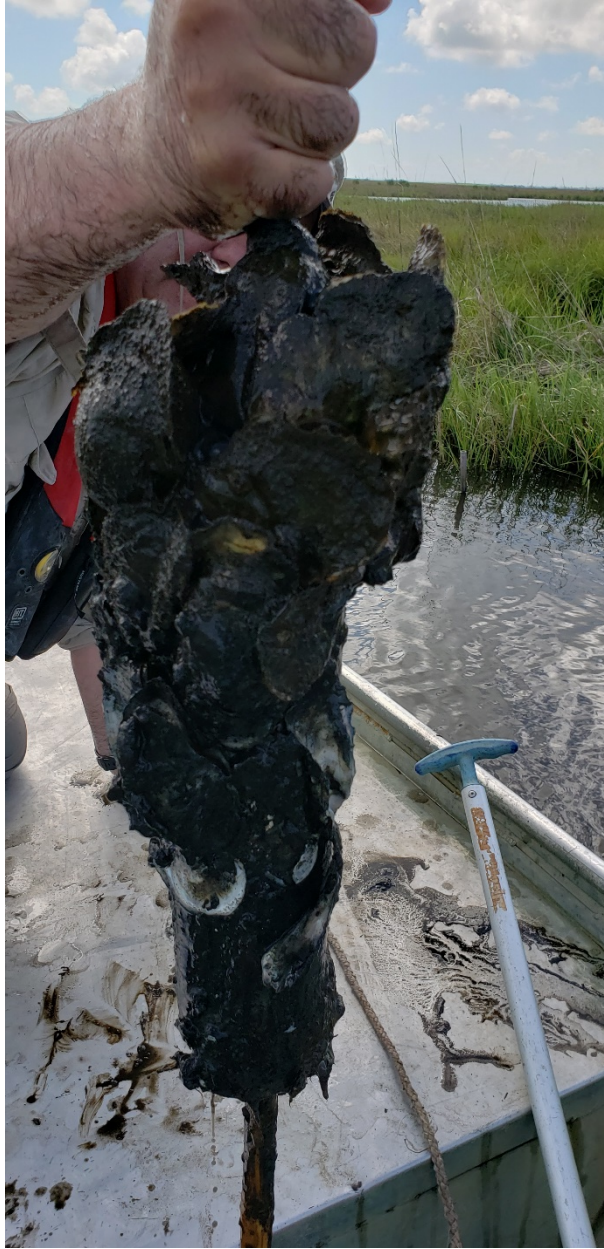
had settled onto the lower end, but the settlement substrate sunk into or was buried by sediment over time thus killing the oysters. Some settlement substrates only had oysters in the middle region (Figure 22) suggesting that the lower end had subsided or was buried by sediment and the upper end was exposed at low tide thus preventing the recruitment or survival of oysters and barnacles.

Figure 20. An Oyster Stake with dead oysters on the lower end of the settlement substrate on 1 June 2022, Golden Meadow site. It appears that the settlement substrate had submerged into or was buried by sediment as indicated by the dark (anoxic) sediment and empty oyster shells.

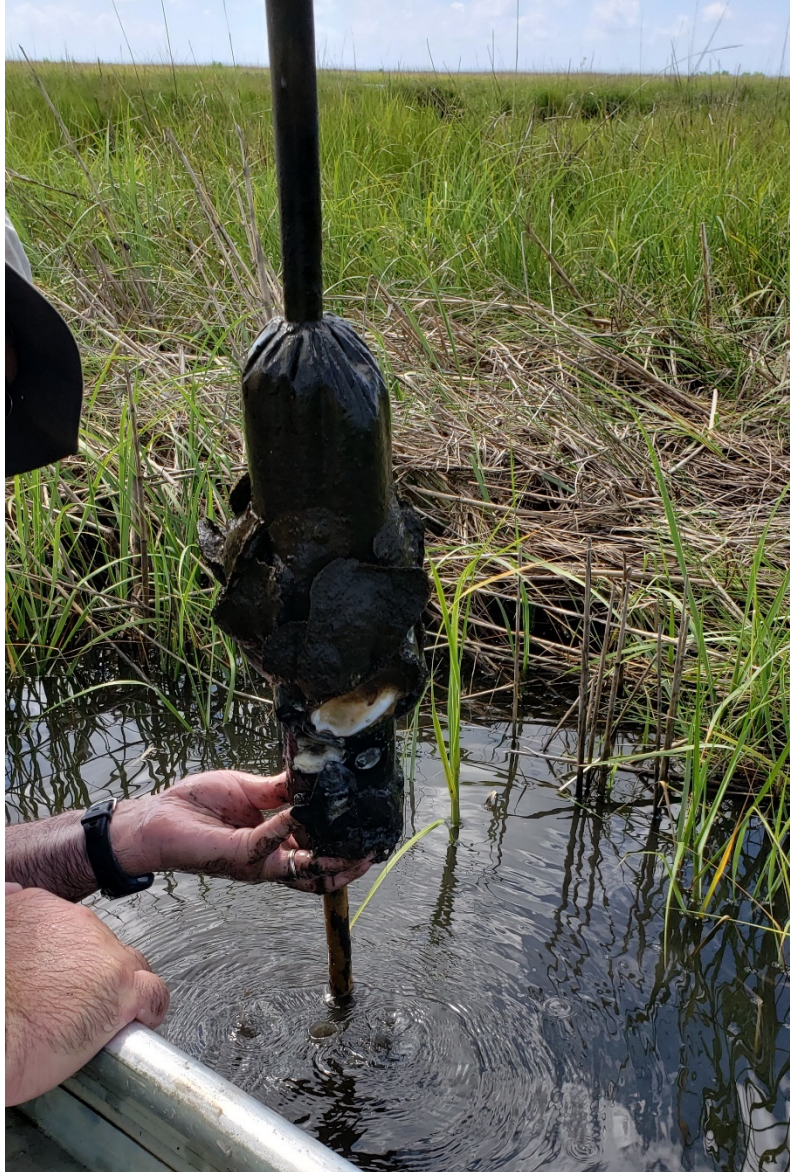
Figure 21. An Oyster Stake with live oysters in the middle region of the settlement substrate and dead oysters on the bottom end of the settlement substrate on 1 June 2022, Golden Meadow site.

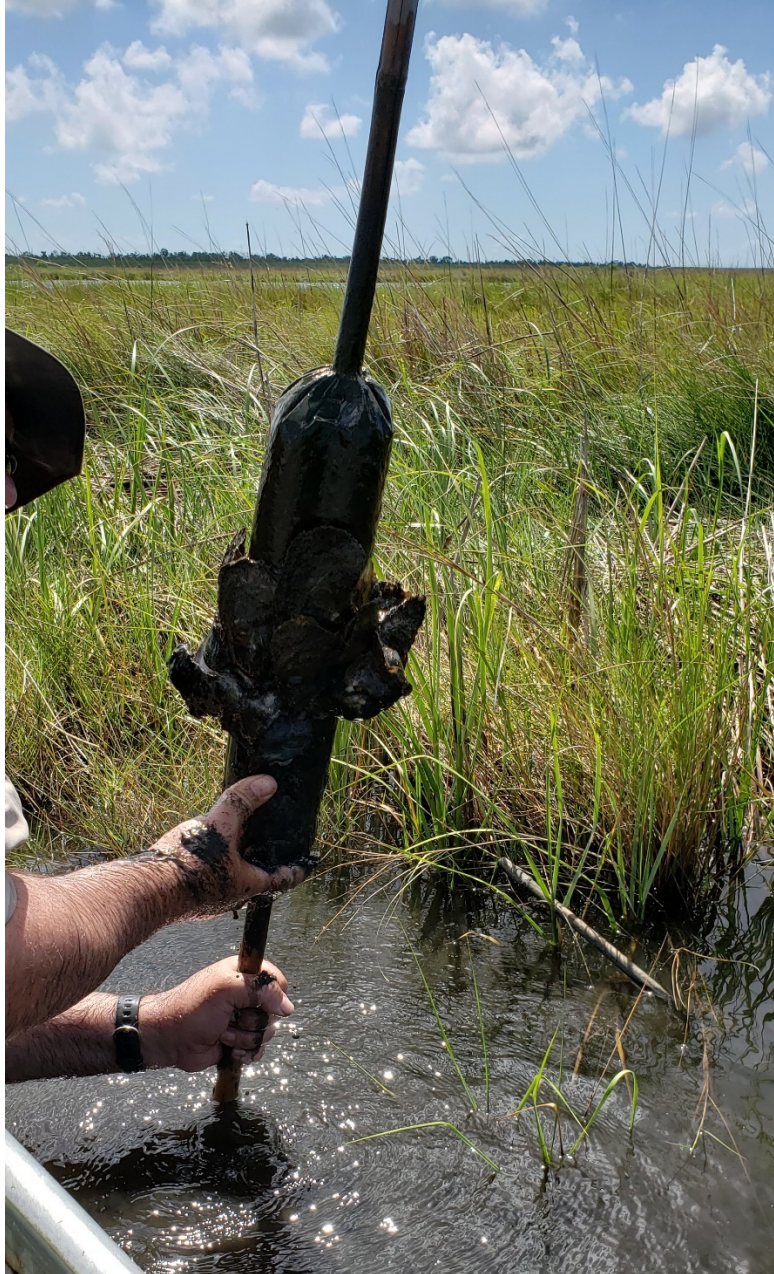
Figure 22. An Oyster Stake with oysters only growing on the middle region of the settlement substrate on 1 June 2022, Golden Meadow site. The lower end of the settlement substrate had submerged or was buried by sediment and the upper end of the settlement substrate may have been exposed at low tide thus preventing oyster and barnacle settlement and growth.

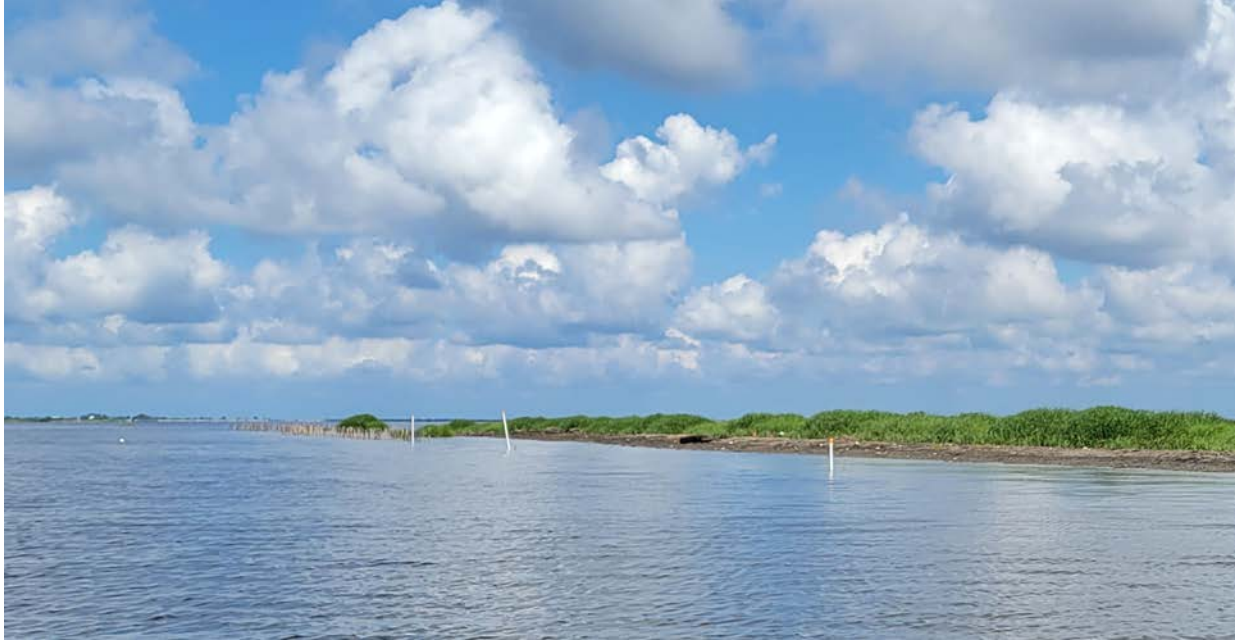
We made the Summer visit on 3 June 2022 to evaluate oyster and barnacle growth on the Cajun Corals and Oyster Stakes. The tide was relatively high and all of the Cajun Corals were submerged. It was difficult to locate the structures and used a paddle to identify the locations of the Cajun Corals. The Cajun Corals were too deep to feel with our hands therefore we could not identify if oysters and/or barnacles had colonized the Cajun Corals.

Figure 23. Vertical PVC poles mark the locations of Cajun Corals that were too submerged for evaluation on 3 June 2022, Pointe aux Chenes site.

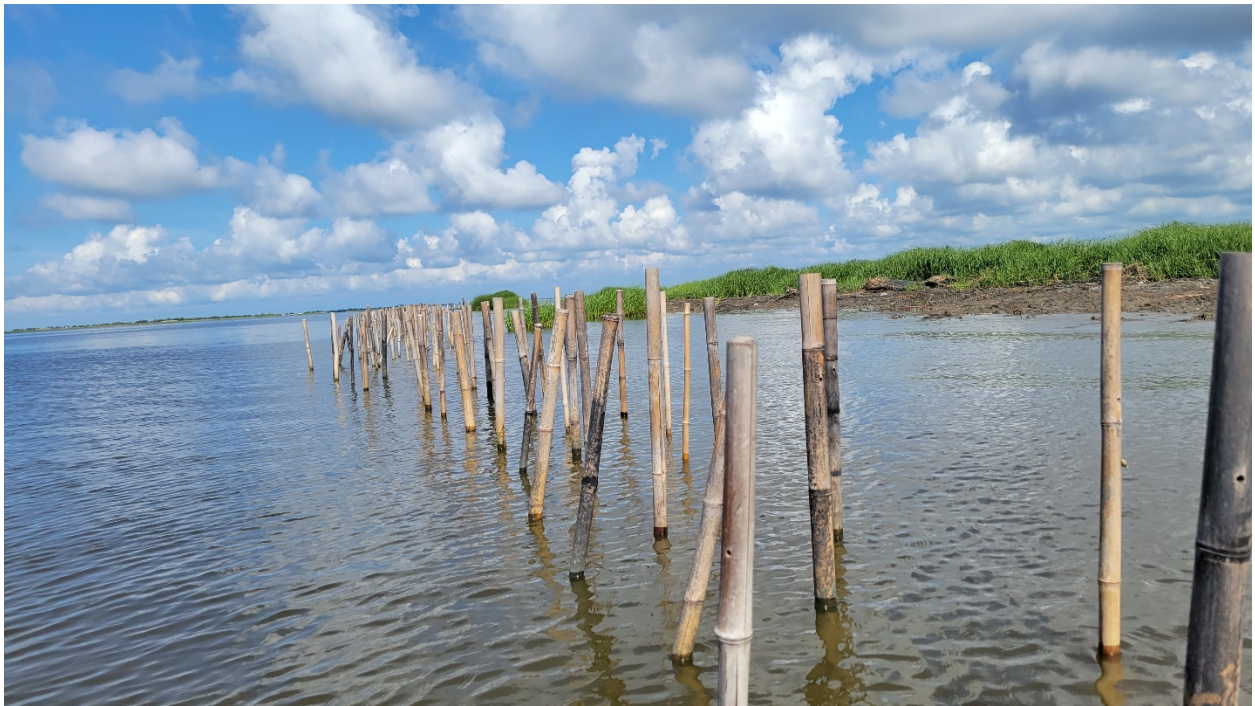
The poles for the Oyster Stakes were above the water line, but all of the settlement substrates were submerged (Figure 24). We evaluated 30 Oyster Stakes and did not observe any oysters, but all Oyster Stakes had solid coverage of barnacles (Figure 25). Some of the Oyster Stake settlement substrates had large cracks (Figure 26), with some cracks extending the entire length of the settlement substrate (Figure 27). We observed three units that had broken in half and fell from the pole while we were extracting the Oyster Stakes. Oyster Stakes at Pointe aux Chene may recruit oysters in the future although the time between installation of the Oyster Stakes and our evaluation may not have been sufficient for oyster spat recruitment to the settlement substrates.

Figure 24. Oyster Stake poles were above the water surface, but the settlement substrates were submerged on 3 June 2022, Pointe aux Chenes site.
