NICHOLLS
STATE UNIVERSITY

**Monitoring and Evaluation of Constructed Marsh Terraces and Marsh Creation
Projects in South Louisiana**

Final Report

24 June 2022

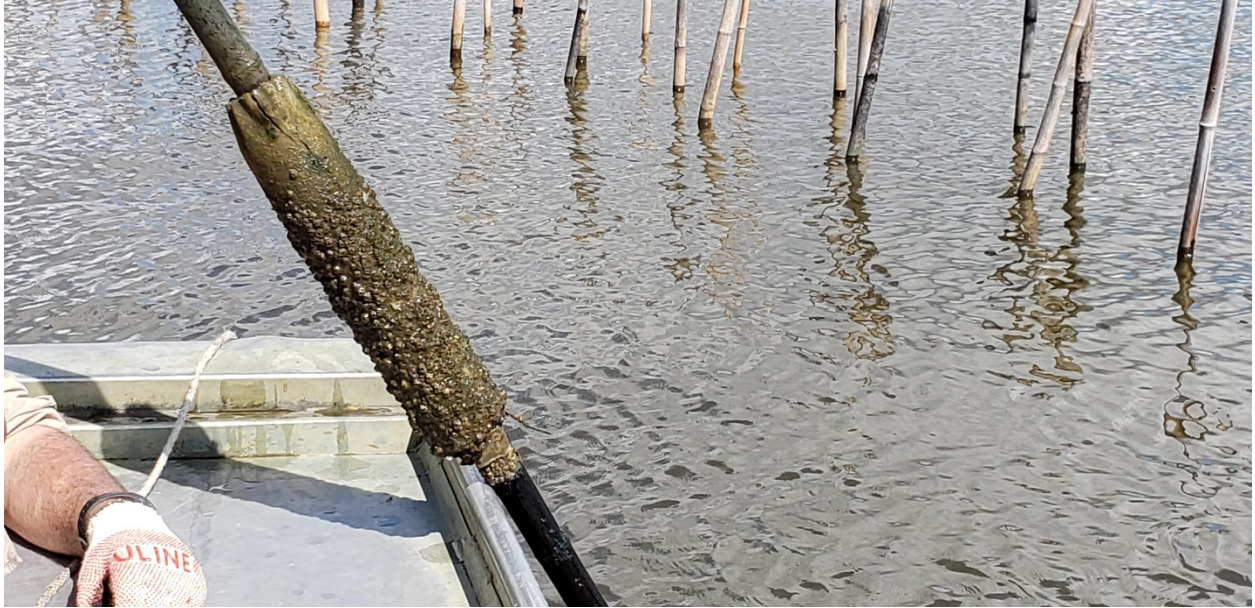
The poles for the Oyster Stakes were above the water line, but all of the settlement substrates were submerged (Figure 24). We evaluated 30 Oyster Stakes and did not observe any oysters, but all Oyster Stakes had solid coverage of barnacles (Figure 25). Some of the Oyster Stake settlement substrates had large cracks (Figure 26), with some cracks extending the entire length of the settlement substrate (Figure 27). We observed three units that had broken in half and fell from the pole while we were extracting the Oyster Stakes. Oyster Stakes at Pointe aux Chene may recruit oysters in the future although the time between installation of the Oyster Stakes and our evaluation may not have been sufficient for oyster spat recruitment to the settlement substrates.

Figure 25. An Oyster Stake with barnacles on the settlement substrate, but no oysters on 3 June 2022, Pointe aux Chenes site.

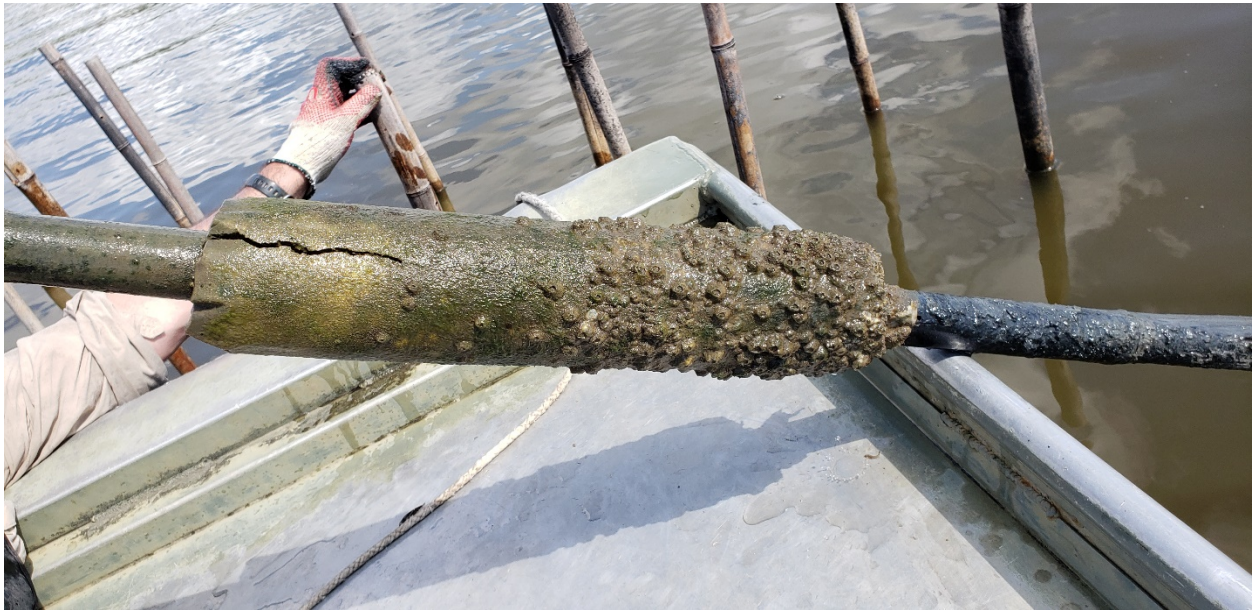
Figure 26. An oyster stake with a crack starting on the top of the settlement substrate on 3 June 2022, Pointe aux Chenes site.

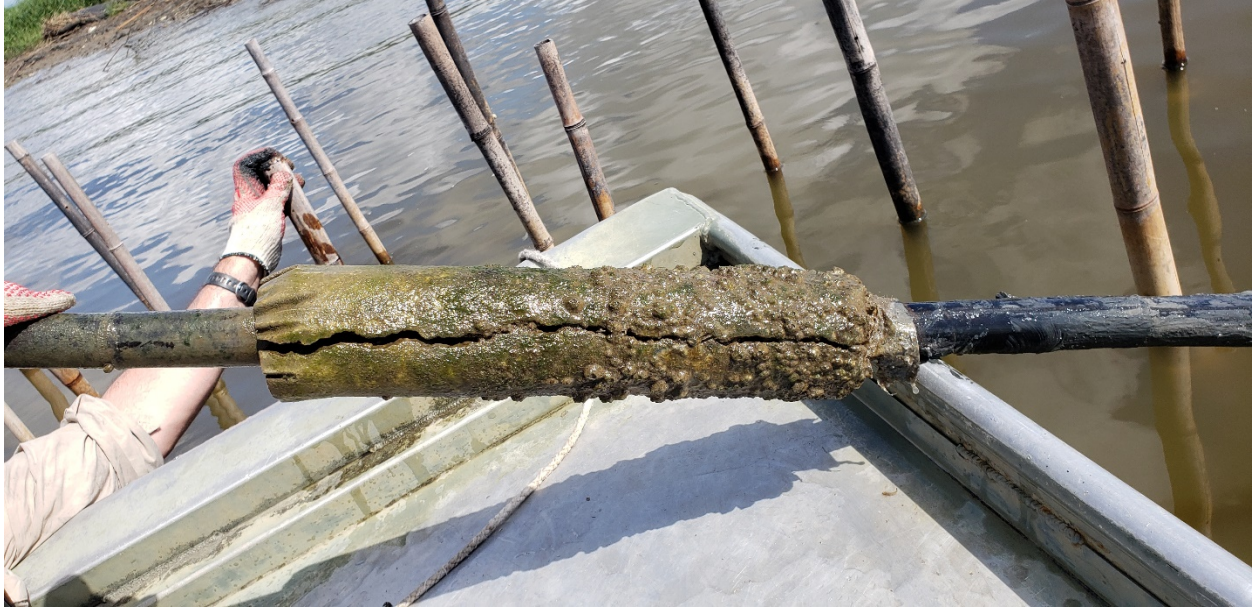
Figure 27. An Oyster Stake with a crack extending the entire length of the settlement substrate on 3 June 2022, Pointe aux Chenes site.

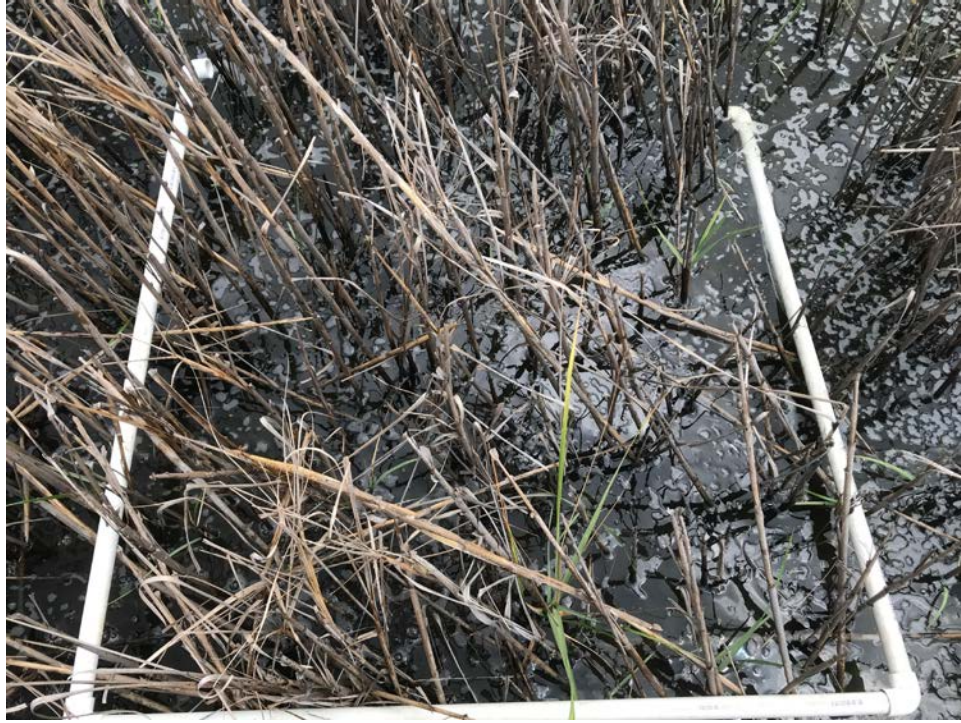
Overall, most plots at both the Golden Meadow marsh fill and Pointe aux Chenes terrace sites exhibited coverage and visual coloration consistent with a relatively healthy coastal marsh in Louisiana. However, several plots at the second marsh fill area in Golden Meadow exhibited comparatively low live coverage and a relatively large amount of standing dead. This area was also characterized by low density, almost fluid soils overlaying a stable substrate and a visual abundance of salt marsh chinch bug *Ischnodemus folicus*. However, both of these phenomena can either be direct stressors to salt marsh grasses, or be associated with areas of stressed salt marsh grass. Notably, the less healthy fill site of Golden Meadow exists as a mosaic of unconsolidated soils with unhealthy vegetation mixed with higher elevation dense

Figure 28. An unhealthy, low coverage plot at the Golden Meadow site (second fill area).

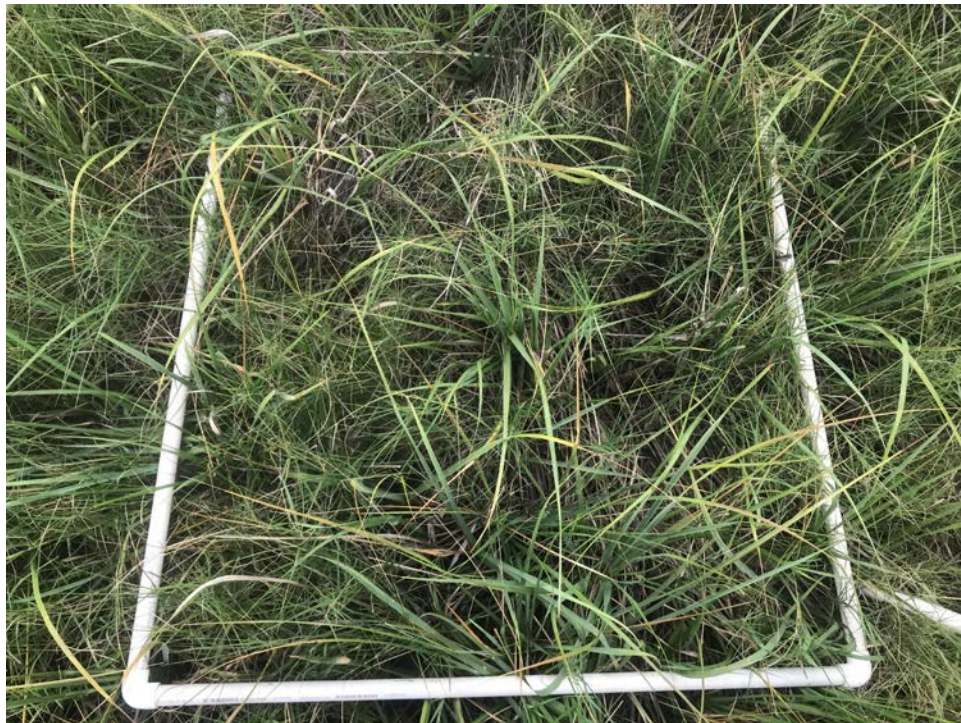
Figure 29. A healthy, high coverage plot at the Golden Meadow site (first fill area).

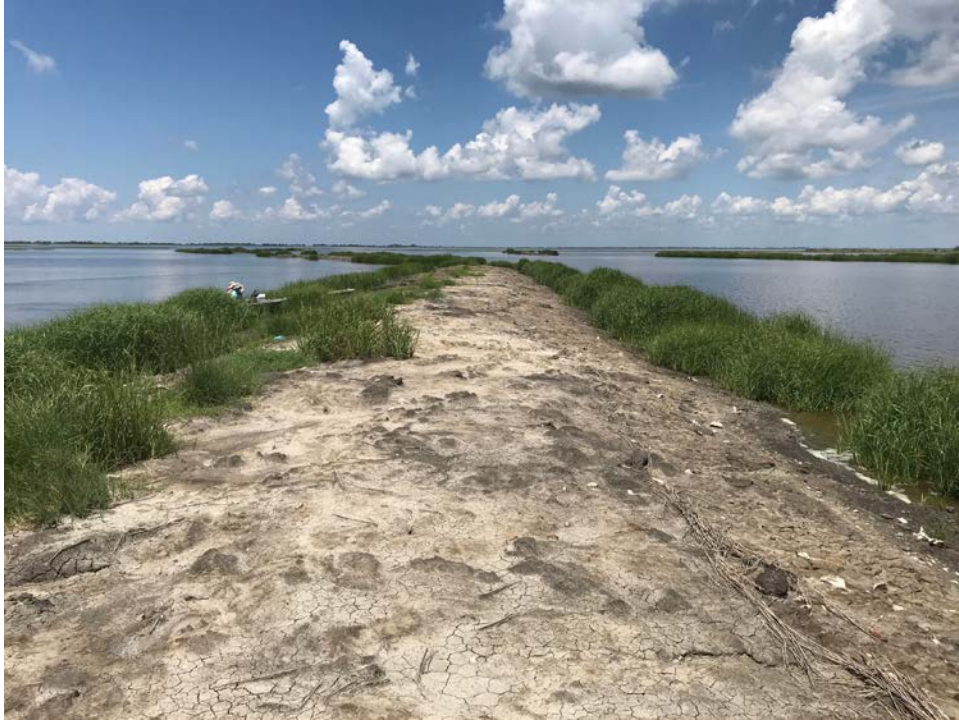
After the oyster and barnacle evaluation on 3 June 2022, visual estimation of marsh vegetation coverage was performed at 20 different 1-m² sampling plots at shorelines of recently established marsh terraces immediately outside the Pointe aux Chenes WMA. Coordinates of potential sampling points were provided by Ducks Unlimited and 20 were navigated to for vegetation sampling. At each 1-m² plot both total and live coverage, as well as species composition was visually estimated in 5% increments. Overall, live vegetation cover at the Pointe aux Chenes site (52.5%) was lower than reported in 2021 at a nearby Coast-Wide Reference Monitoring Site (CRMS 3296; 71.3%) as compared by a one-sample t test ($t_{1,19}=4.95$, $p<0.001$). Live vegetation cover ranged from 15 to 85% at the Pointe aux Chenes site. As noted above for the Golden Meadow site, cover was collected in different years, by different personnel, and with different plot sizes (1-m² versus 4-m²), and thus conclusions based on this comparison should be appropriately caveated. Species composition was consistent between the two sites, with cover dominated by *Spartina alterniflora* and *Spartina patens*, although *Distichlis spicata* was also found at the Pointe aux Chenes site. Importantly, the cover values reported for the Point aux Chenes terraces reflect coverage at the terrace shorelines, which generally exhibited robust healthy growth (Figures 30 - 32). Terrace center lines were typically bare (Figure 33), but are anticipated to fill in as the established clonal grasses at the edge continue to expand to the interior.

Figure 30. Terrace at the Pointe aux Chene site illustrating high edge vegetation cover, but minimal vegetation at terrace crest.

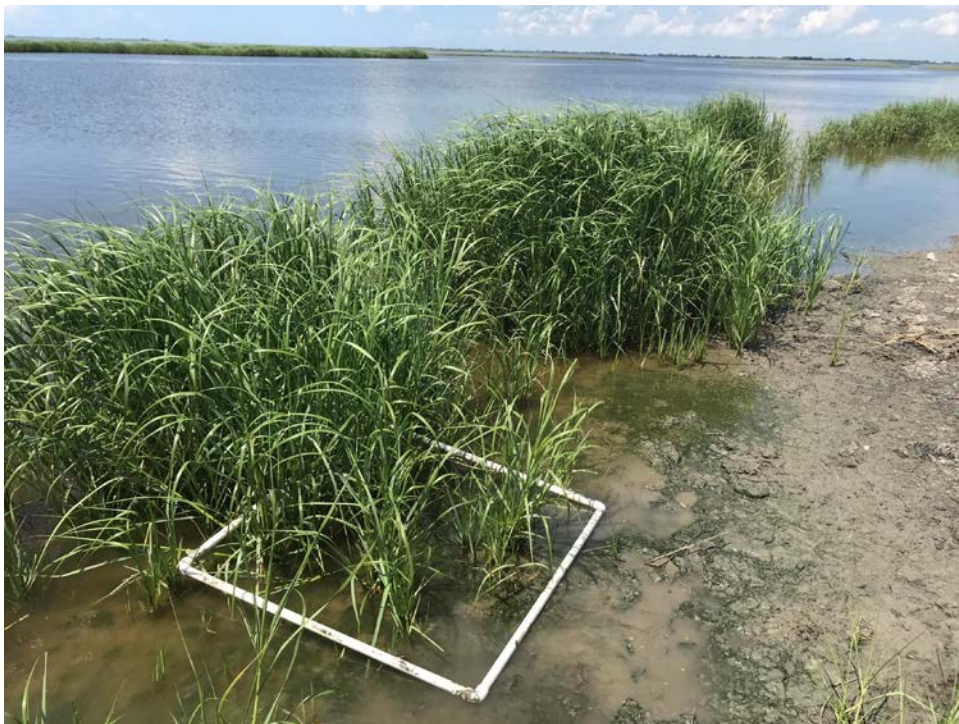
Figure 31. Sampling plot at a Pointe aux Chene terrace illustrating high *Spartina alterniflora* edge cover.

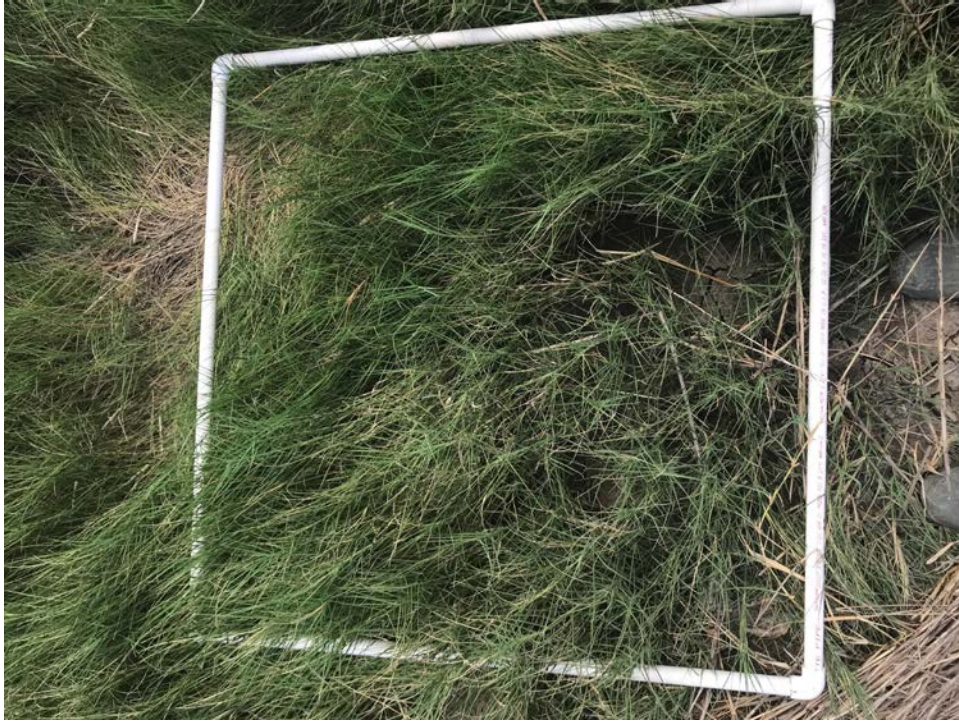
Figure 32. Sampling plot at a Pointe aux Chene terrace illustrating high *Distichlis spicata* cover on the slope to the terrace crest.

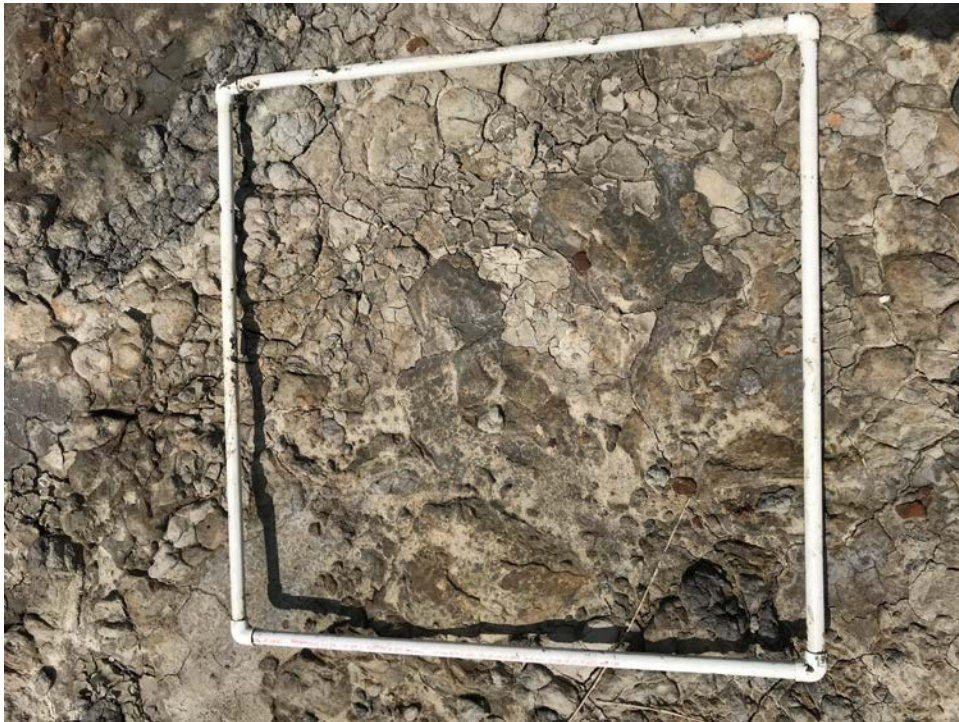
Figure 33. Sampling plot at a Pointe aux Chene terrace illustrating lack of vegetation establishment at the terrace crest.

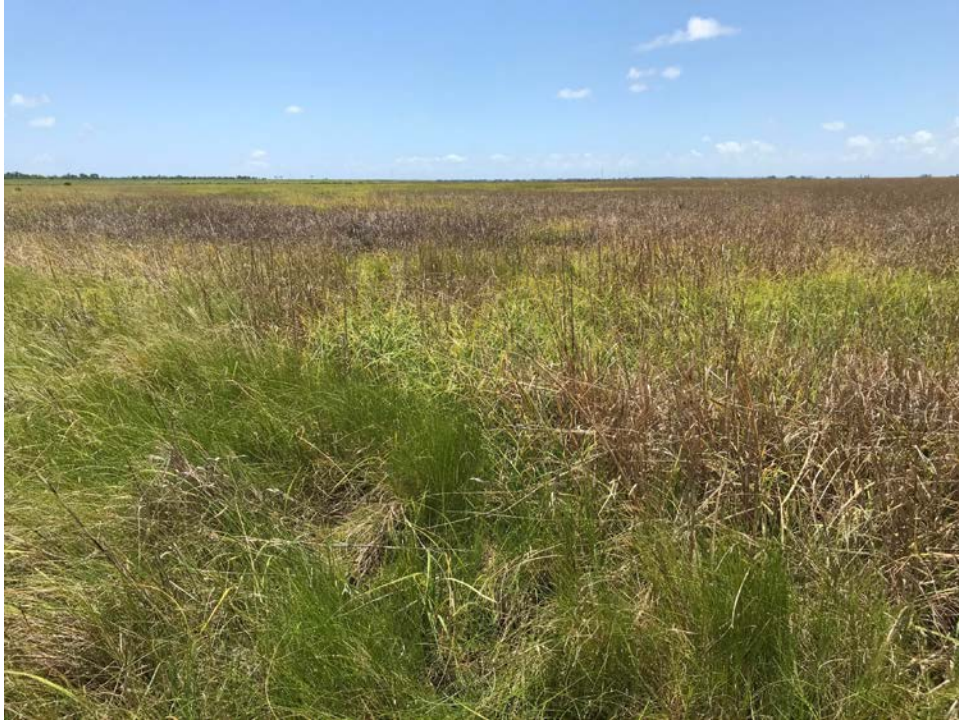
soils colonized by health vegetation (Figure 34). This suggests that if the stressor affecting this less health marsh is ameliorated, there is an abundance of proximity coastal marsh vegetation that would rapidly expand into these areas.

Figure 34. Landscape view of the mosaic of healthy and unhealthy marsh portions of the second marsh fill area of the Golden Meadow site.
