United States Department of the Interior

U. S. FISH & WILDLIFE SERVICE

Attached are data in regards to our July 3, 2018 electrofishing sampling at Snow Brook on Rt 15 in Sedgewick, Hancock County, ME. Coordinates: -68.657342 44.370458 Decimal Degrees.

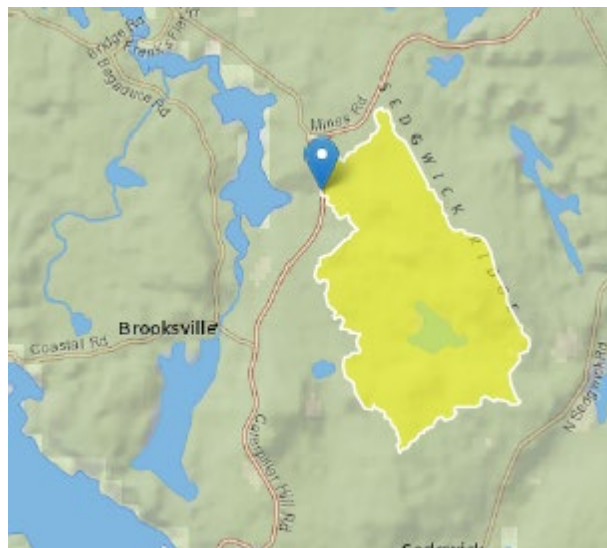
Maine Habitat Viewer: Rt 15 Crossing. Site ID: [50875](#) Barrier. 48 x 7 ft perched culvert

Since this location has high native species diversity and the road is a barrier to upstream fish, I highly support your intentions of replacing this crossing with an open bottom structure that will pass flood events exceeding 100 year frequencies as shown in the attached Stream Stats outputs.
