2021-2022 Snow Brook Drone Report

- Land Cover Change Analysis:

Location: Snow Brook, Sedgwick, Maine

Client: Maine Coast Heritage Trust

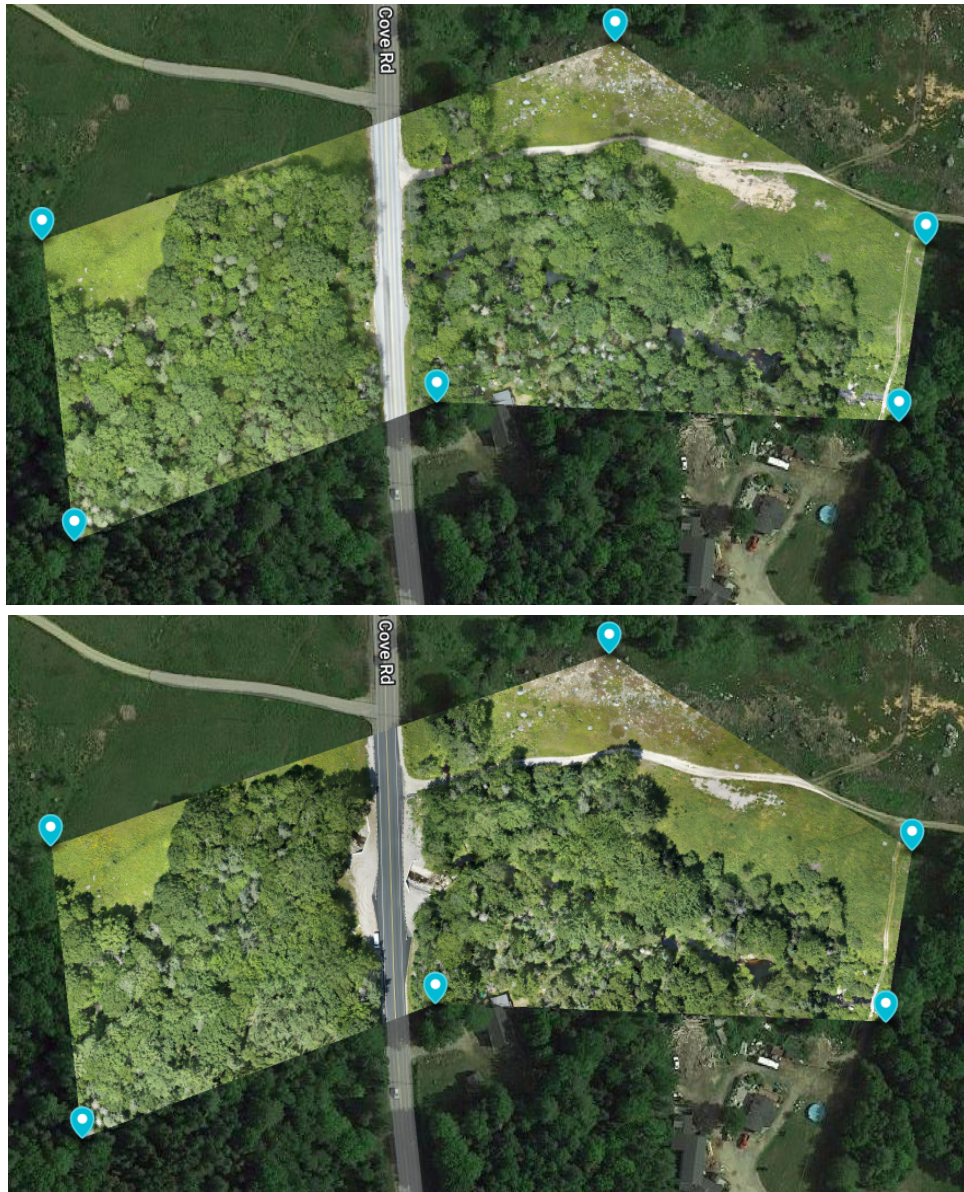
2021 Top: 2022 Bottom

In addition to structural data collection from the LiDAR, we also performed red, green, blue spectral data collection to create photographic-based orthomosaics to try to determine if land cover classification changed.

Using Maximum Likelihood Classification training algorithms in ArcGIS Pro we feed spatially-identical orthomosaics from the inter-tidal zone upstream over Snow's Cove Rd up to a set of rapid's by a four wheeler bridge. We report homeostasis everywhere that was not affected by installing the new bridge, besides grasses reclaiming blueberry field that had wood chips piled before spreading. This was not a change due to the project.

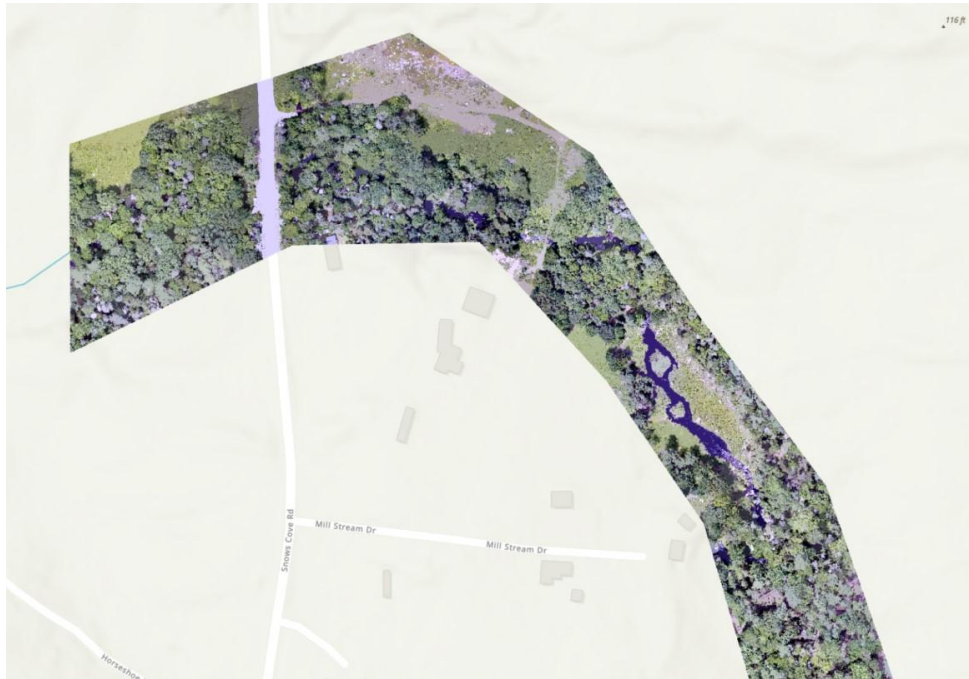
We also ran Maximum Likelihood Classifications of the dogleg at Snow Brook which included the wetlands and woody wetland and again were unable to find any statistical change. Below is a raster colored by land classification.

Water, developed, barren, deciduous forest, evergreen forest, shrubland, and herbaceous (grassland) classifications are present
