Re: Monitoring Report for Dollar Bay Wetland Restoration Project

This letter constitutes the first monitoring report for the Dollar Bay restoration project located in Texas City, TX. In brief, the project appears to be on track, although the marsh vegetation is still developing and not yet meeting full performance standards. The detailed report follows. Please do not hesitate to contact us directly if we can provide any additional information or address any concerns.

Project Overview

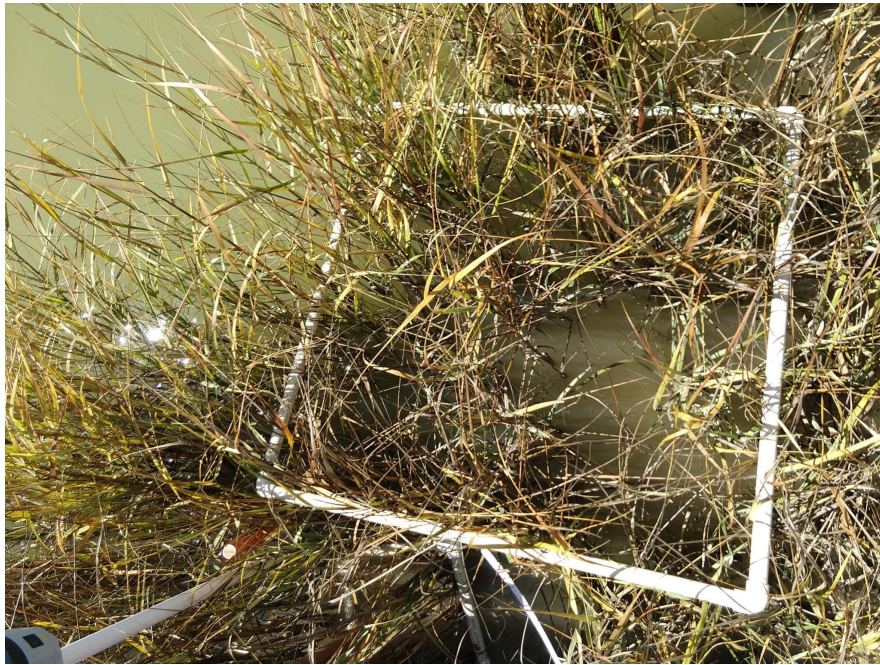
Figure 1: Example of a quadrat at the origin point of transect DB3 with *Spartina alterniflora*, PVC marker stake, and Trimble R2 GNSS.

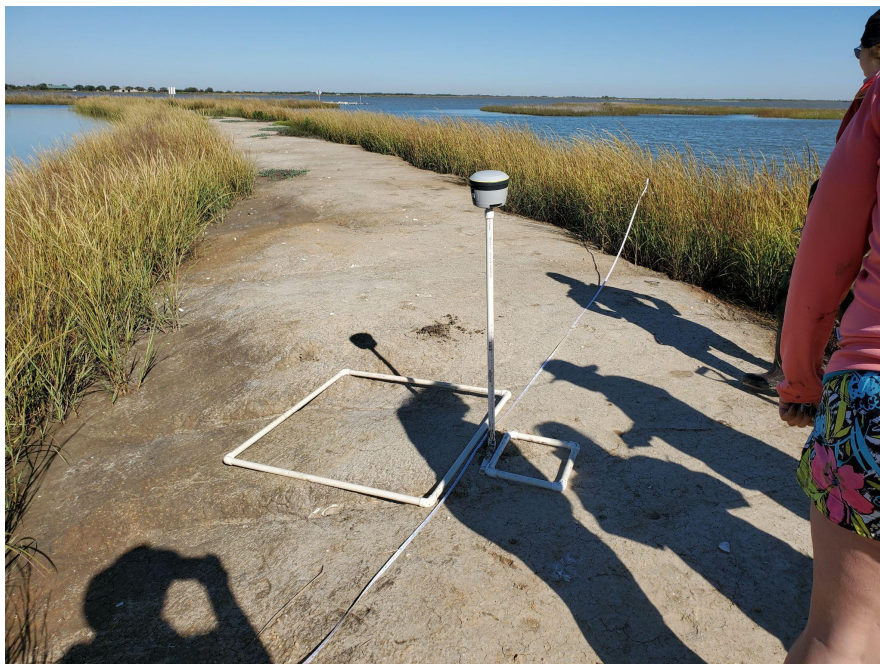
However, data includes measurements from the crown of the terrace in addition to the edges. The terrace crown was typically composed of only bare ground with no plants, because plantings were only done along the terrace edges. Excluding the crown data, average *S. alterniflora* density was 129 stems, and the *S. alterniflora* average aerial coverage was 26.2%, indicating plants at the marsh edge are meeting performance expectations for stem density. The lower coverage numbers indicate that the marsh vegetation is still undergoing growth and development (ecological succession). The low vegetation coverage at Site DB10 may also indicate impacts by erosion or edge sloughing hindering plant growth. If the observed growth rate continues, we expect the *S. alterniflora* vegetation to meet the coverage target within five years.

Figure 2: Example of a quadrat at the midpoint of a transect with bare ground.

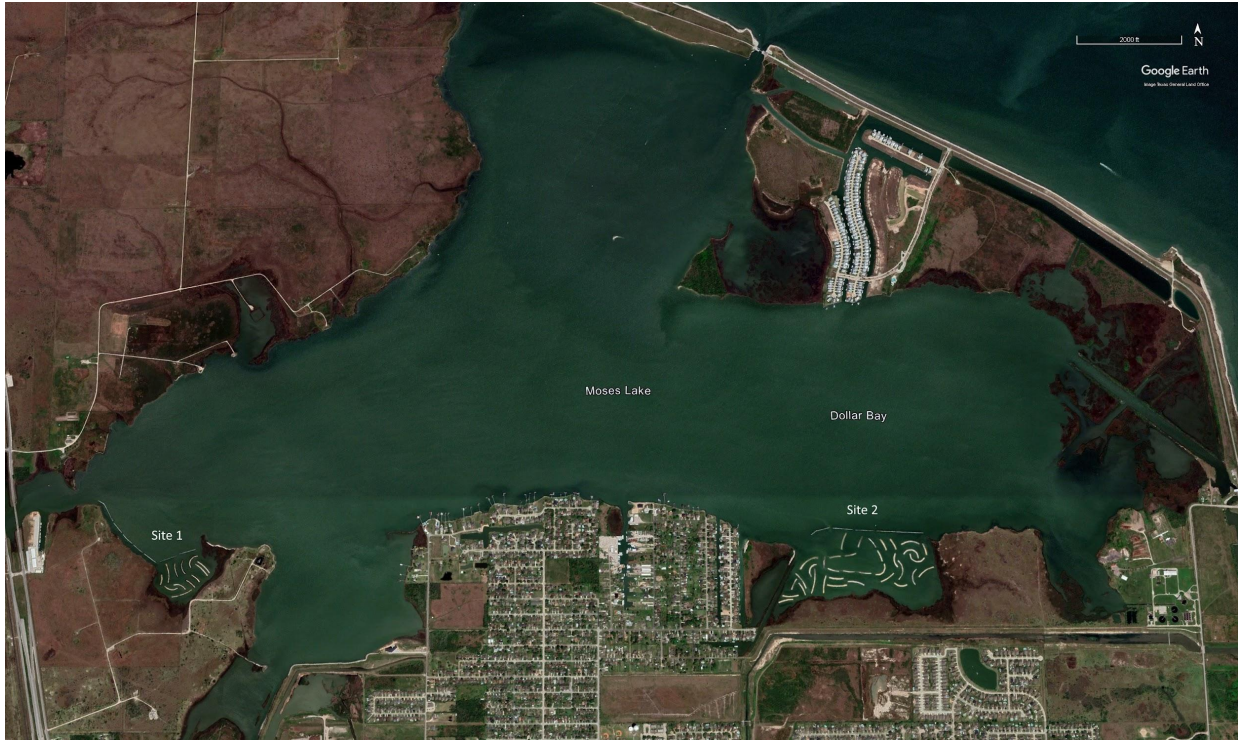
Figure 3: Satellite image of Dollar Bay and Moses Lake, showing site 1 and site 2 of the terrace wetland restoration project. Source: Google Earth, Landsat / Copernicus. (Image date: July 2022)

3. Project purpose: Create approximately 11-15 acres of low marsh habitat to restore aquatic habitat previously lost to ground subsidence and erosion.
4. Location: Two sites of terraced wetlands constructed in Moses Lake - Dollar Bay, located in Texas City, Texas, 77590 (Fig. 3, 5). Site 1 Lat: 29.41870365751326 Long: -94.95106302089012; Site 2 Lat: 29.419394918108072 Long: -94.91280646057884. 15 terraces (6 in Site 1, 9 in Site 2) were randomly selected for sampling.

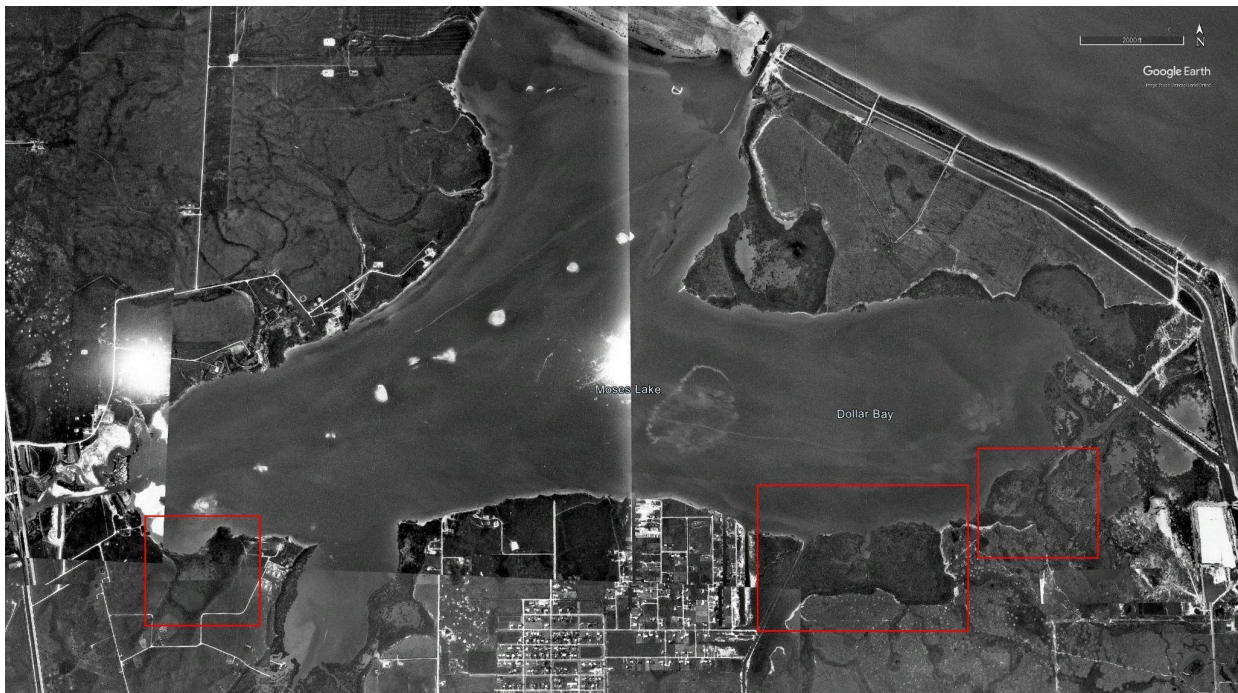
1. The Dollar Bay restoration project is a terraced wetland constructed to restore wetland habitat previously lost to subsidence (Fig. 4), built in Spring 2021. Initial plantings of adult *Spartina alterniflora* (aka *Sporobolus alterniflorus*) were completed between 2021-2022 (exact planting dates vary by site). Monitoring will be conducted during the first two years, using the plot transect method to obtain data on plant density, aerial coverage, *Spartina a.* chlorophyll production, and *Spartina a.* biomass.

Figure 4: Historical image of Dollar Bay from 1969. Red boxes indicate wetland areas that were lost due to subsidence. The Dollar Bay restoration project aims to restore the lost habitat. Source: Google Earth, Texas General Land Office.

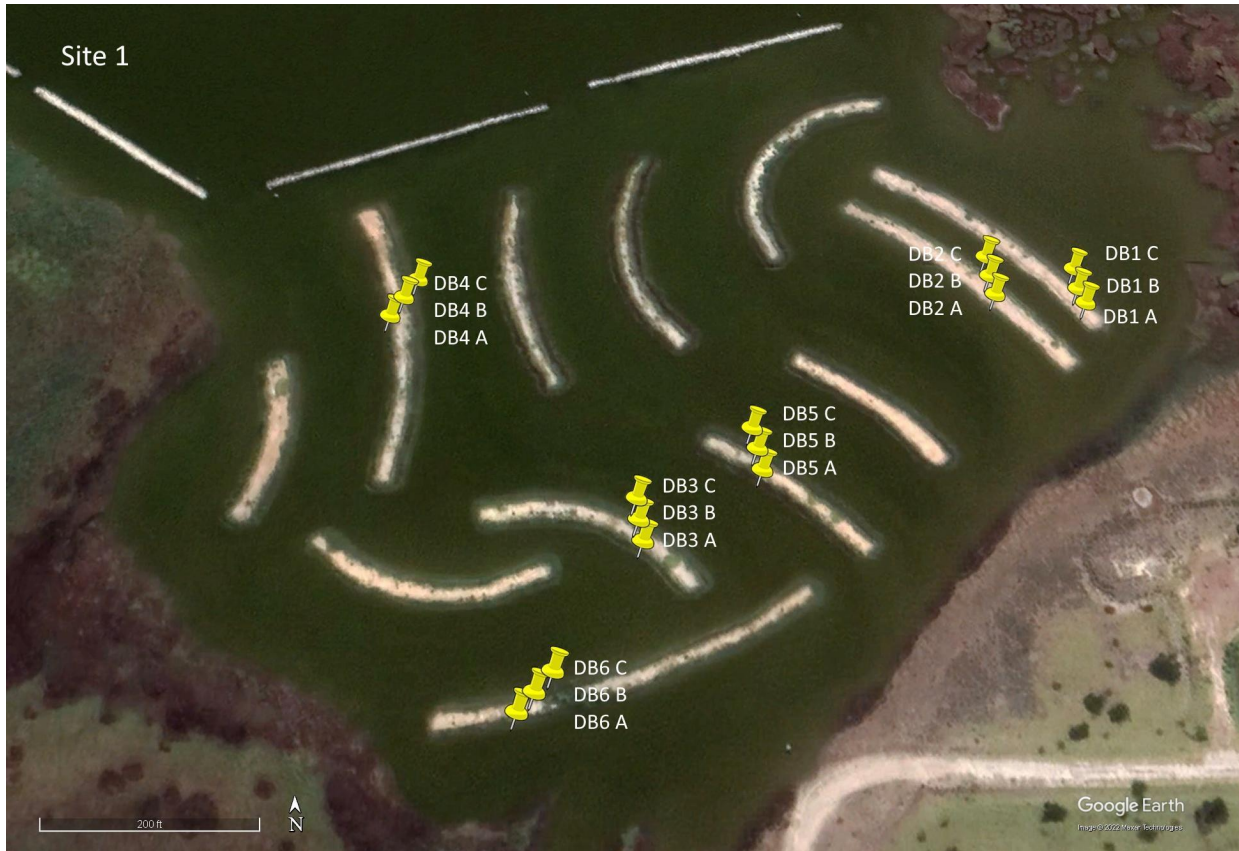
Figure 6: Satellite map showing where each study transect and quadrat is located in site 1 of the Dollar Bay restoration project. Source: Google Earth, Maxar Technologies

Data was collected by plot transect method, using 15-meter transects laid at an approximate 45-degree angle across the width of the terrace, generally arranged from south (origin) to north (terminus) to measure community metrics on both sides and at the crown of each terrace (Figure 6, Figure 7). The location of the origin of each transect was located with a Trimble R2 GNSS receiver for latitude, longitude, and calculated elevation (AMSL), and marked with a PVC stake. Three 1m² plots were placed along the north edge of each transect, one at each end and one at the midpoint, for a total of 45 plots and 15 transects.

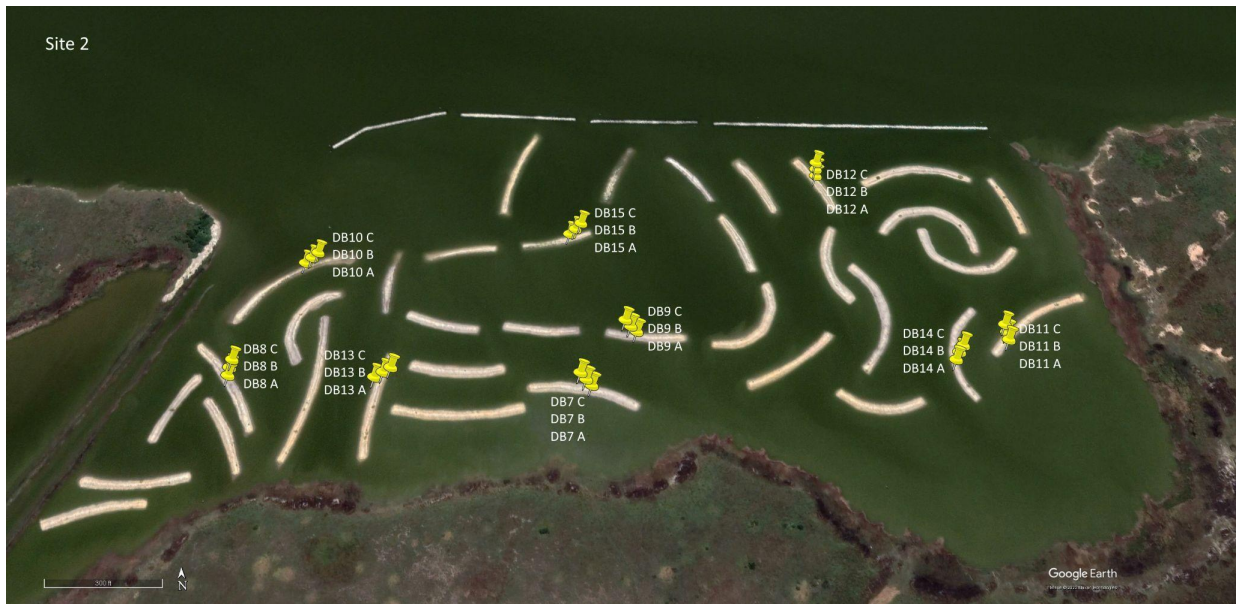
Figure 7: Satellite map showing where each study transect and quadrat is located in site 2 of the Dollar Bay restoration project. Source: Google Earth, Maxar Technologies (Image date July 2022)
