Lake Superior Shoreline Restoration

Preliminary Design Report

April 15, 2021 | 13290.102.R2.Rev0

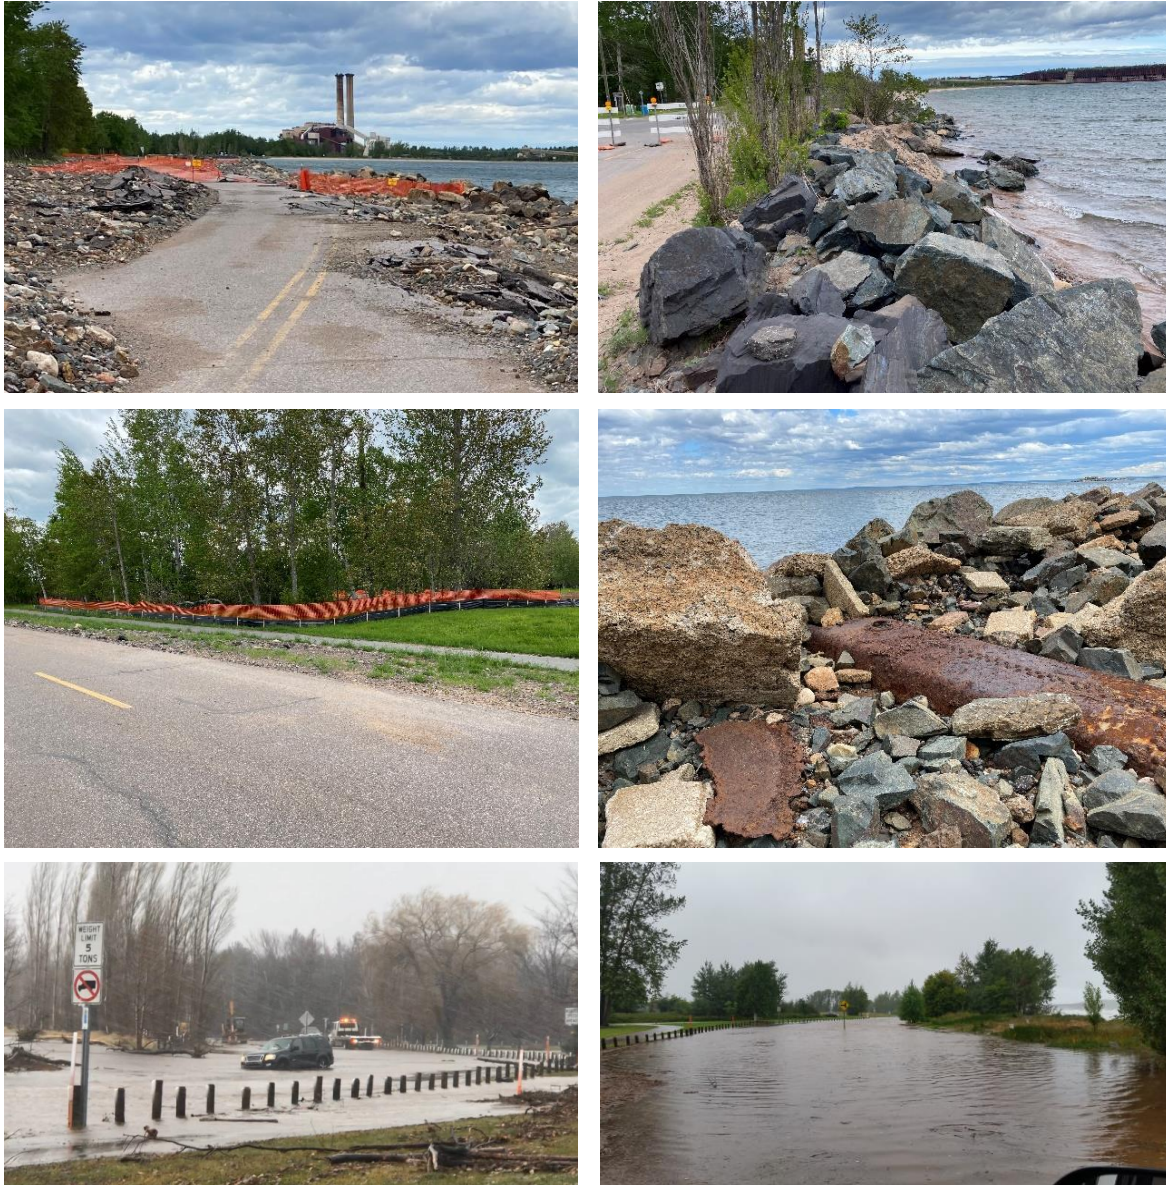
Figure 2.1: Shoreline Conditions

- Overall – Most of the 4,000 ft shoreline is a public eyesore, a serious public safety hazard, offers no waterfront pedestrian access, and does not contribute to the surrounding ecosystem. In some portions of the site, the area adjacent to the shoreline will remain vulnerable to flooding unless protection is upgraded.

- Former Roadway - Immediately landward of the existing revetment and adjacent to the shoreline are the asphalt remnants of the former Lakeshore Boulevard, which has been damaged by ongoing erosion and wave overtopping. Damage is most severe in the southern reach of the project site and moderate along the northern portion of the site.

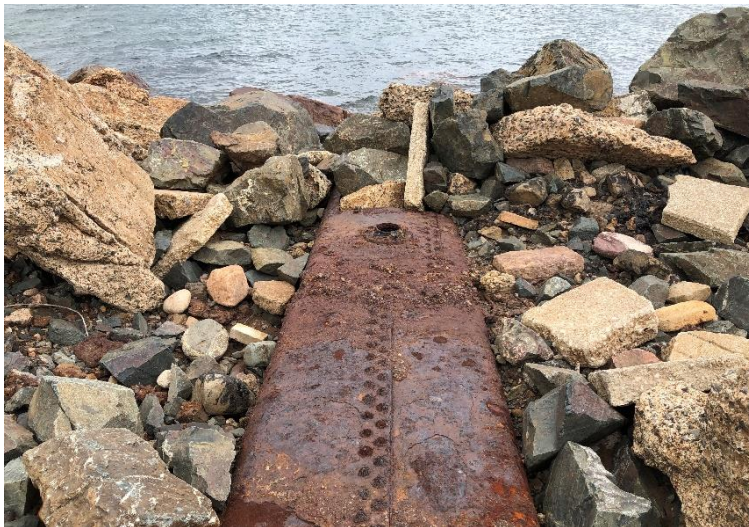
Figure 2.2: Possible Historical Retort Discharge Pipe from Cliffs-Dow Site

- Large remnant steel outfall with the observed presence of tar like substance, which may be the direct discharge identified in the 1998 Barr report (Figure 2.2).
- Large amounts of scrap pig iron and slag located along the shoreline and between the existing revetment and former road.
- Six-inch (6") steel pipe with observed tar residue inside.
- Building materials from historical upland operations.

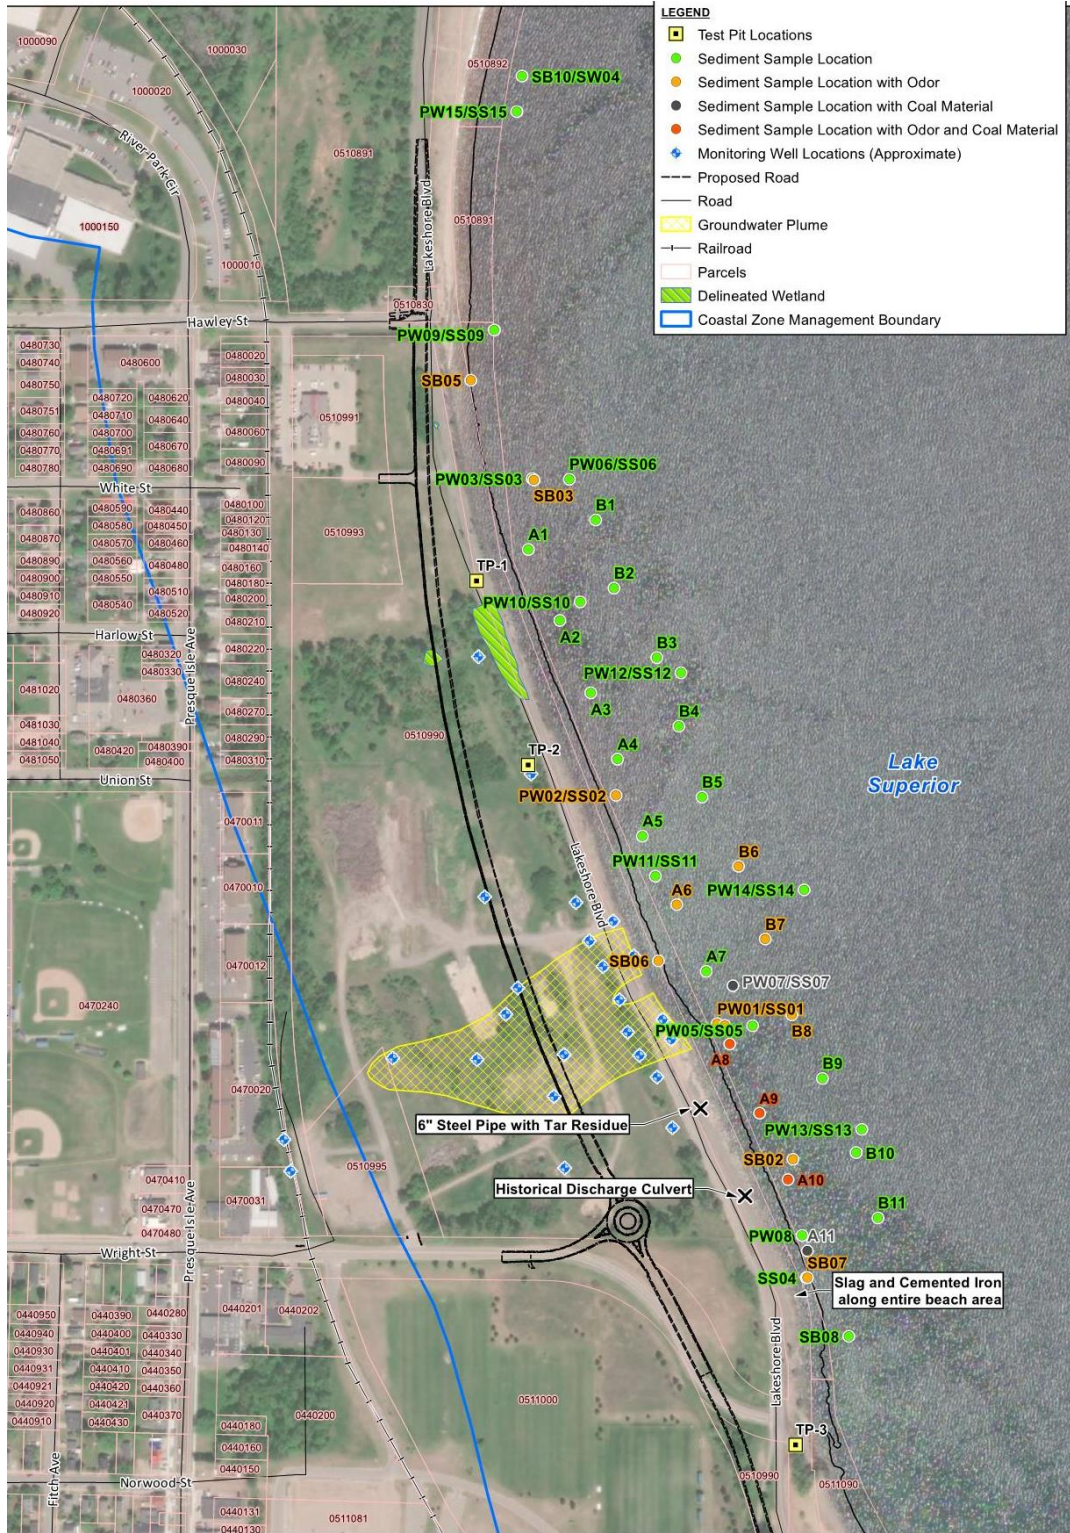
Figure 2.3: Cliffs-Dow Areas of Environmental Interest

In 2016, 2017, and 2018, EGLE conducted sediment borings to identify impacts within the upper layers of the sediment. These investigations found evidence of wastes from the historical industrial activities, including coal fragments and “campfire like” odors. A nearshore sediment coring investigation was undertaken to further identify the general nature of impacts. The sediment coring investigation was completed in May 2020 and observed coal-like material and the presence of odors within the sediments. The locations at which these were found are indicated on Figure 2.3 and are compared with the previous findings by EGLE (Ref Appendix B).

For the findings that represent individual locations, GPS coordinates were collected from locations identified during the Baird team’s site reconnaissance. The scrap pig iron and slag deposits were consistent across the majority of the nearshore area; this suggests the materials may have been placed there as fill. In addition, a wooden pile wall was observed, which appeared to extend along the entire length from Wright Street to Hawley Street. Recent erosion in this area has exposed the piles, the steel tieback wires, and deadman anchors.

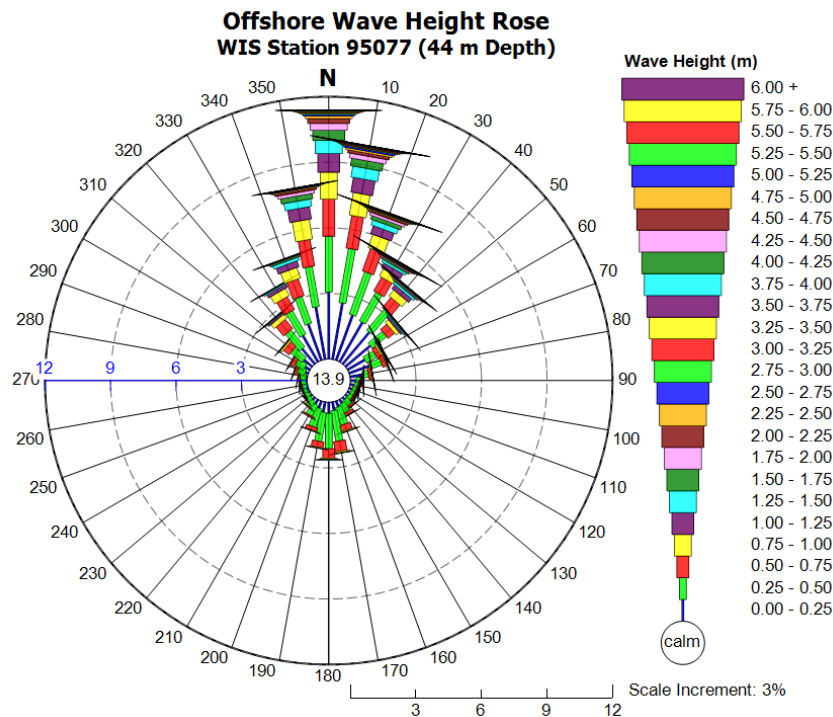
Figure 3.1: Offshore wave height rose at Marquette

- Offshore waves arrive from the northeast (NE) to northwest (NW) window approximately 60% of the time. Significant wave heights greater than 20 ft may occur during extreme storms from north-northeast (NNE) direction.
- Offshore waves arriving from the northeast (NE) to southeast (SE) window (i.e., easterly waves) occur approximately 10% of the time, with wave heights reaching 10 to 12 ft.
- Wave heights are less than 2 ft (i.e., relatively calm conditions) approximately 70% of the time. Wave heights are greater than 5 ft approximately 5% of the time. Wave periods range between 2 to 12 seconds.

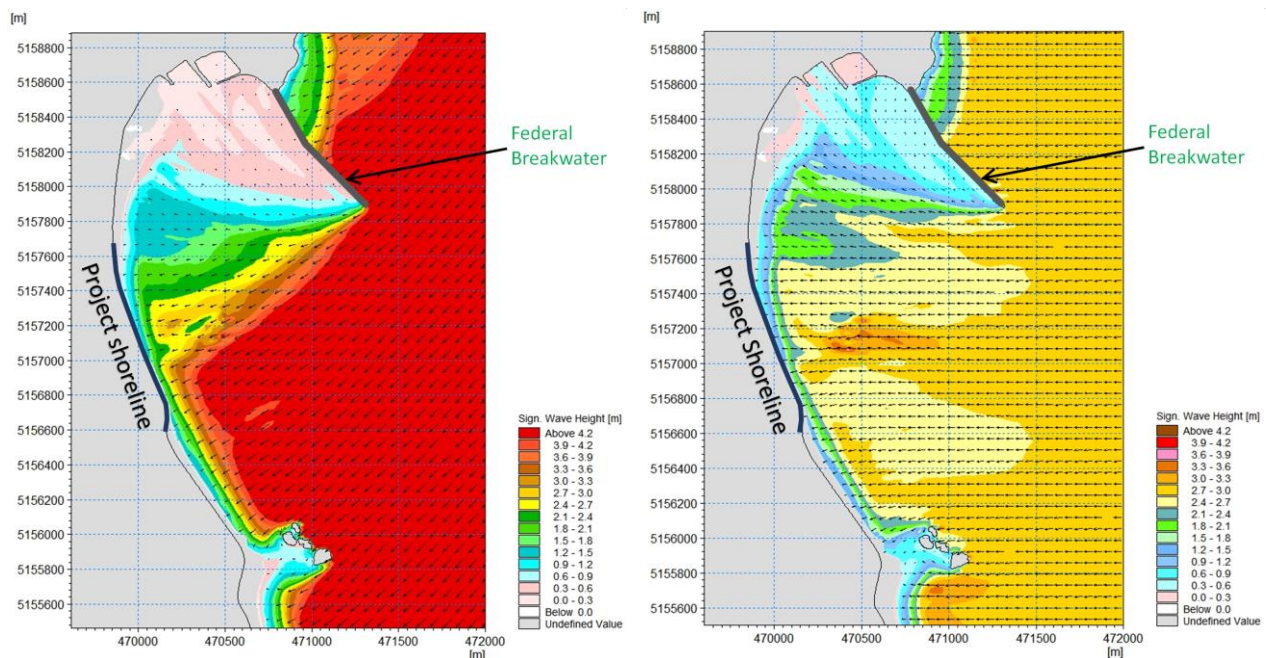
Figure 3.2: Model results (waves from NE direction on left, waves from E direction on right)

Examples of wave height patterns under a strong northeasterly (NE) event, as well as an easterly event (E), are displayed in Figure 3.2. The color shading in this figure represents the significant wave height H_s , and the arrows indicate the wave propagation direction. The model results illustrate how waves undergo refraction as they approach the project site. The results also indicate that the Federal breakwater has a significant impact on the nearshore waves in front of the shoreline, resulting in progressive reduction in wave height as one moves north into the shadow zone of the Federal structure. The sheltering effect progressively increases as the wave direction turns from east through NE to north and beyond.

Nearshore Wave Climate - To understand the nearshore wave climate, the offshore waves were transformed to various nearshore locations along the project shoreline using the Danish Hydraulic Institute (DHI) MIKE21 Spectral Wave (SW) model. Offshore wave conditions were defined at the model boundaries using the WIS data, and nearshore bathymetry was obtained from the USACE 2011 LiDAR data. Wave transformation calculations were performed for average lake level conditions (i.e., ~ 601.8 ft IGLD'85).

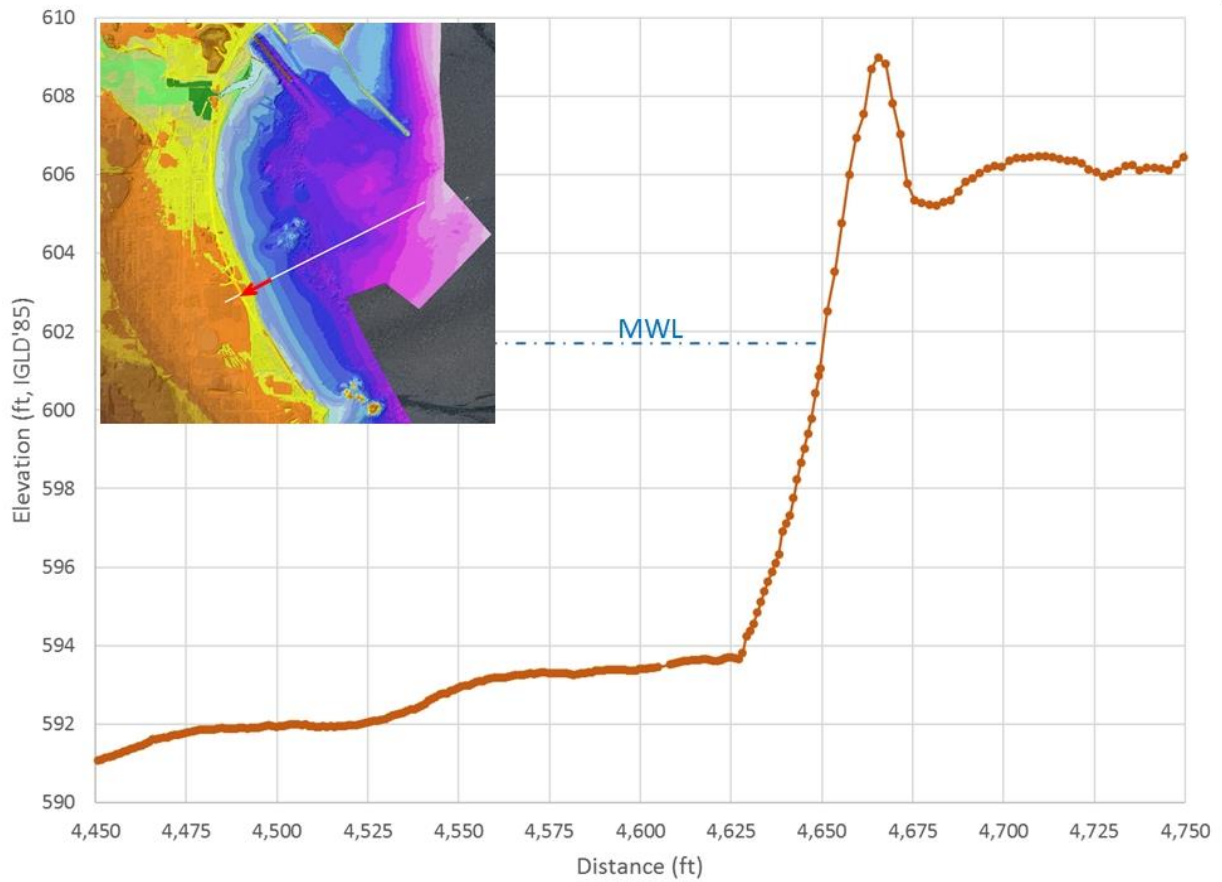
Figure 6.2: Typical nearshore profile along the southern half of Reach B (2020 survey)

Figure 6.2 shows a typical nearshore profile along the southern half of Reach B. The nearshore lakebed in front of the existing stone revetment is relatively deep, with more than 8 ft of water under mean water level (MWL) conditions. Lakebed deepening is a common issue along many armored shorelines on the Great Lakes. This is believed to be the result of ongoing (slow but steady) removal of sediment cover from the lakebed by waves and longshore currents while the shoreline has been kept in place by the shore armoring. Eventually, the lakebed reaches a depth where non-storm waves are unable to generate typical nearshore processes such as wave breaking and longshore currents. As such, the transport of lakebed sediment only happens under severe storm events and even that may be at small levels. Lakebed borings using a check-valve sampler completed for this study indicate that the sediment thickness on the lakebed in this area is limited to 1 to 3 ft (Figure 2.3 and Appendix B).

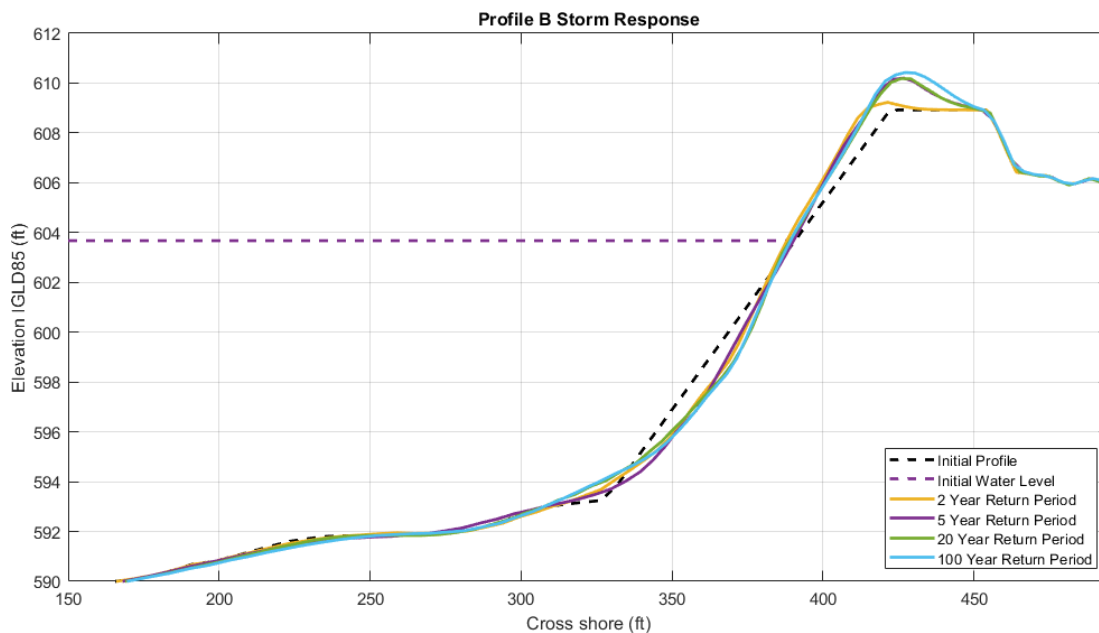
Figure 6.6: XBeach-G model predictions for the exposed profile near the south end

Figure 6.6 shows model prediction results at the more exposed (south) section of the Living Revetment (Profile B). The model predicts erosion of the lower slope and accretion of the upper slope, including the development of a moderate storm berm under 5-year and greater wave conditions. It is not possible to predict if this would translate to significant alongshore movement of the stones and if so, what would the rate of transport be. It does indicate that periodic maintenance, including returning of displaced stones (or adding new stone), may be required every five years on average.

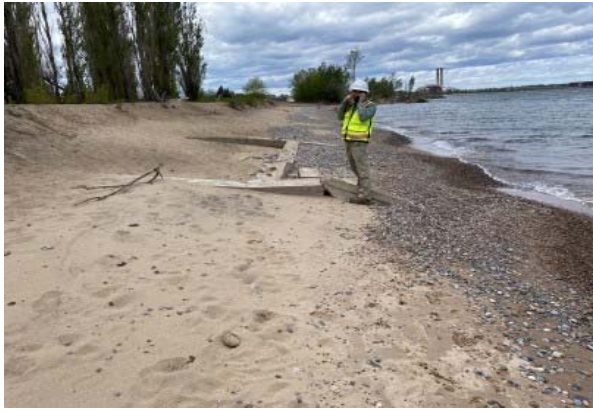
022 - Newly exposed concrete foundation on the NMU beach. Near Location 3.

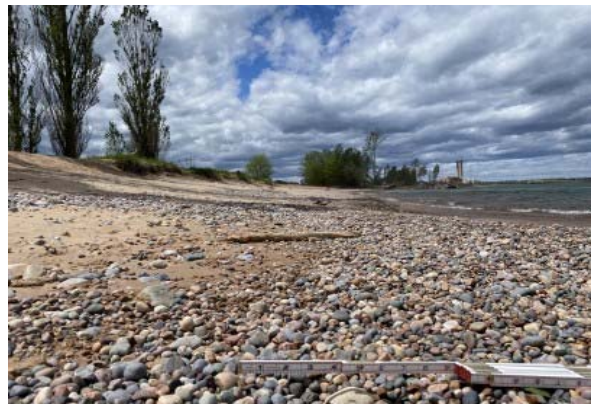
023 - Gravel accumulated on the beach near the waterline. Near Location 3.

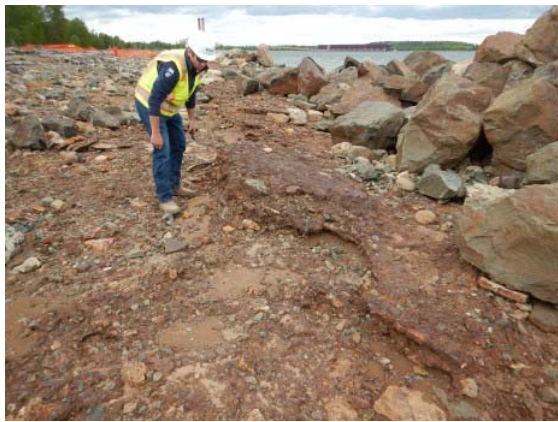
075 - Cemented iron-sand-cobble-slag conglomerate found along shoreline of project site. Location 8.

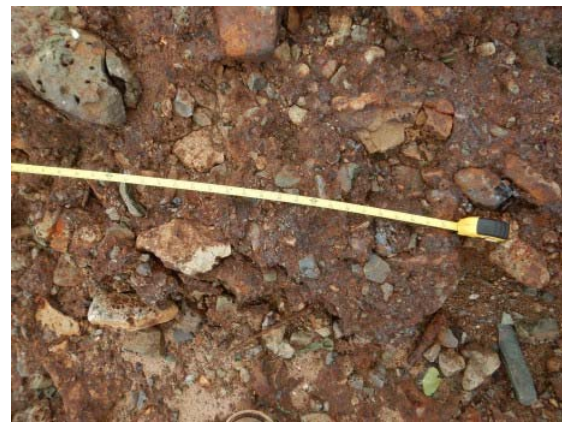
079 - Cemented iron-sand-cobble-slag conglomerate found along shoreline of project site. Location 8.

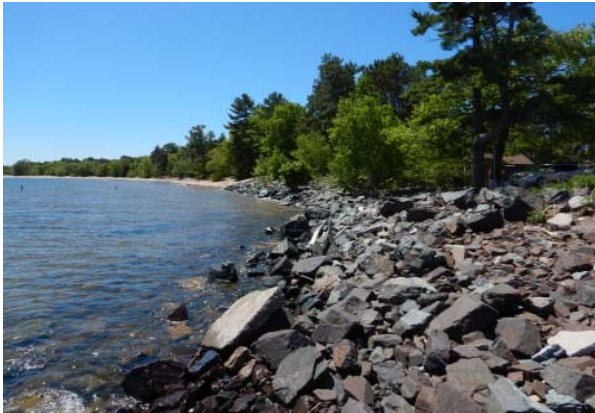
009 - Looking south along the shoreline at Shiras Park. Relatively new armoring indicates ongoing erosion. Location 1.

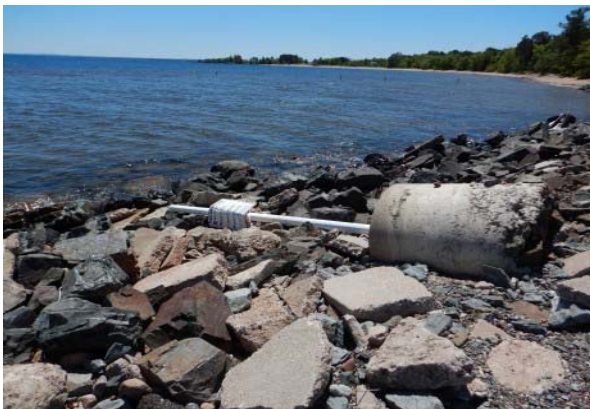
005 - Sign advising swimmers against dangerous currents and water conditions has toppled due to chronic erosion. Location 1.
