American Littoral Society  
Restoring Ecologically Beneficial and Resilient Infrastructure At The  
Mouth of Maurice River, Basket Flats  
Abiotic Physical Monitoring Report for 2023

Stockton University Coastal Research Center

*November 2024*

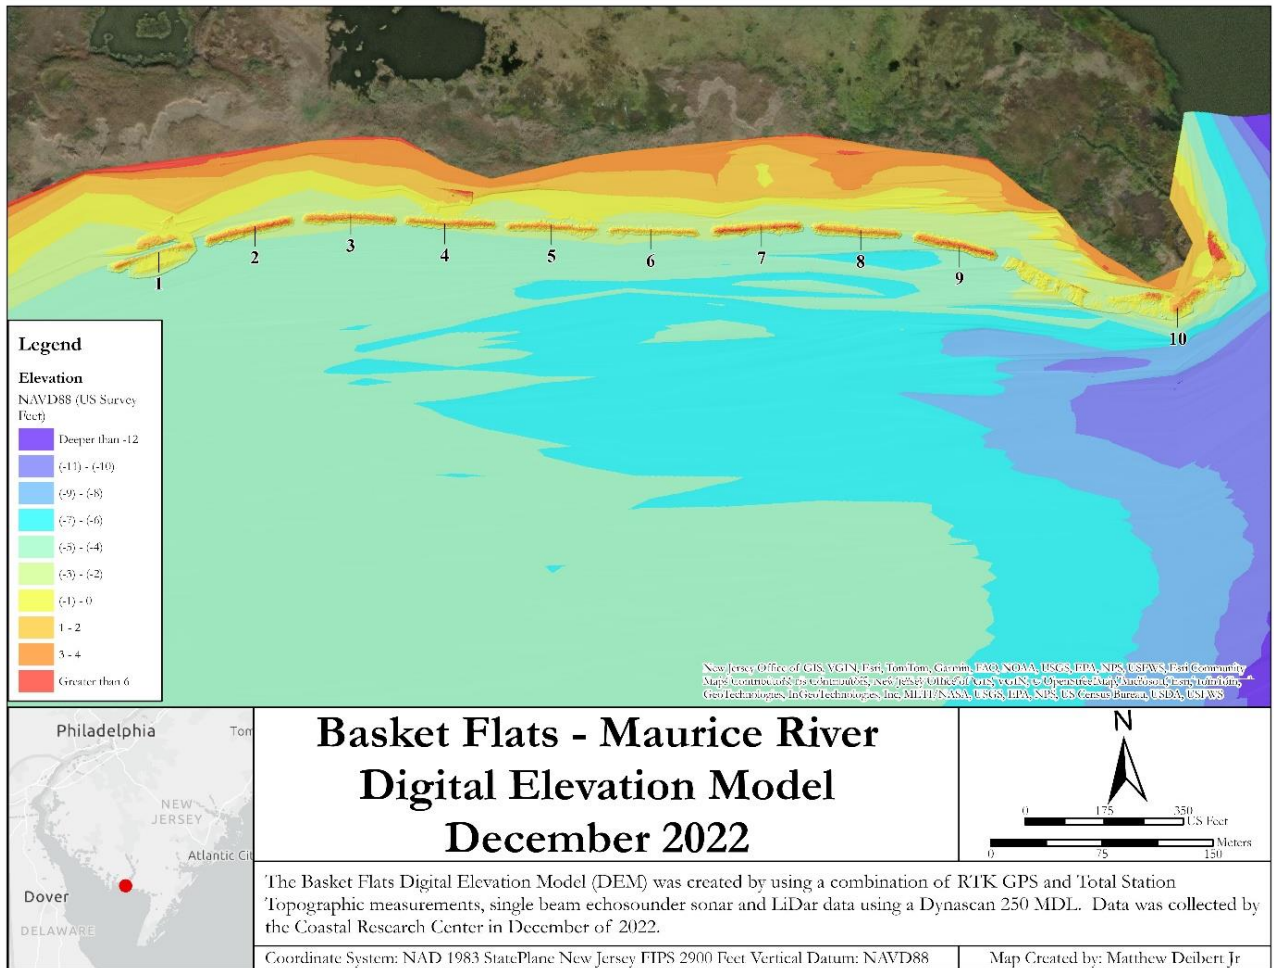
**Figure 17. The December 2022 DEM shows surface conditions following installation of the breakwater units and the partial revetment/sill. Breakwater units are labeled 1-9 from west to east while the revetment/sill is labeled as number 10. The color pattern again indicates reds and orange are regions with higher elevations while blues and purple are regions with lower elevations.**

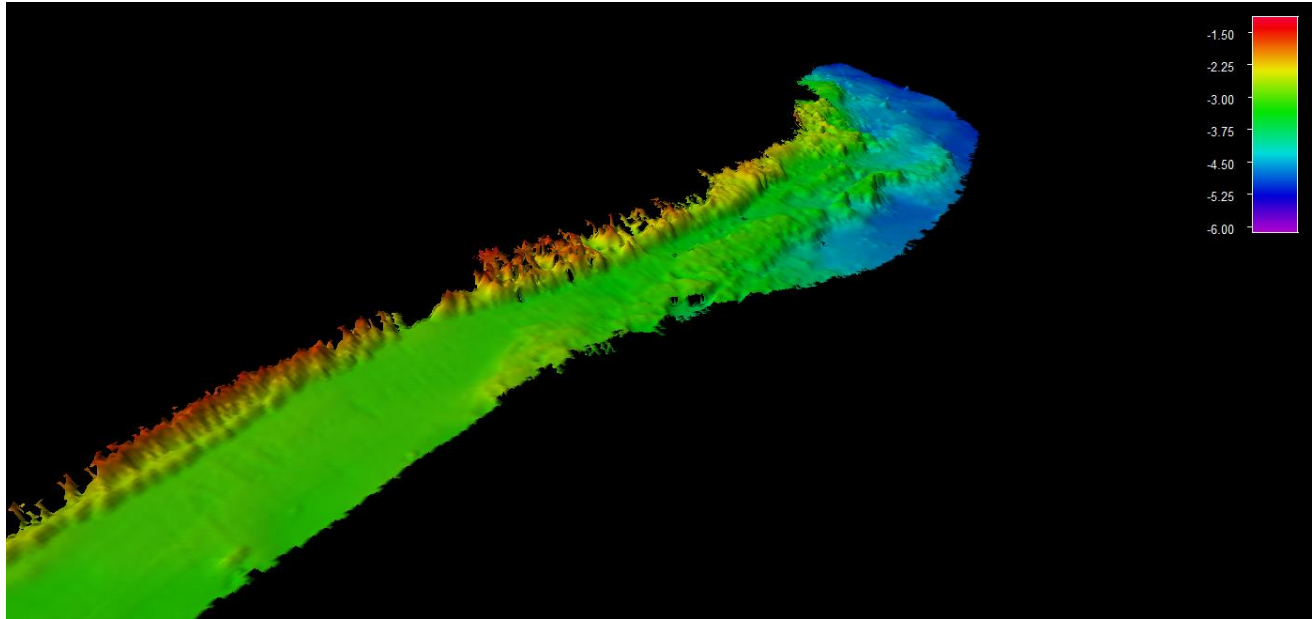
**Figure 55. Shows the spatial relationship between Breakwater unit #9 and the sill and revetment #10 to the far right. The bay floor seaward of unit #9 is consistent in elevation while towards unit #10 the bay floor quickly drops into the deeper channel off the tip of Basket Flats. The seaward rock slope elevation also decreases moving towards the tip on unit #10.**
