### Technical Memorandum

**To: Loren Brokaw**  
**Washington State Department of Fish and Wildlife**

**Subject: Initial fish results from Leque Island restoration.**

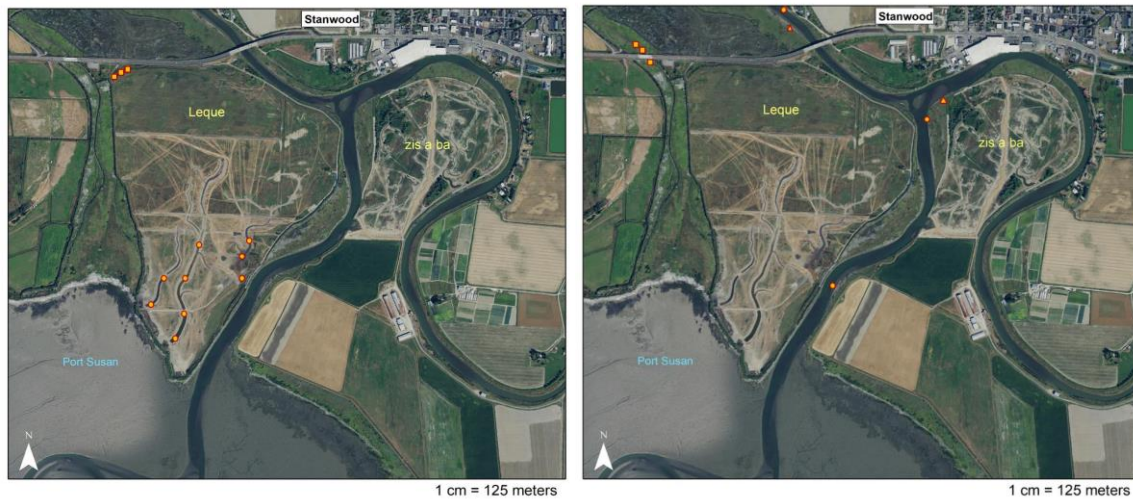
Figure 1. Location of the Leque Island fish sampling sites within the restoration area (left panel) and within the restoration locations (right panel). Beach seine sites are shown as circles, stick seines are shown as squares and fyke traps are represent by triangles (from Henrichs et al. 2020).

Leque Island fish monitoring was conducted between February and August in the restoration area that comprises three tidal channels opening toward the southern end of the island and the Davis Slough tidegate that opens to the east into Davis Slough (Figure 1). Since we need to account for change over time and abundance can change year to year, eight reference site locations are also monitored during the same period. Fish were caught using stick seines (25 ft by 6 ft), beach seine (80 ft by 6 ft) and fyke nets (40 ft by 10 ft) all with 1/8 in mesh. Nets were deployed during ebb tides when water is contained in the wetted channels leaving the marsh surface dewatered (see Henrichs et al. 2020 for details).
